**RE: Addendum #4 25-40 Utility Services Dive Services**

A comprehensive inspection was conducted by In Depth Inc. on both the saltwater and freshwater sides of the Deer Point Dam between March 14 and 16, 2025. Certified commercial divers performed the inspection, documenting physical defects, corrosion, biological fouling, and the condition of structural and mechanical components.

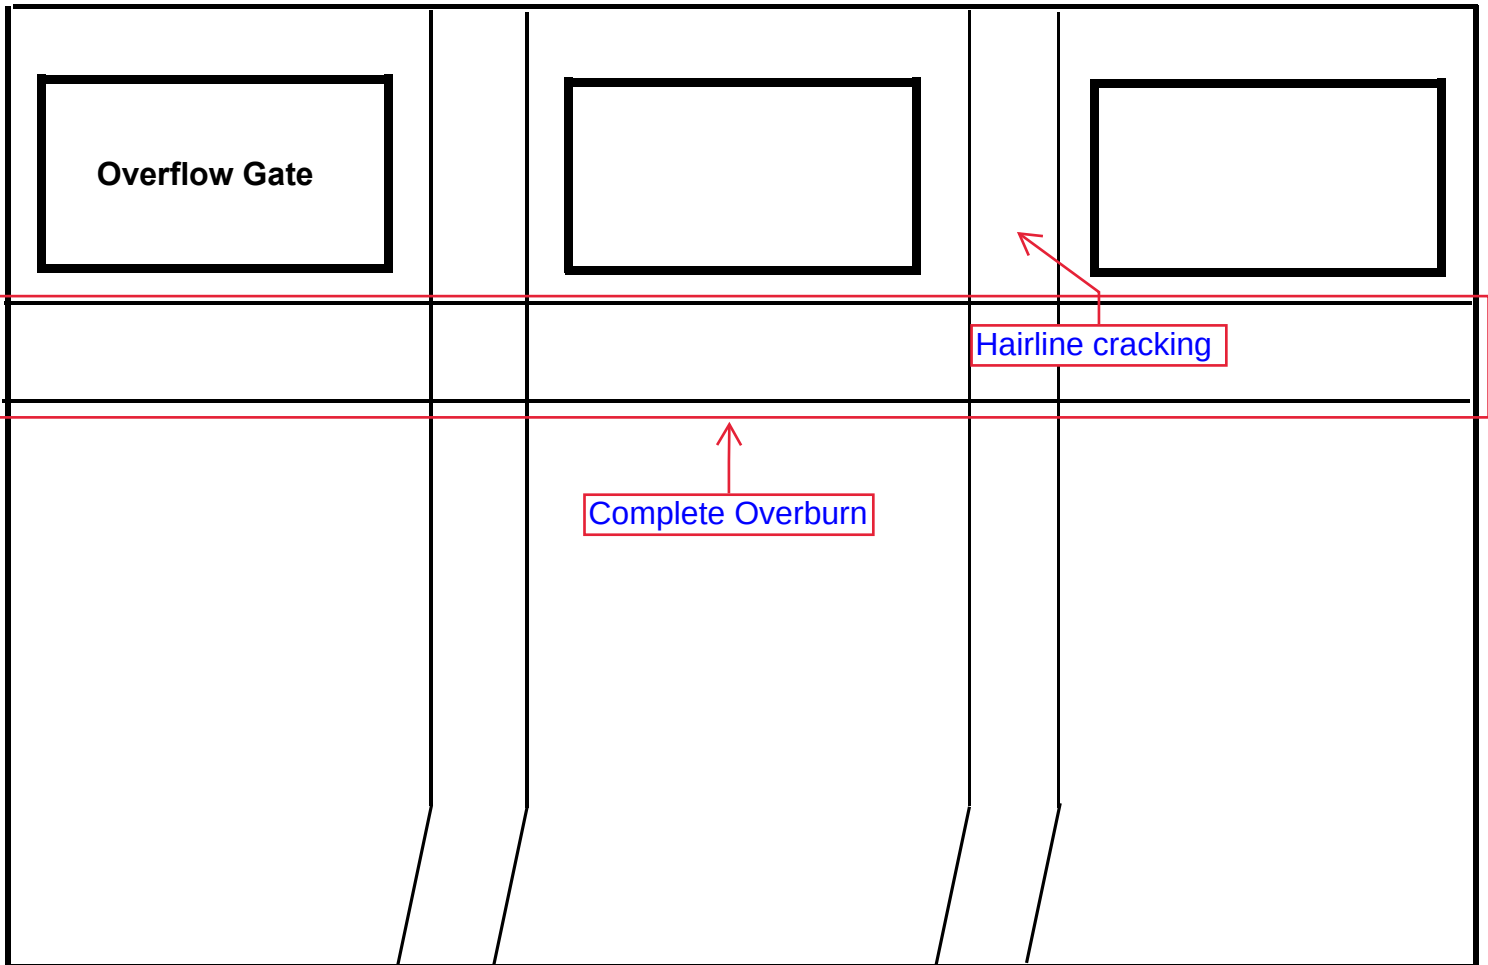
Bent Abutment

- Complete over burden in this bay
- Z-sheets are inaccessible
- Flapper gates in Fair condition; graffiti and minor debris
- Tie back brackets in Good condition; hardware welded
- Exposed aggregate and bug holing present on concrete
- Hairline crack on concrete pile between right and middle gate
- No repairs were carried out

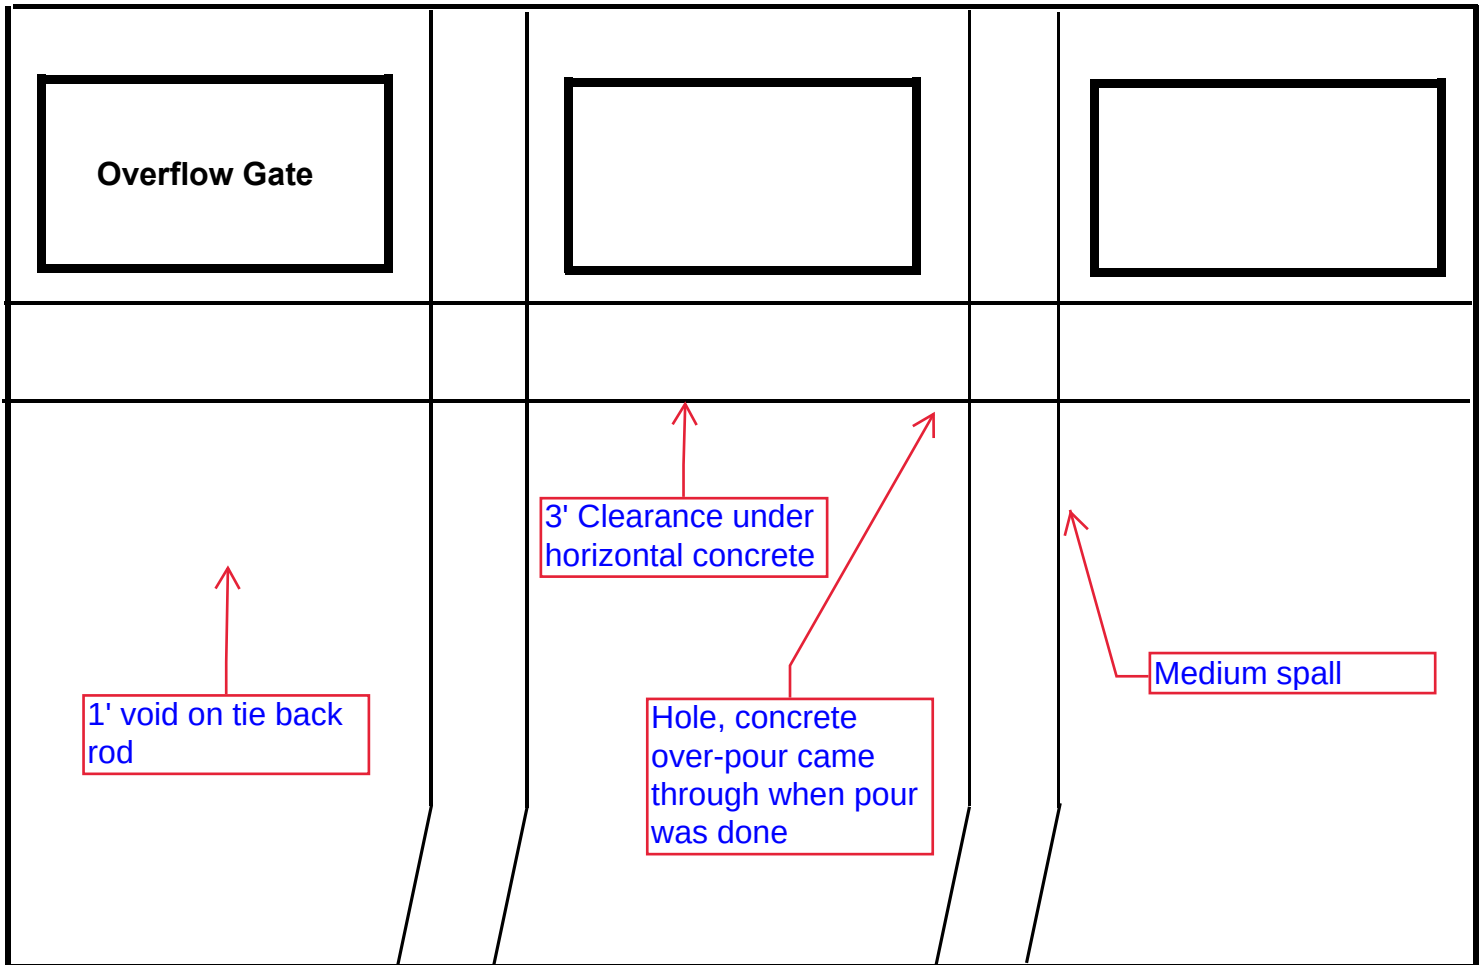
**Bent** 2

- Moderate growth on Z sheets
- Minor scaling noted on Z sheets
- Minor growth present on pile
- Moderate exposed aggregate present on header
- Minor crack on underside of pile cap repaired with Splash Zone

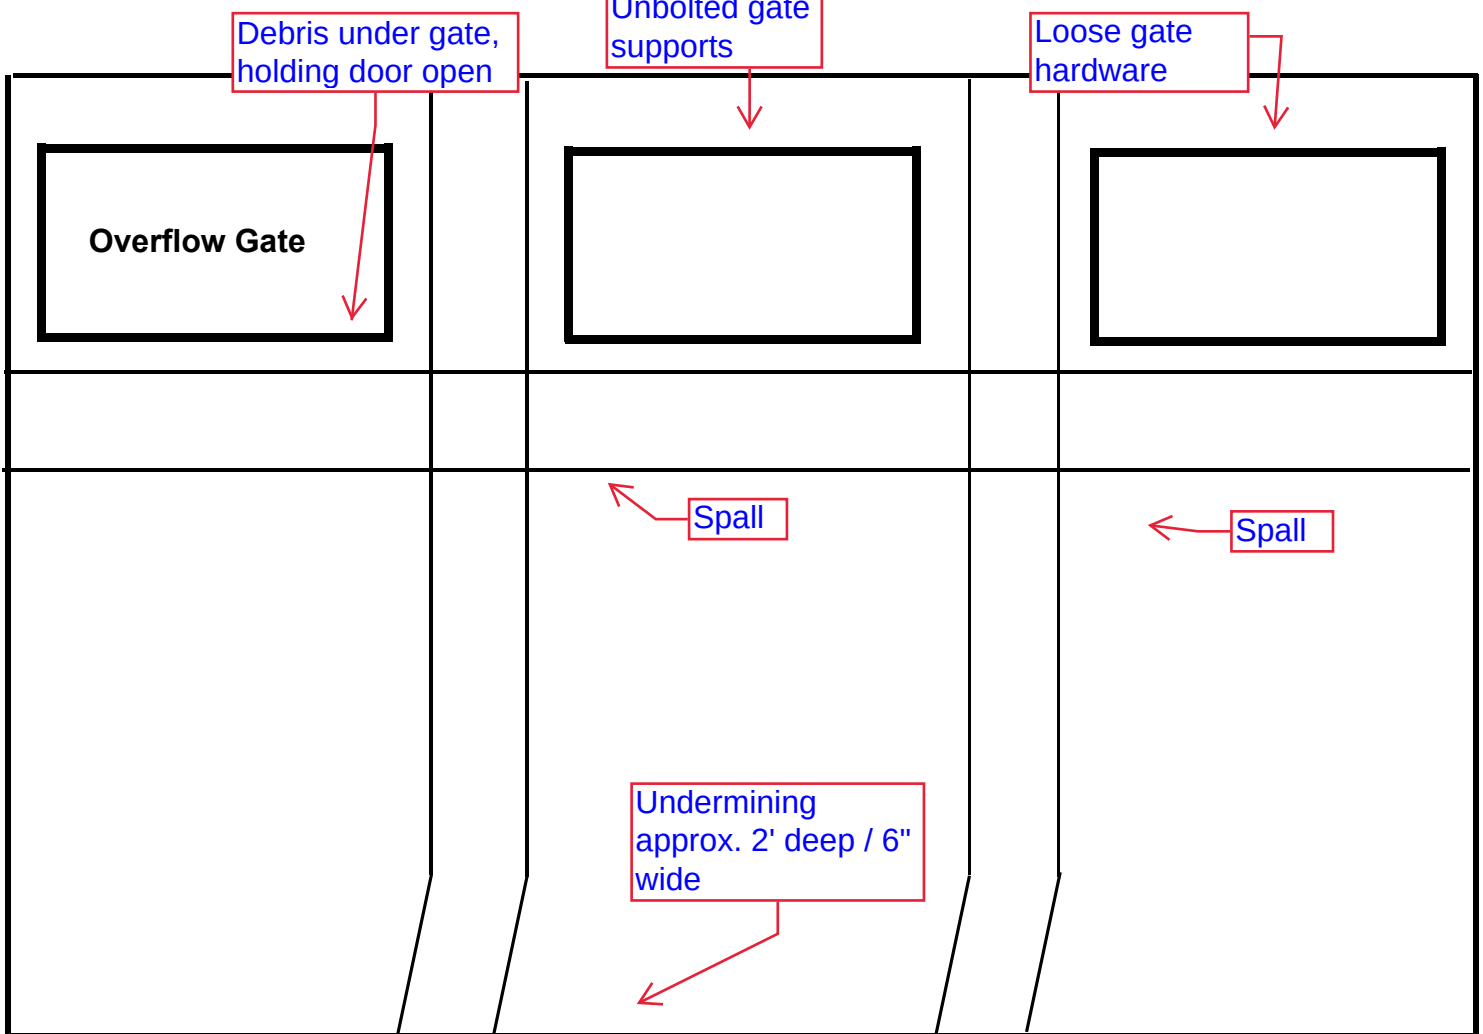
Bent 3

- Minor to moderate growth on Z sheets
- Moderate scaling noted on Z sheets
- Minor spalling (small - medium) present on header
- Moderate growth noted on pile
- Right flapper has debris in it keeping gate open
- Heavy marine growth
- Heavy exposed aggregate
- All holes have been patched

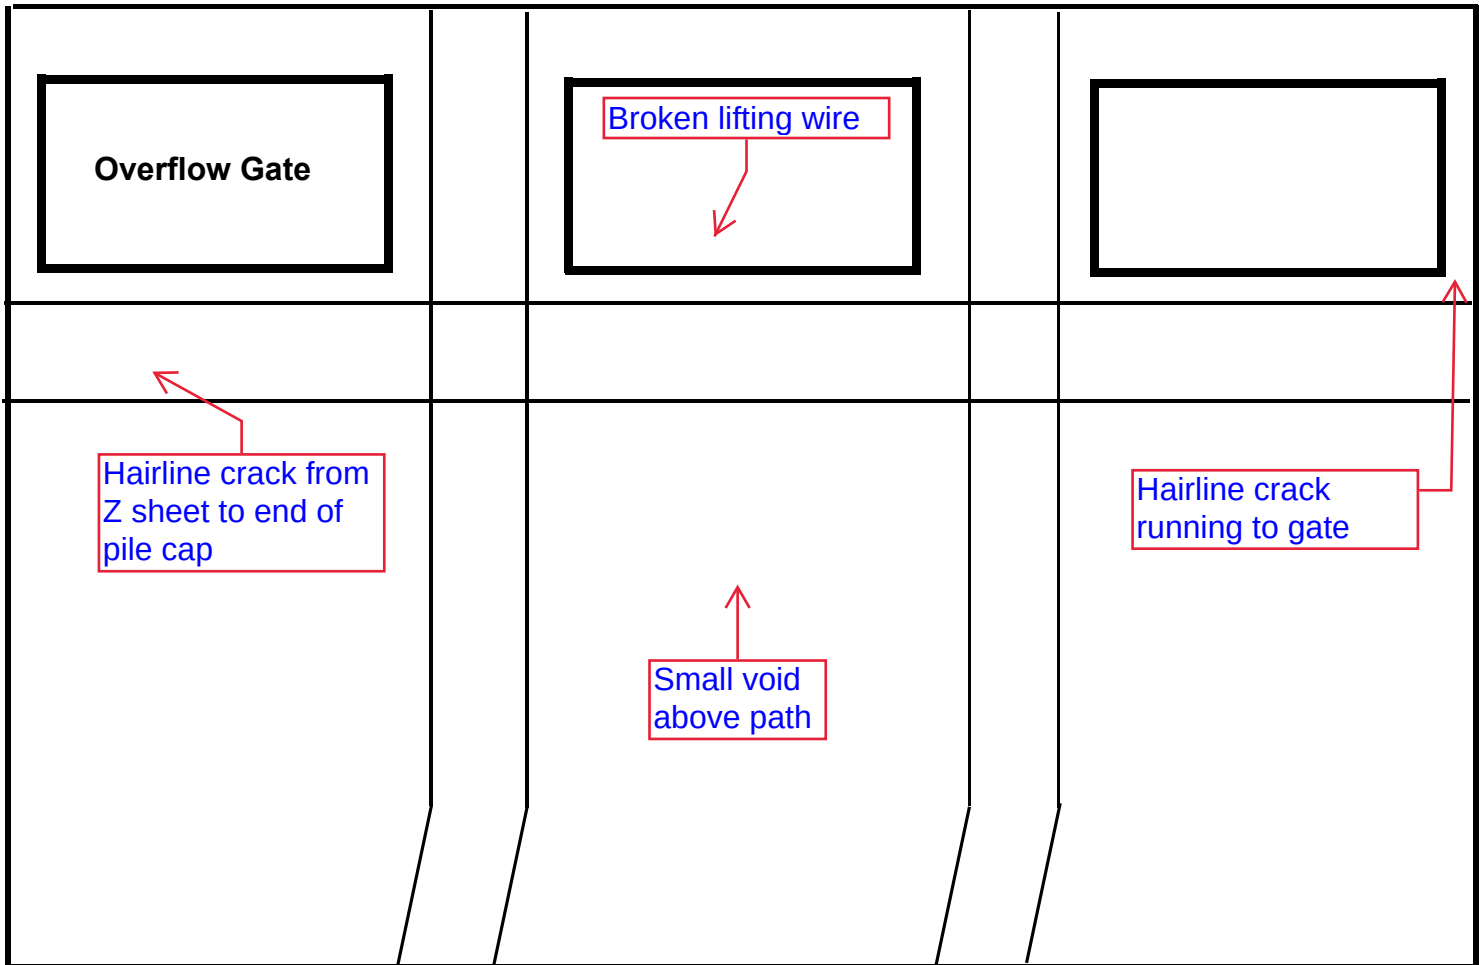
**Bent** 4

- Minor growth present on Z sheets
- Minor scaling noted on Z sheets
- Patches in place over pre-existing holes
- Heavy exposed aggregate on concrete
- Small hole 1" diameter above patch in the middle gate  
16" below header

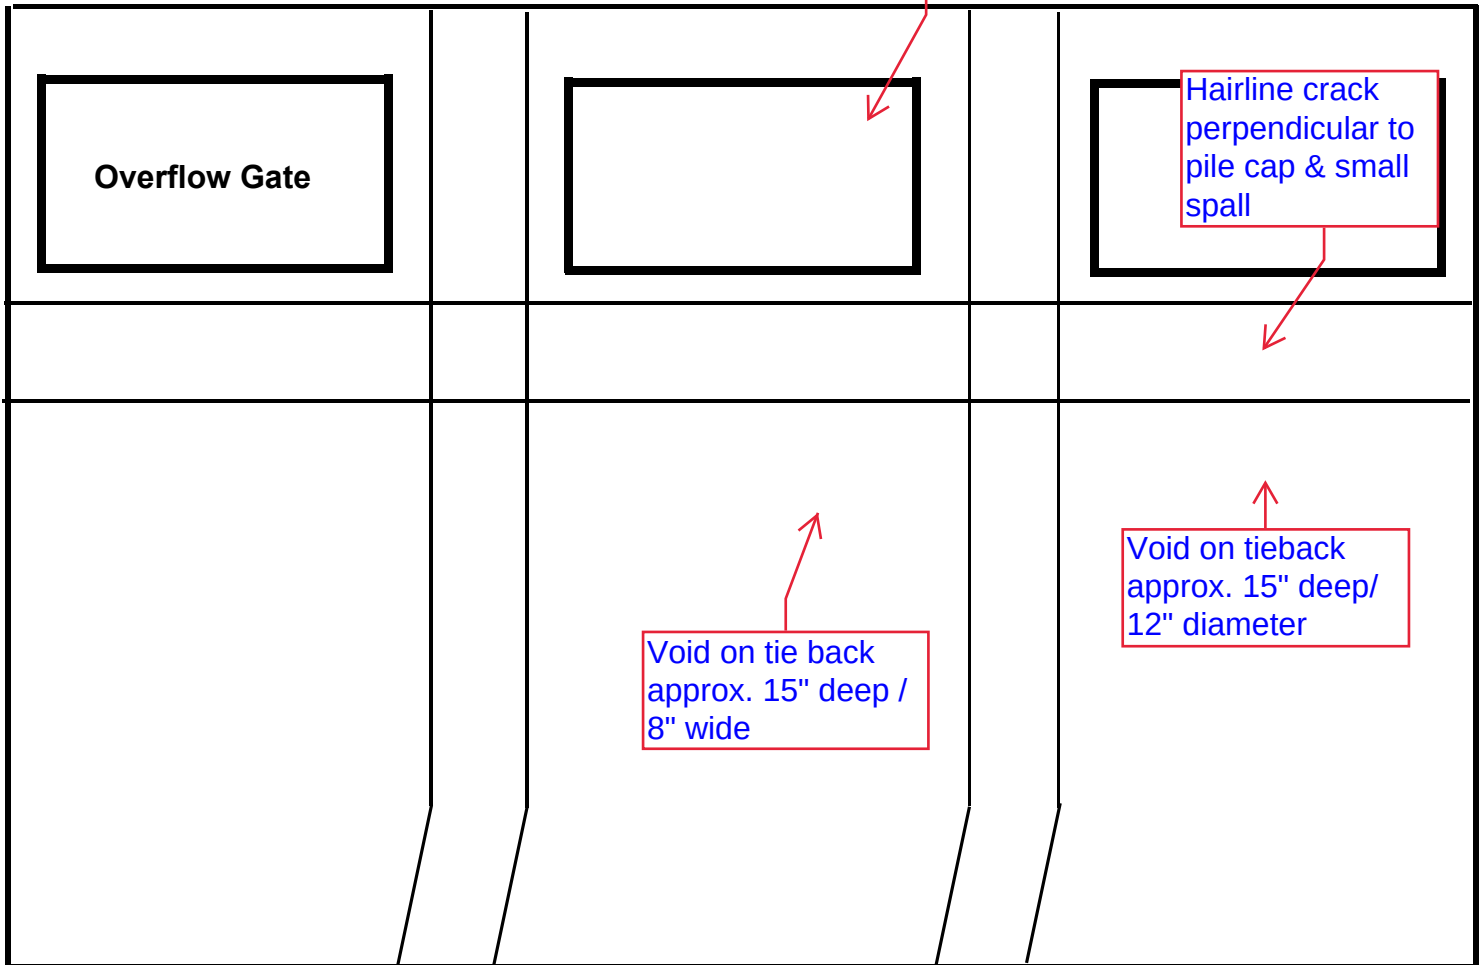
Bent 5

- Minor scaling noted on Z sheet
- Minor growth on z sheets & piles
- Heavy marine growth present
- Heavy exposed aggregate on concrete
- Area of undermining under middle gate near right gate, area is 5' wide and 1-2' deep
- Missing piece of wood on left flapper gate top left corner
- No repairs were performed

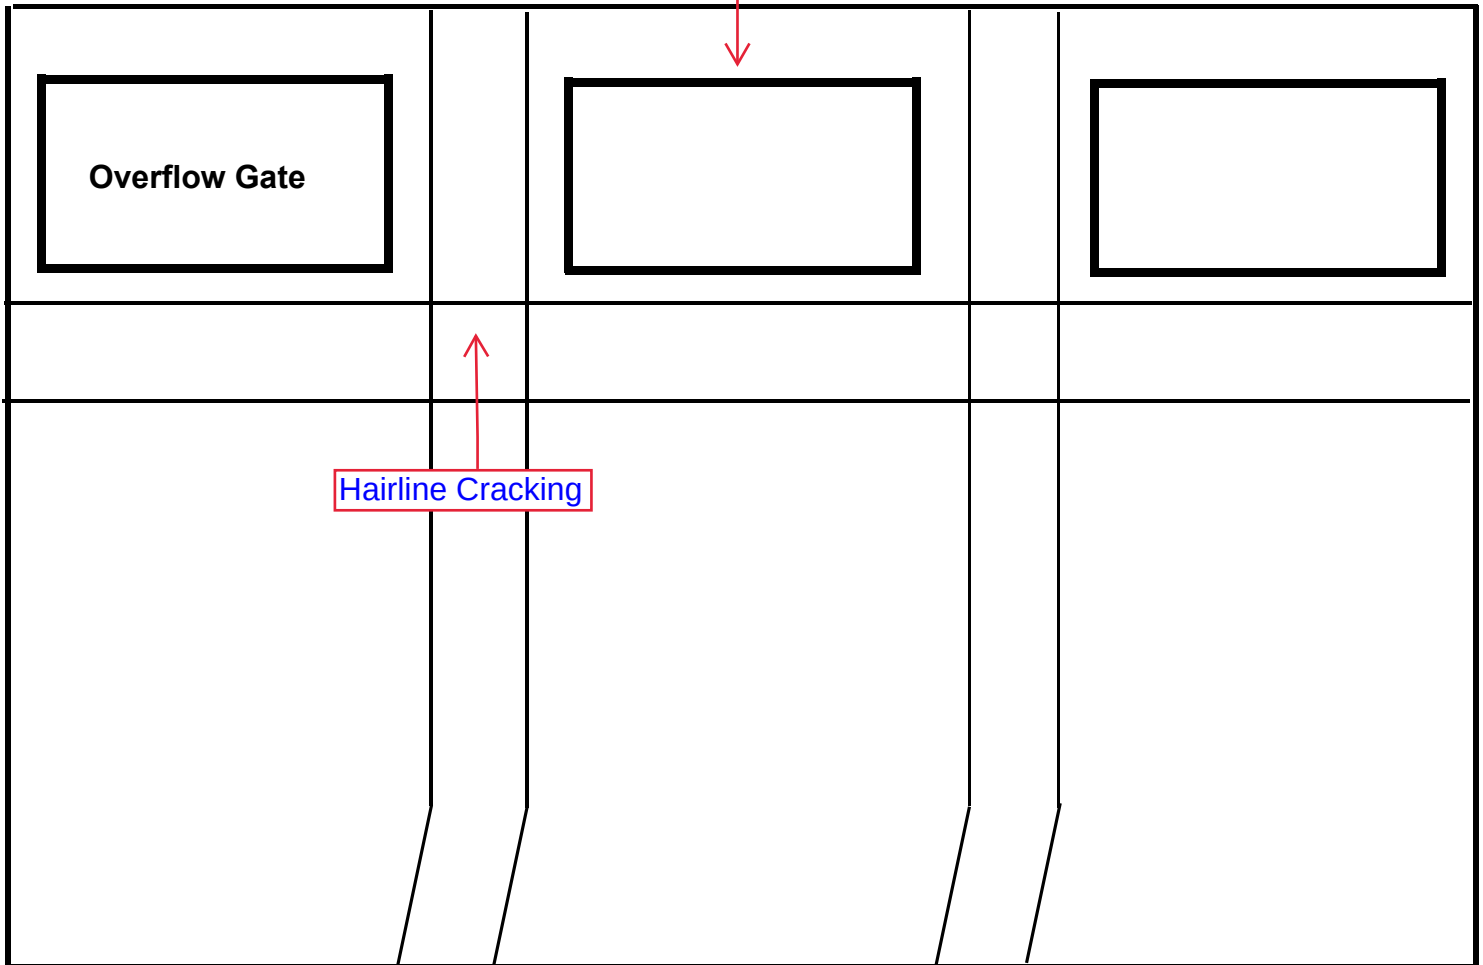
Missing hardware

- Minor growth noted throughout Z sheets & pile
- Minor scaling present on Z sheets
- Corrosion present throughout with moderate marine growth
- All holes patched over
- Heavy exposed aggregate on concrete
- Exposed reinforcement on header
- Cracking present on pile between middle gate and left gate

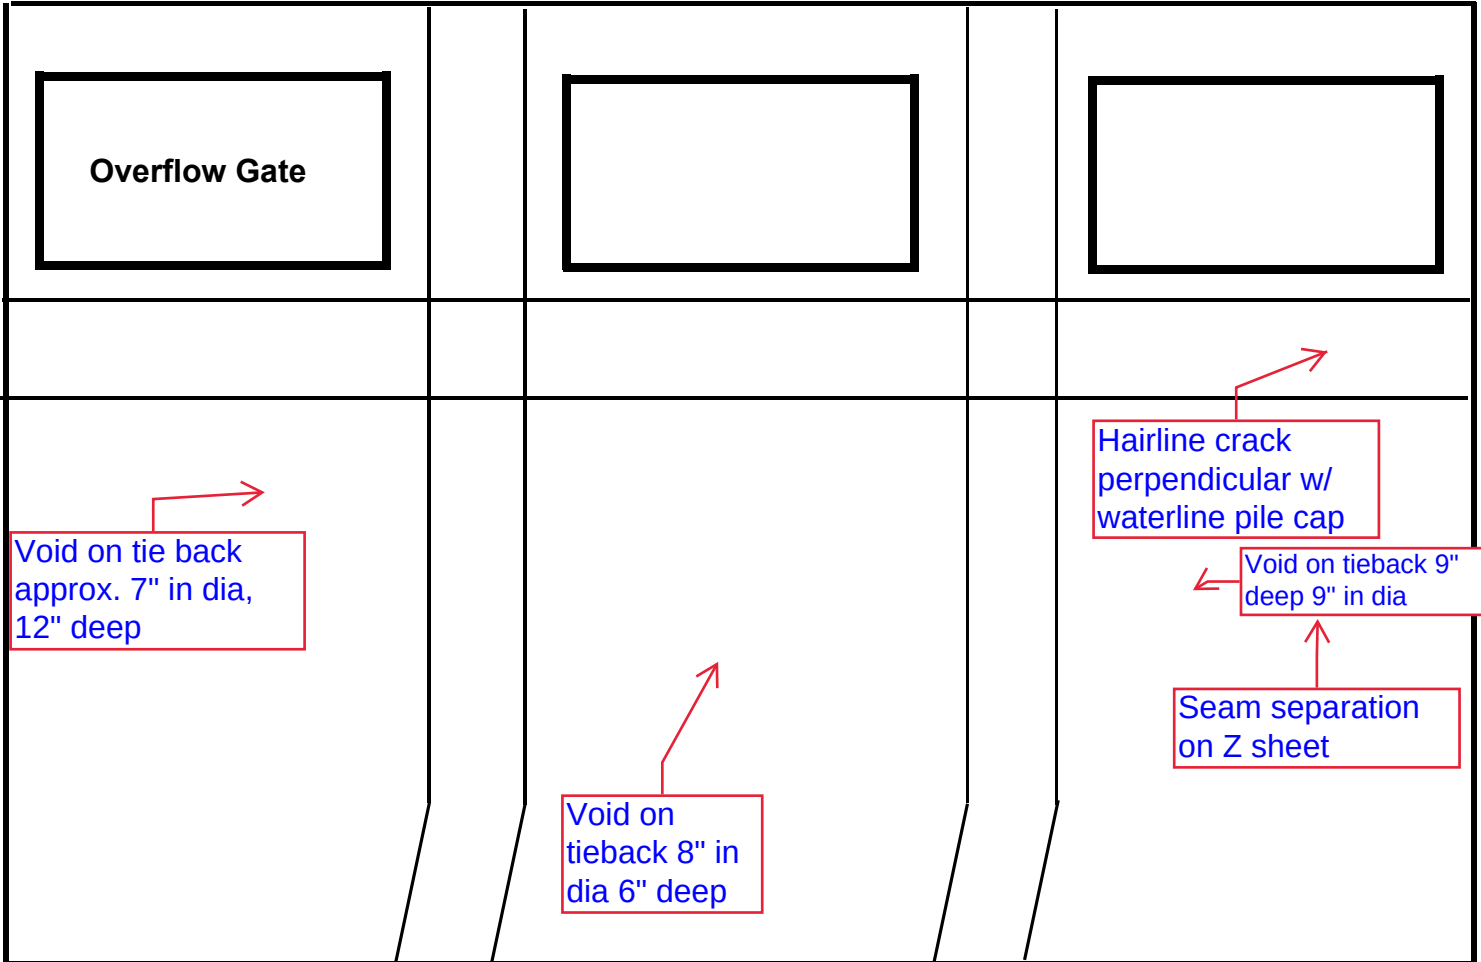
Bent 9

- Minor scaling present on Z sheets
- Minor to moderate growth on Z sheets / pile
- Minor corrosion noted
- Void on right tieback, 8"x6"x5" deep
- Exposed aggregate heavy at the waterline
- Video corrupted here had to redo

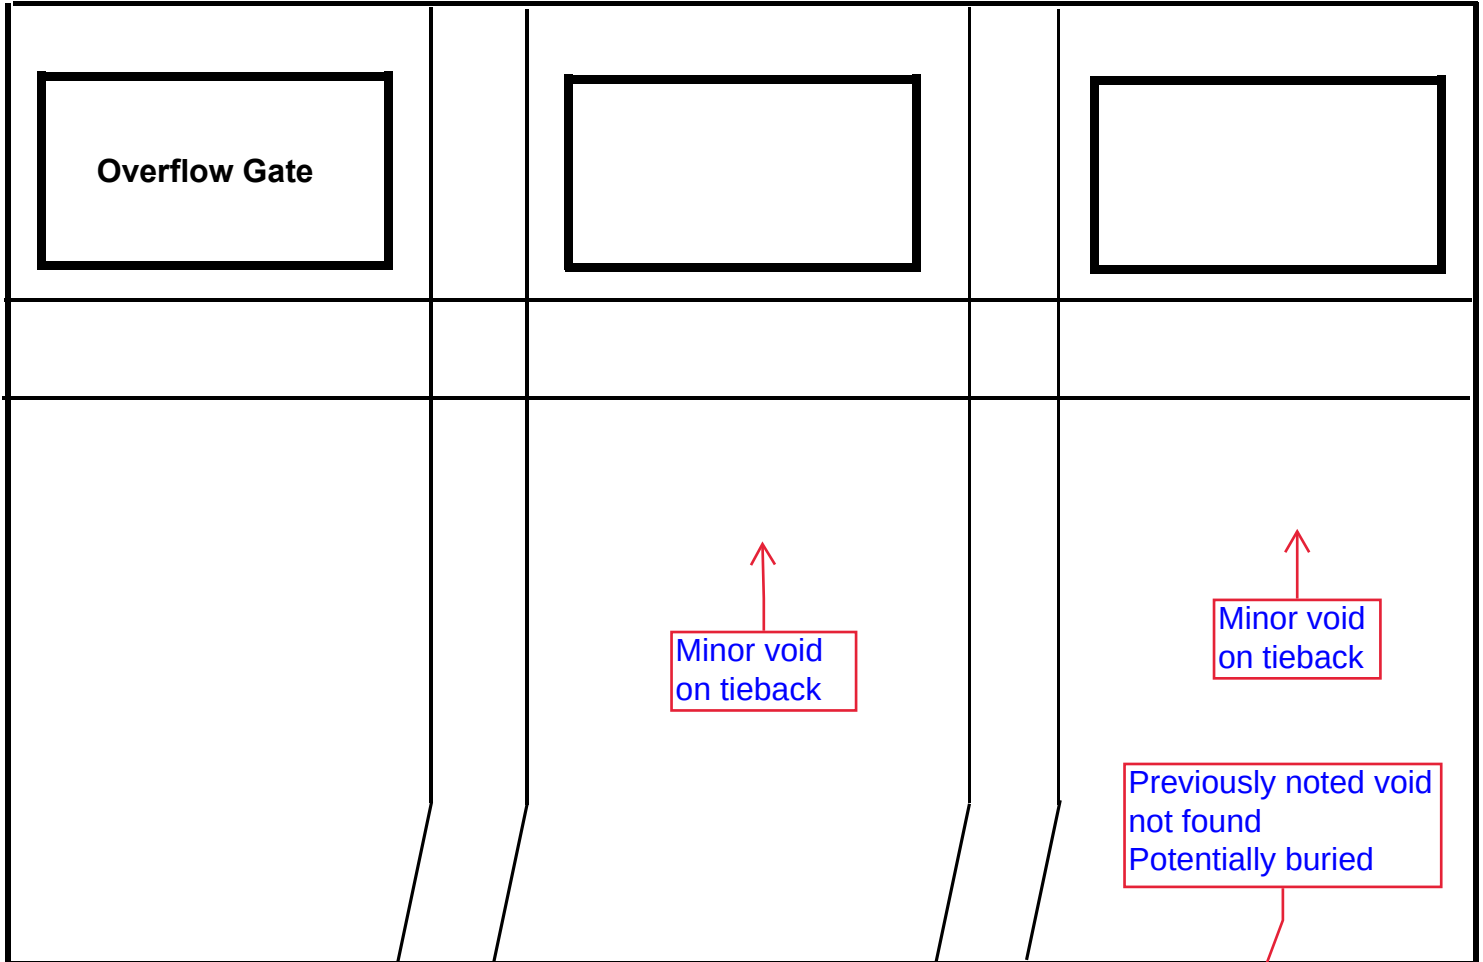
**Bent** 10

- Moderate to heavy growth on Z sheets / piles
- Corrosion noted throughout
- Hole has been patched
- Exposed aggregate present on concrete
- Minor tieback voids (1/2" to 1")

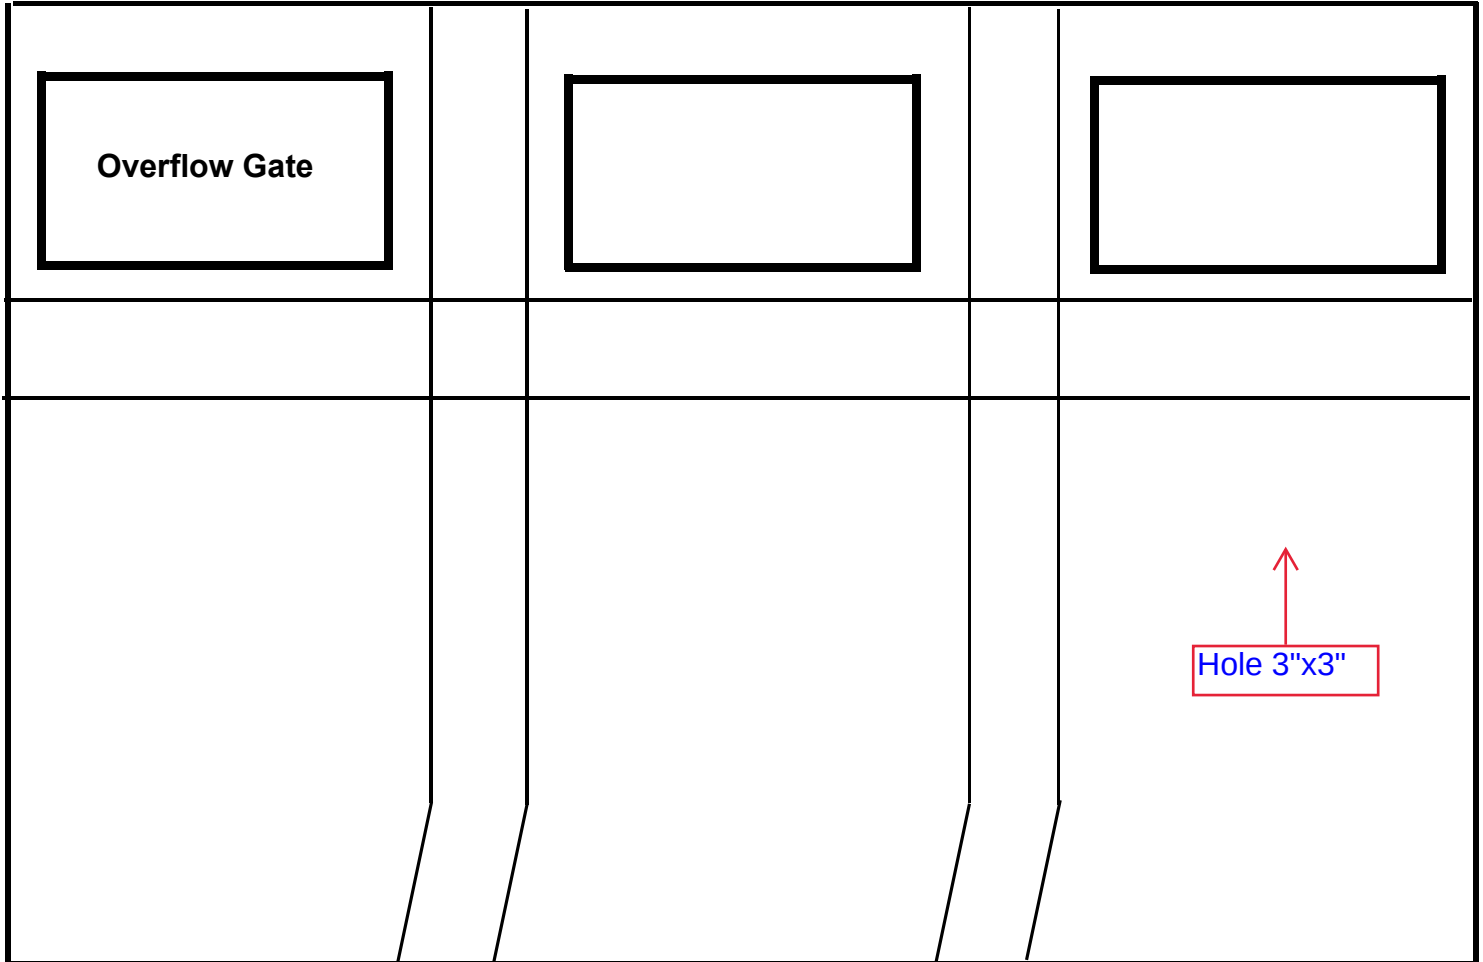
**Bent** 12

- Minor corrosion noted
- Moderate to heavy marine growth
- Right side gate hole found 3"x3" 20" from top of header closer to right side
- All other holes have been patched
- Exposed aggregate at waterline
- Missing hardware on middle flapper gate
- Loose hardware on left flapper gate

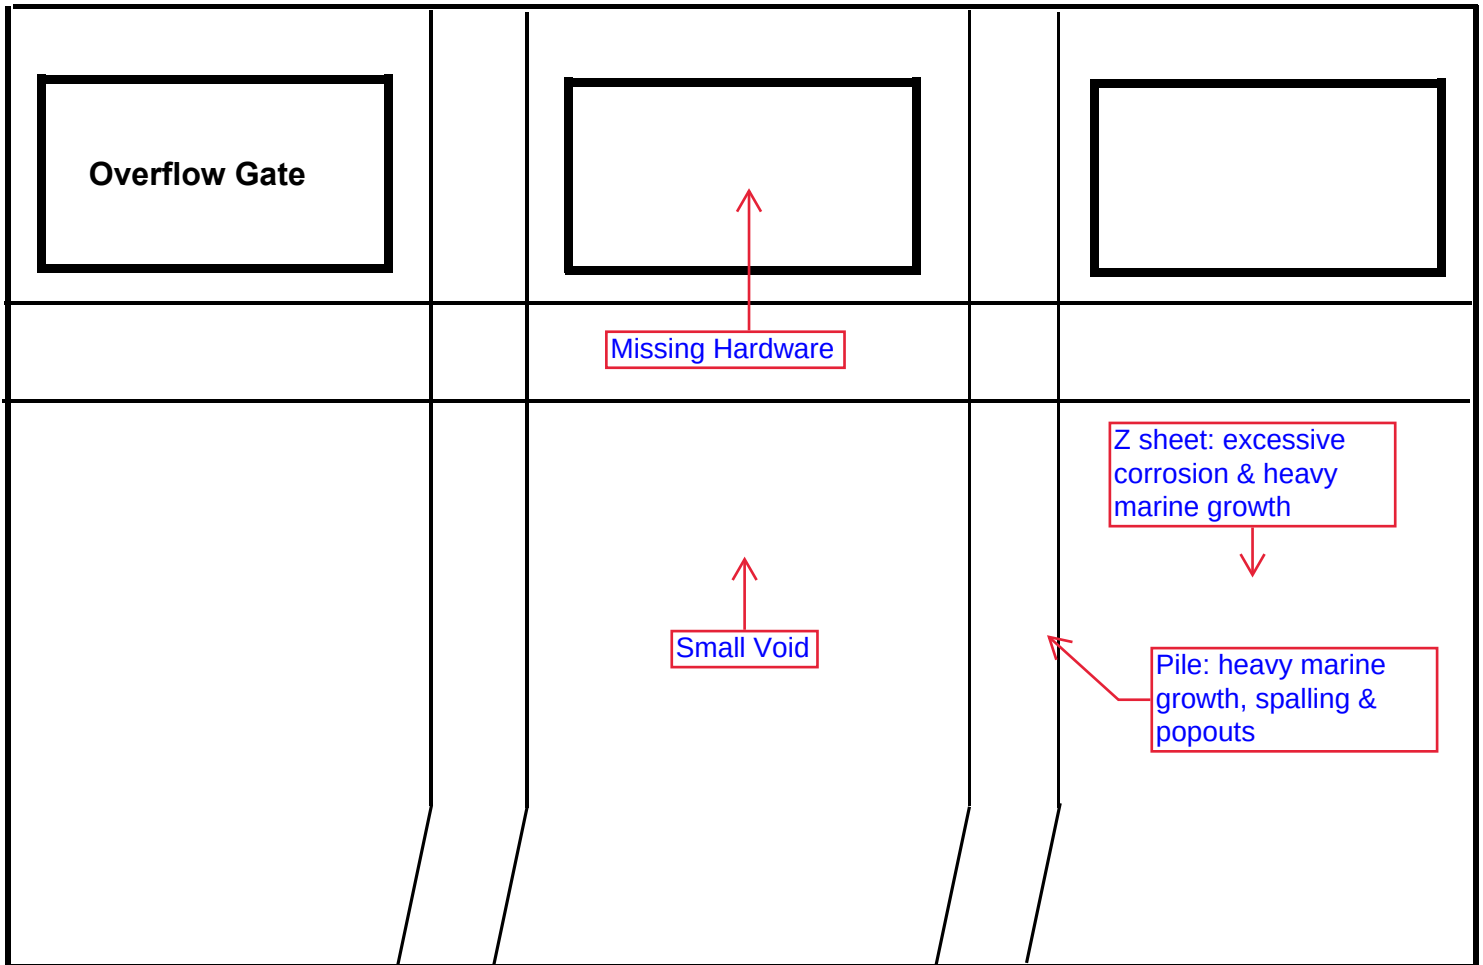
**Bent** 15

- Moderate corrosion present on Z sheets
- Moderate growth at splash zone / heavy below waterline
- Missing hardware on middle gate
- Patches in place
- Small hole 1-1/2"x3"x1/4" under Gate #2 located approx. 36" from header

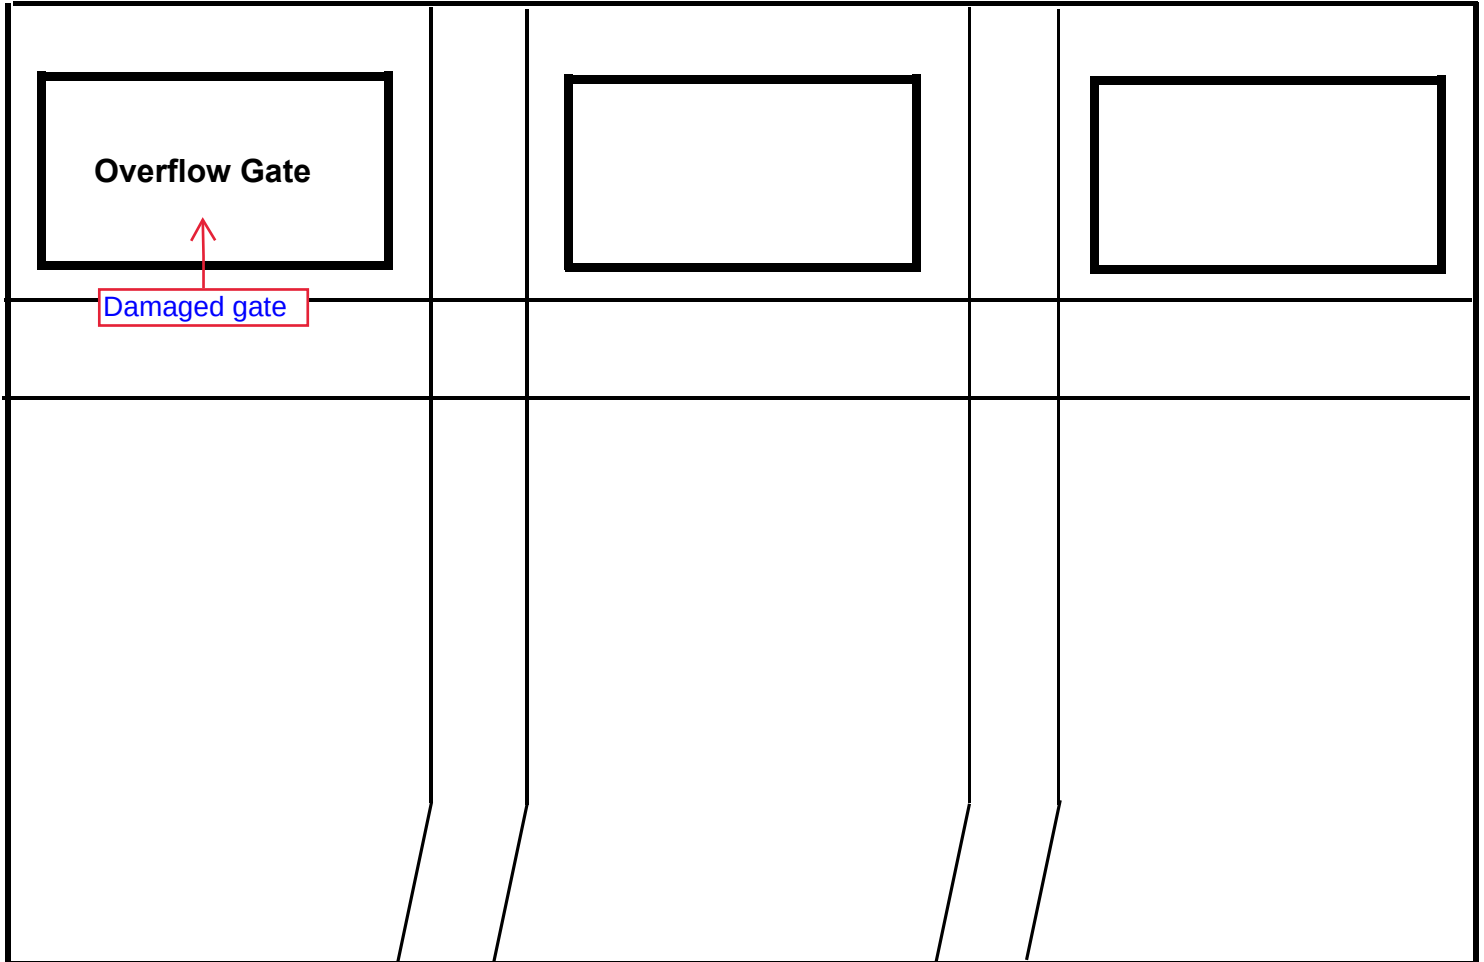
**Bent** 17

- Heavy growth noted on Z sheets / piles
- Moderate corrosion on sheet pile
- Holes have been patched
- Exposed aggregate on concrete
- No undermining noted
- Holes (x3) in left gate with unsecured hardware

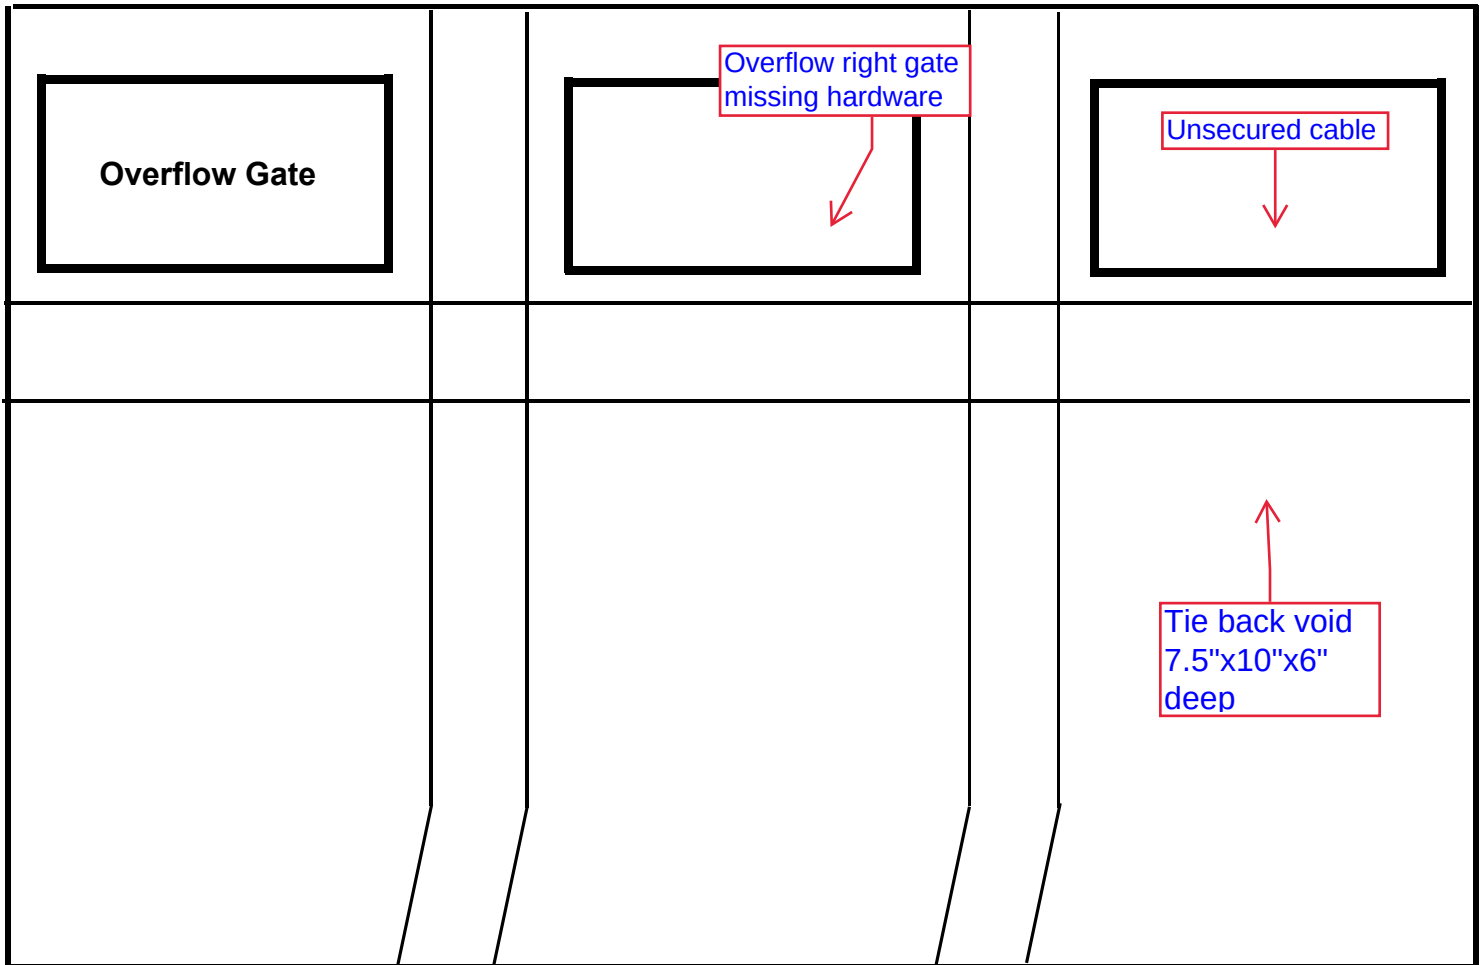
**Bent** 20

- Heavy marine growth
- Heavy corrosion
- Holes have been patched
- No undermining noted
- Exposed aggregate on concrete
- Void on tieback on right side
- Middle gate missing hardware

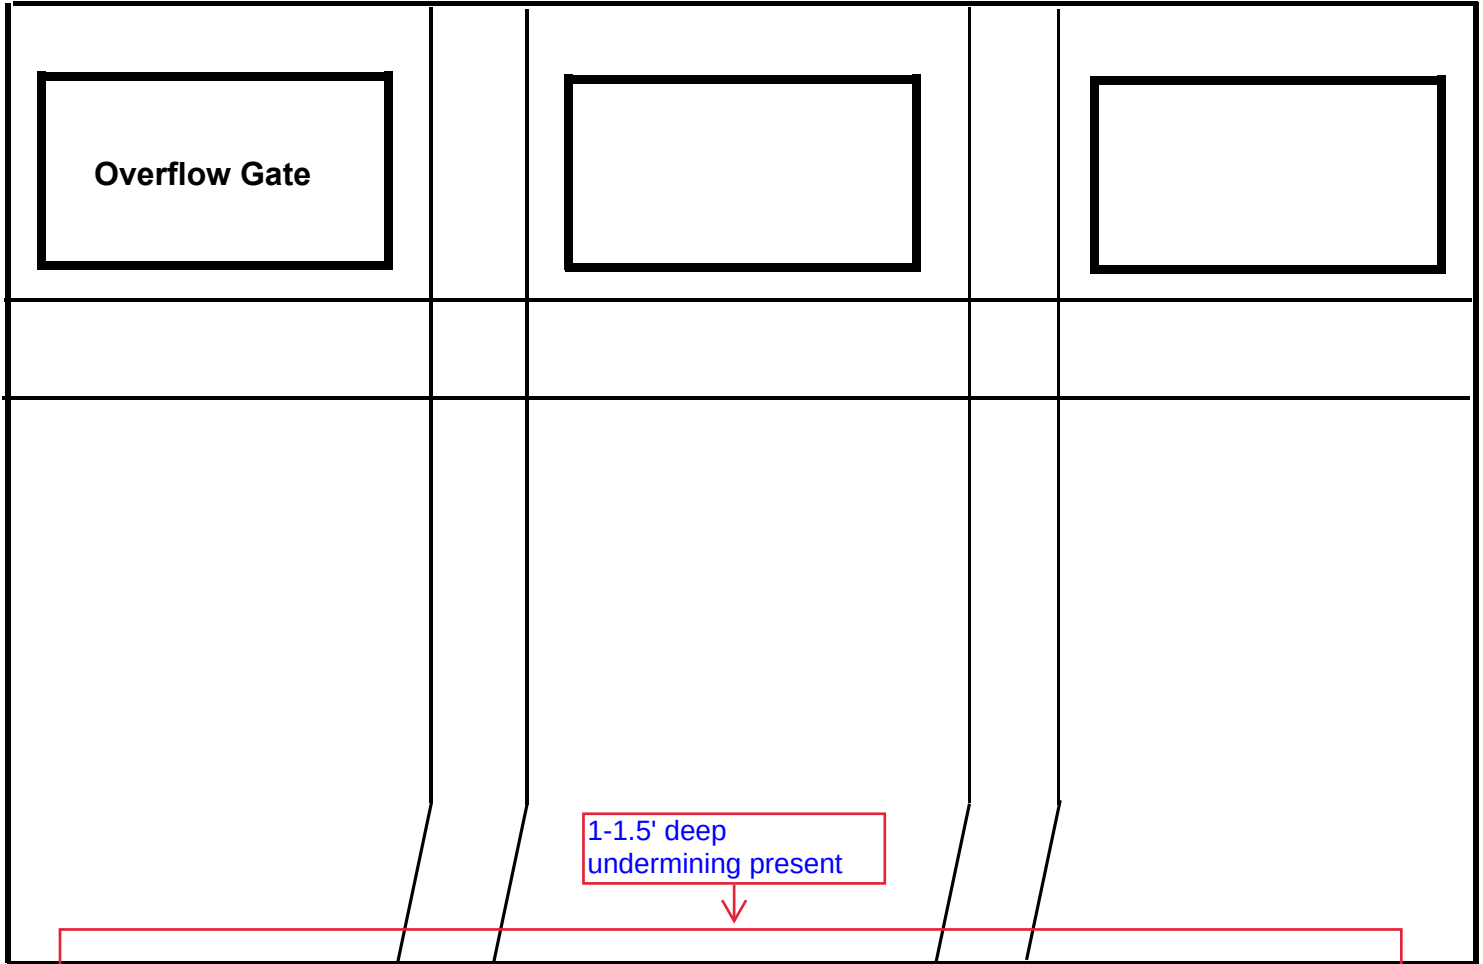
**Bent** 21

- Heavy growth noted throughout
- Heavy corrosion noted
- Holes have been patched
- Undermining present along left, middle, and right gate 1-1.5' deep

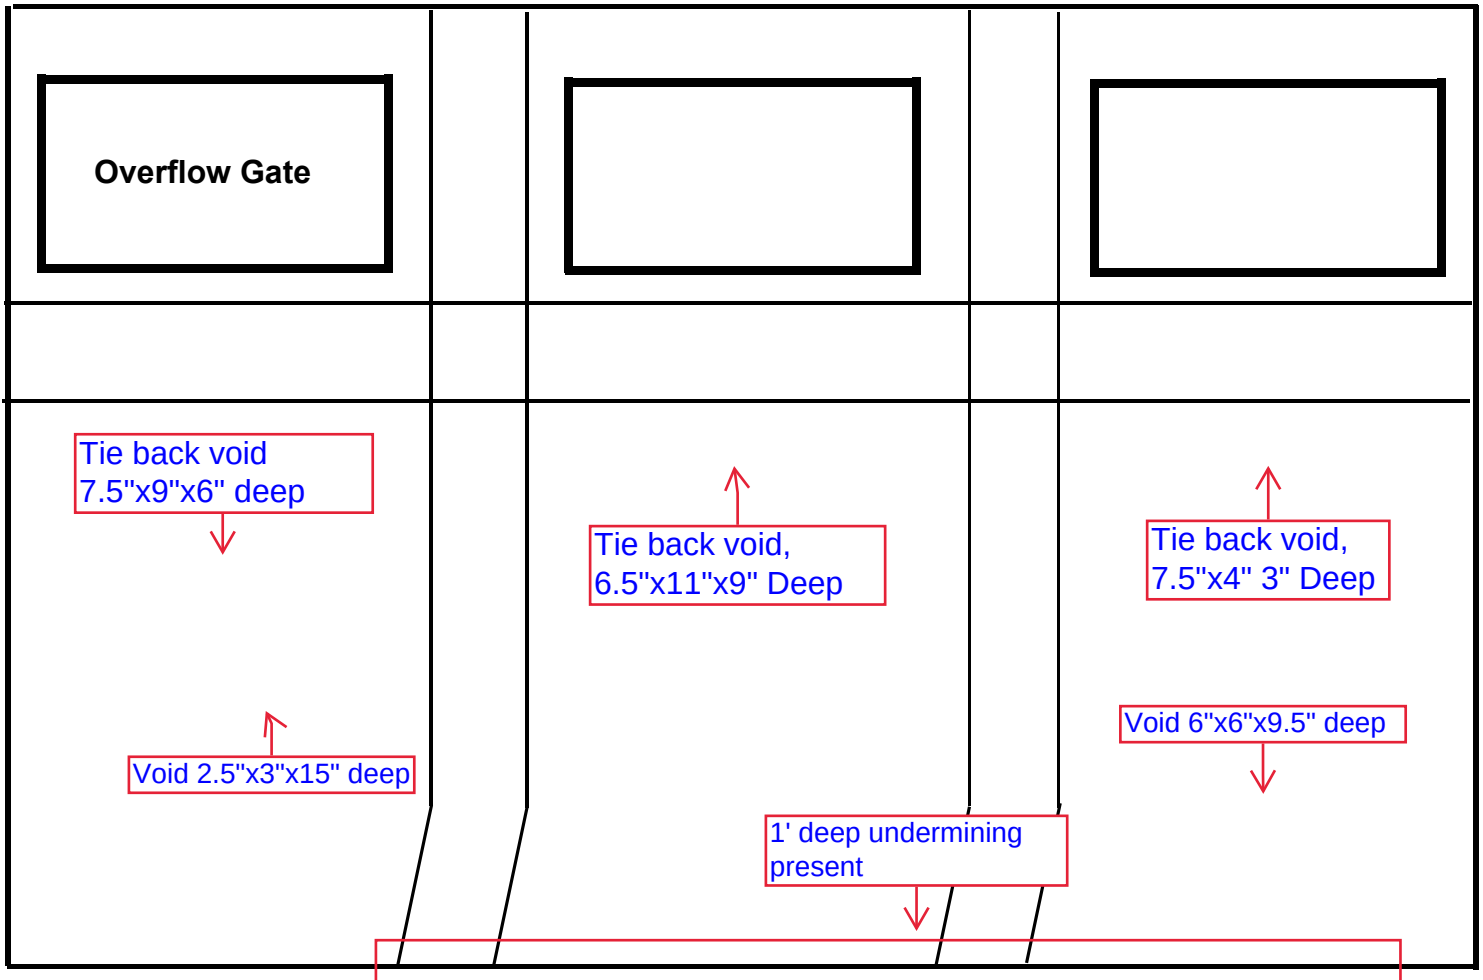
Bent 23Bent 22

- Heavy marine growth present throughout
- Heavy corrosion unlocalized throughout
- Hole found 6"w x 6"h x 9.5"d right gate, 52" from header
- Exposed aggregate at the waterline
- Void on tieback right side, 7.5"h x 4"w x 3"d
- Void on tieback middle 6.5"h x 11"w x 9"d
- Void on tieback left 7.5"h x 9"w x 6"d
- Hole found left gate, 2.5"w x 3"h x 15"d, 37.5" from header

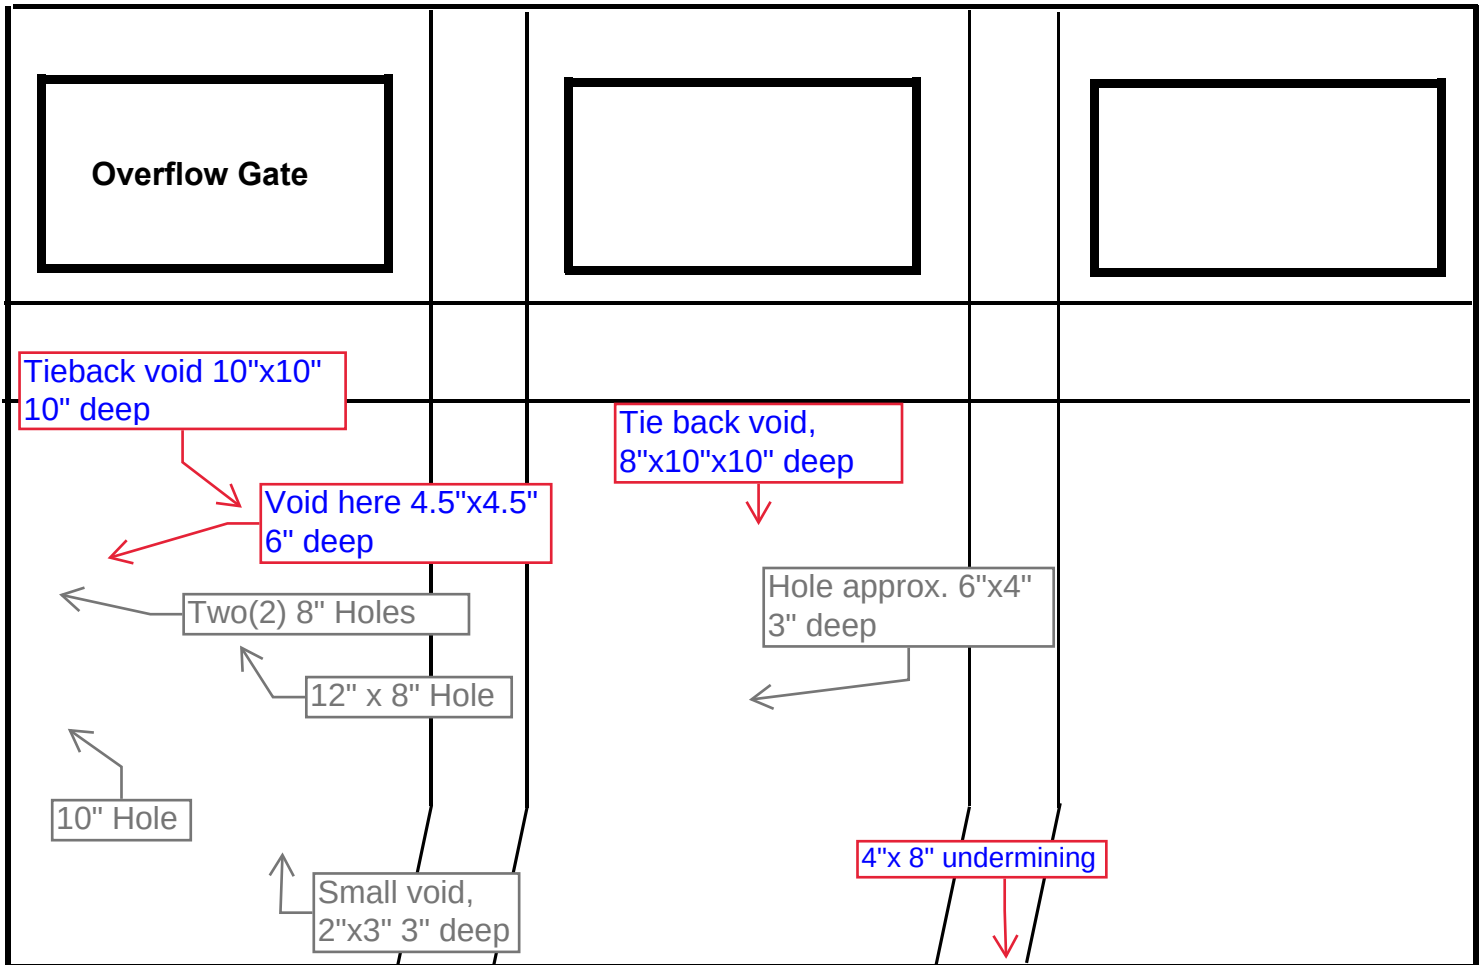
Bent 23

- Consistent rating with old report
- Exposed aggregate at the waterline
- Significant/ Heavy marine hard growth noted throughout
- Hole found left gate, 4.5"w x 4.5"h x 6"d, 20" from header
