**RE: Addendum #4 25-40 Utility Services Dive Services**

A comprehensive inspection was conducted by In Depth Inc. on both the saltwater and freshwater sides of the Deer Point Dam between March 14 and 16, 2025. Certified commercial divers performed the inspection, documenting physical defects, corrosion, biological fouling, and the condition of structural and mechanical components.

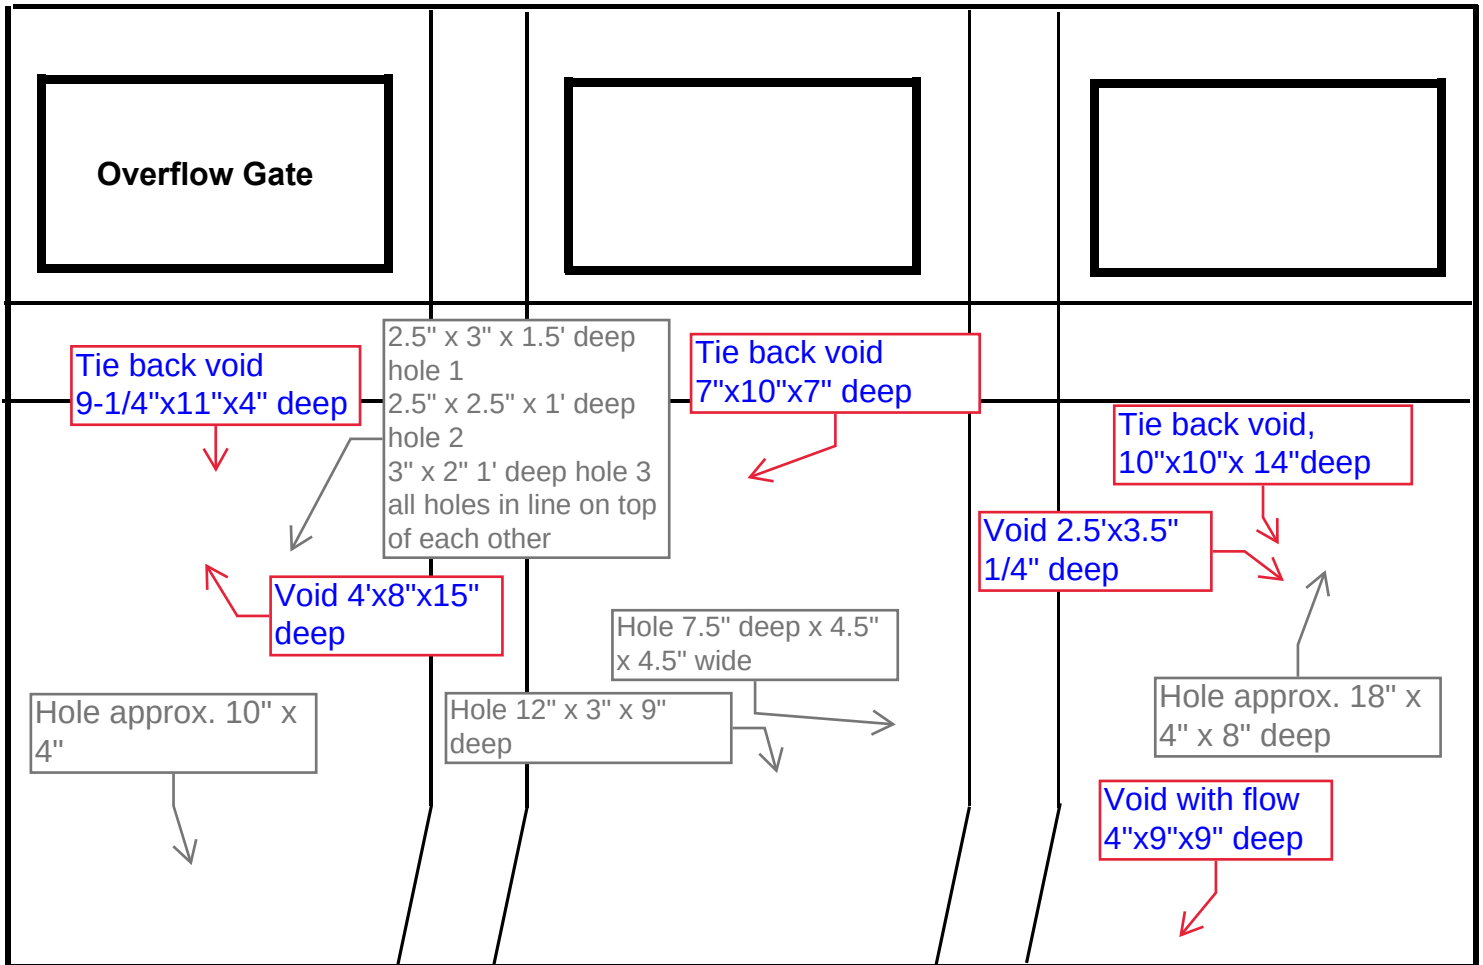
Bent 25Bent 24

- Significant/ Heavy marine growth
- Scaling present
- Significant corrosion present
- Heavy exposed aggregate at the waterline
- Void on right gate tie back with water flow (10"w x 10"h x 14" deep)
- Void on middle gate tieback (7"w x 10"h x 7" deep)
- Void on left gate tieback with water flow (9-1/4"w x 11"h x 4" deep)
- Void right gate, 2.5"w x 3.5"h x 1/4"d, 46" from header
- Void right gate with flow, 4"w x 12"h x 9"d, 46" (near bottom)
- Void left gate 4"w x 8"h x 15"d, 42-1/2" from header

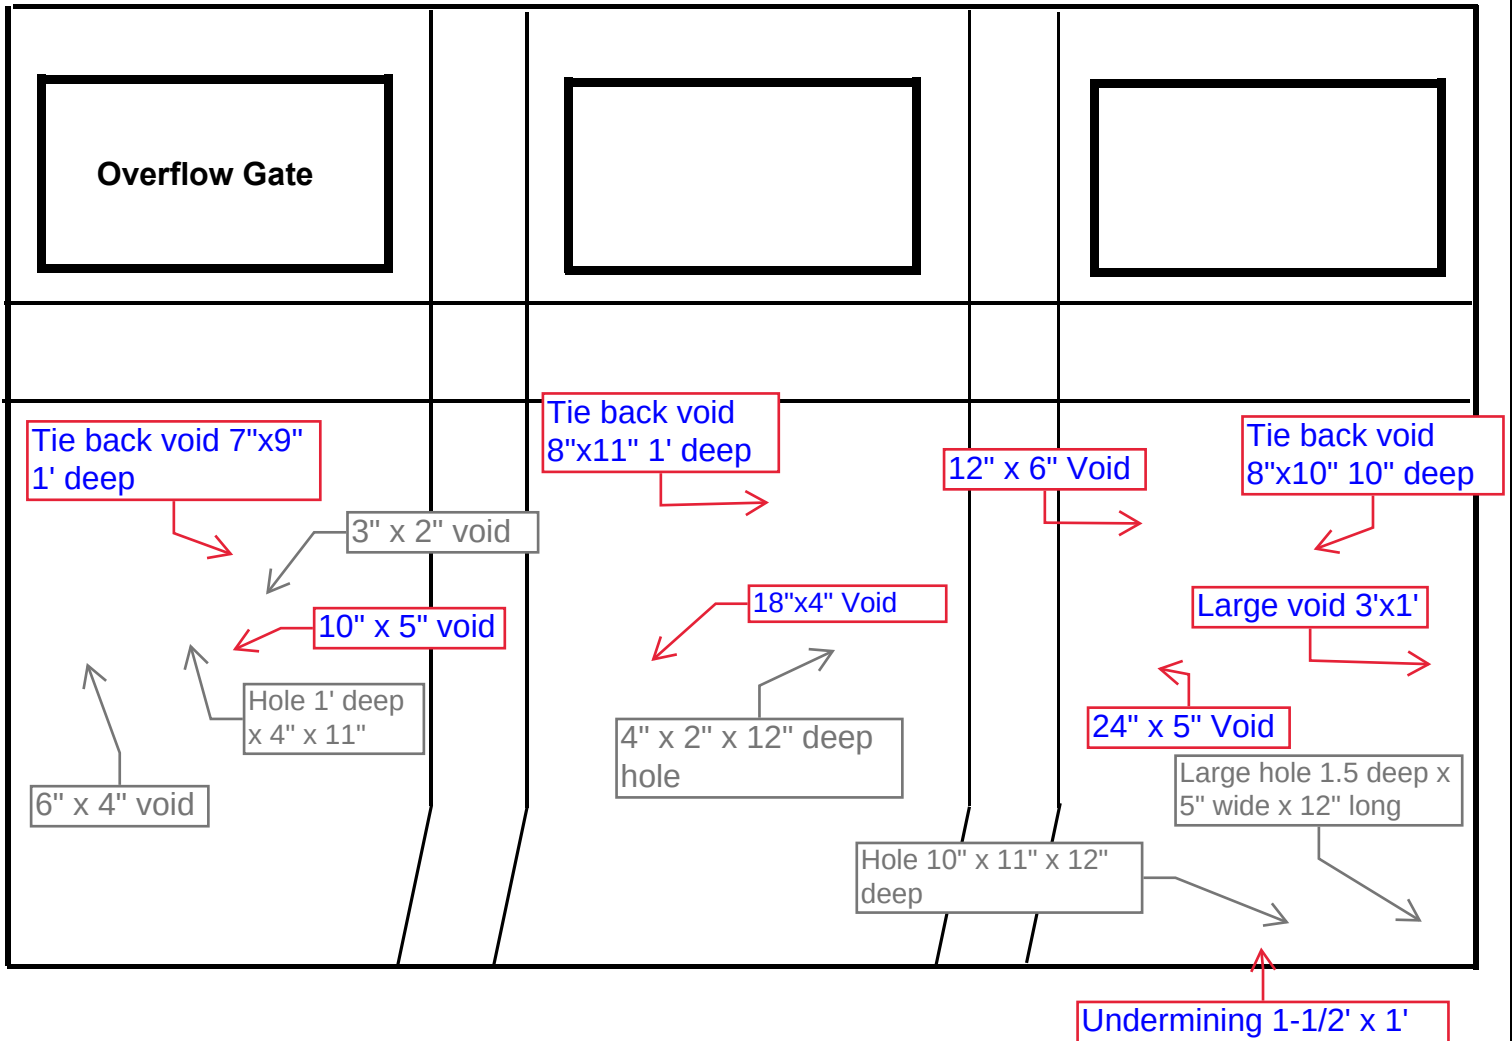
Bent 26

- Heavy marine growth present throughout
- Heavy corrosion unlocalized throughout
- Exposed aggregate present at waterline
- No undermining noted in middle gate and left gate

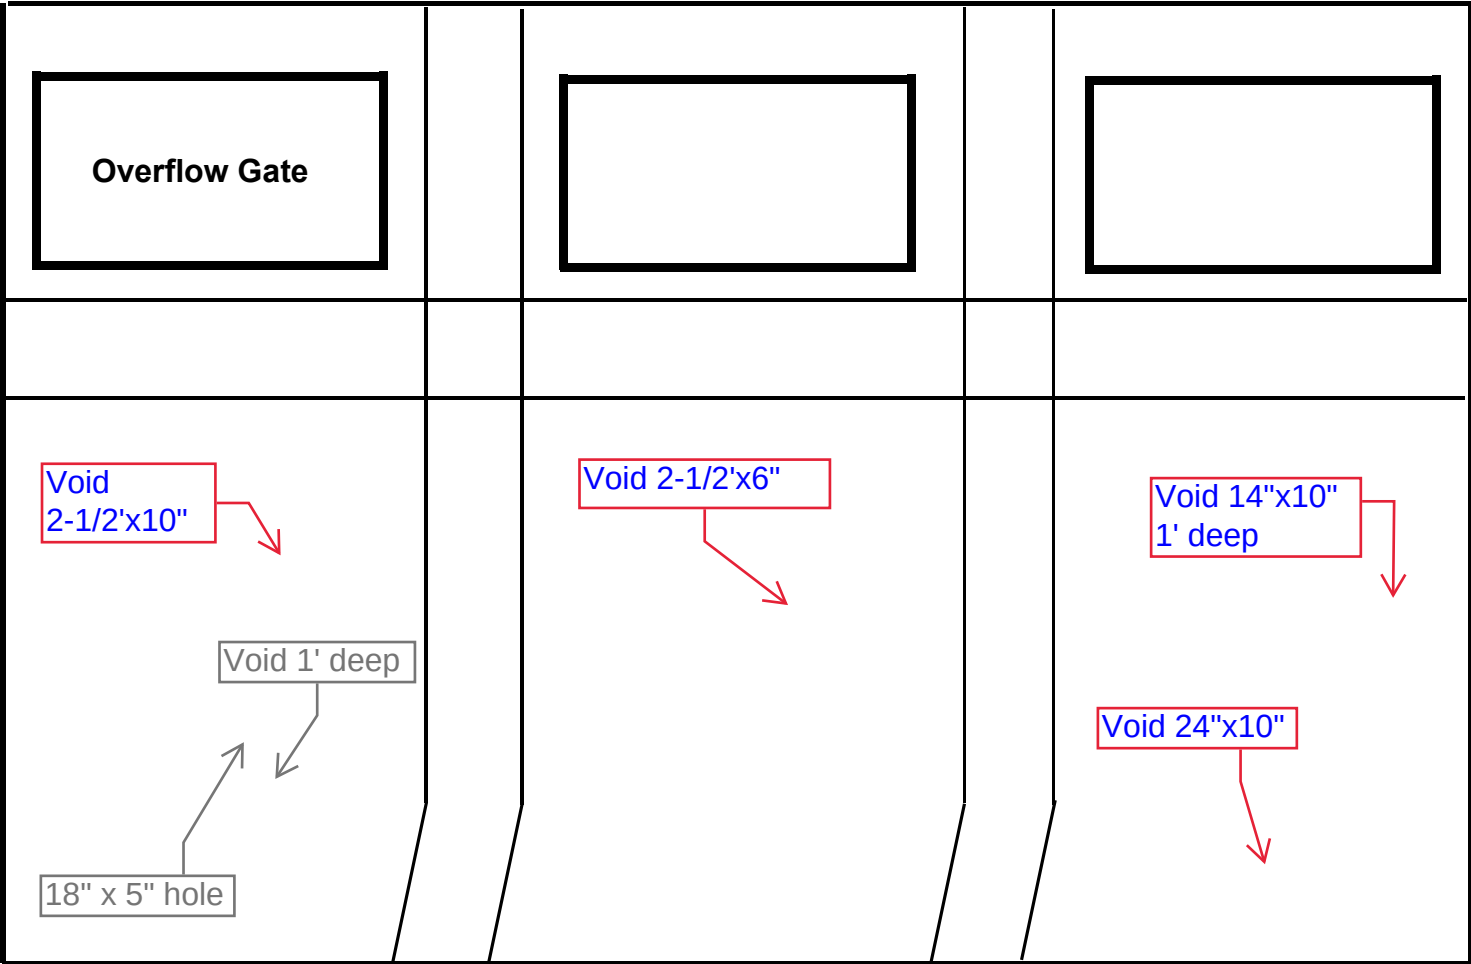
**Bent** 27

- All overflow gates missing hardware
- Heavy marine growth
- Heavy corrosion
- No undermining found
- Holes are still present

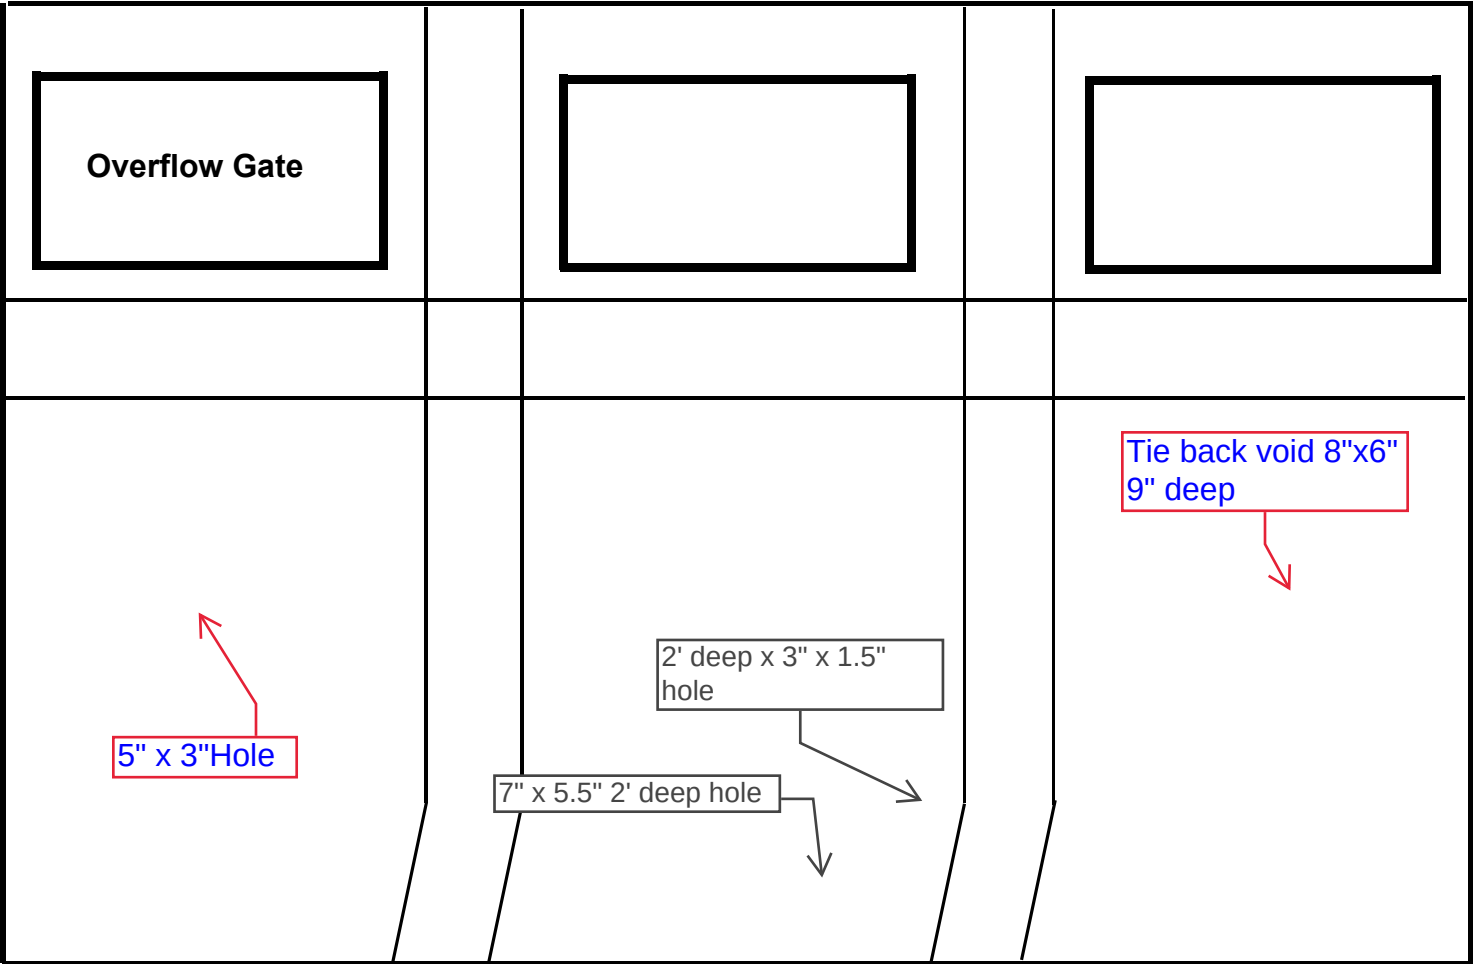
**Bent** 28

- Heavy marine growth present throughout
- Heavy corrosion unlocalized throughout
- No undermining noted
- Exposed aggregate on concrete

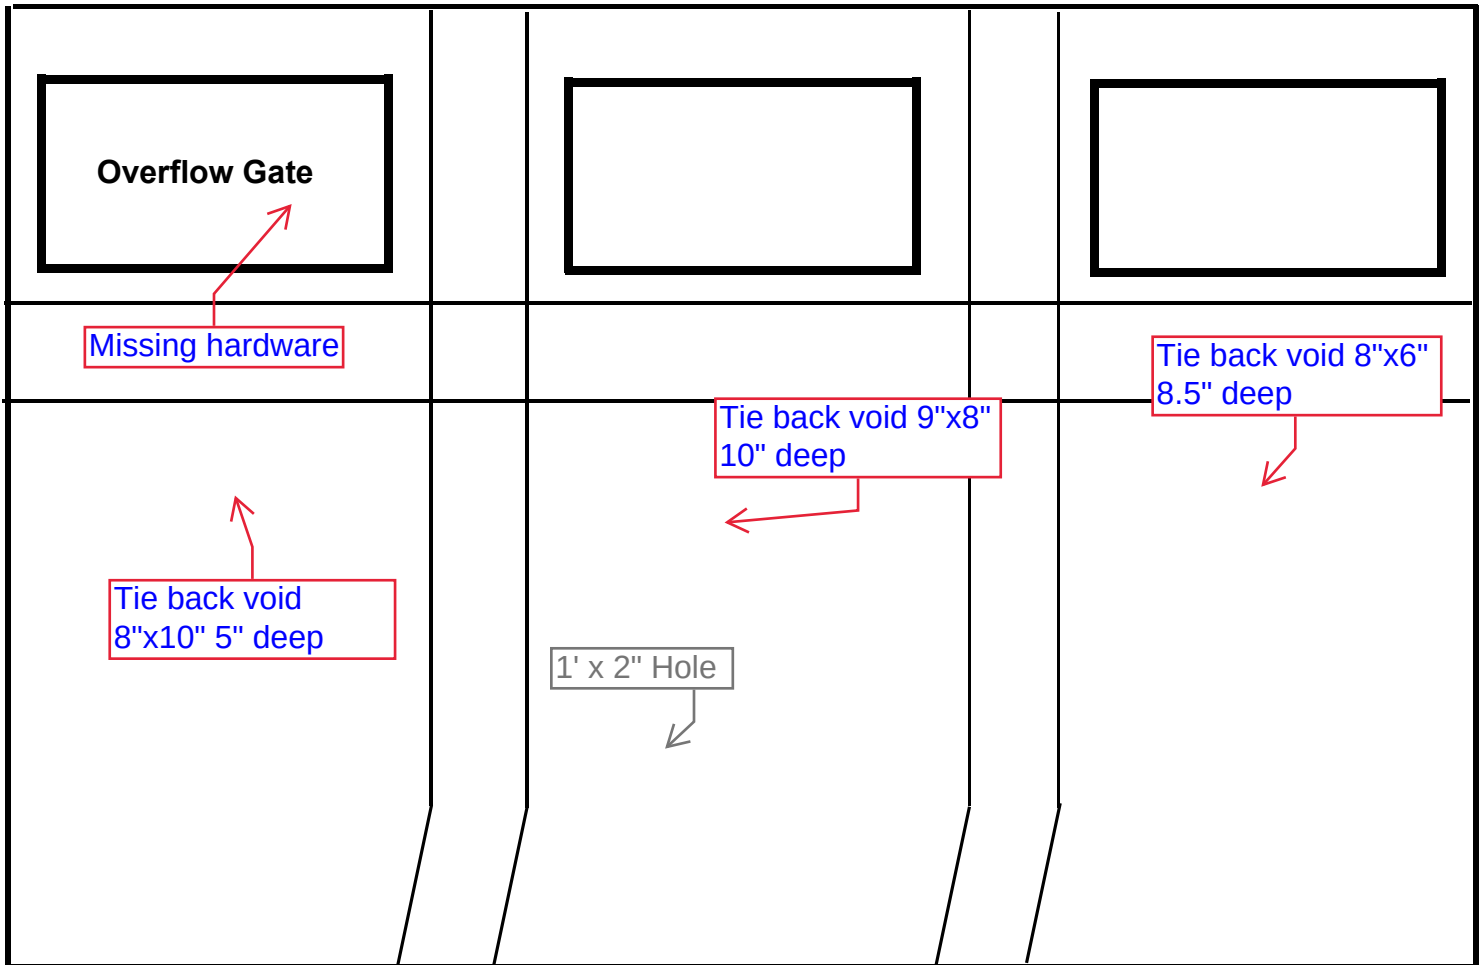
Bent 29

- Heavy marine growth
- Heavy corrosion
- No undermining noted
- Exposed aggregate at the waterline
- Rusted hardware on right flapper
- Missing hardware on left flapper

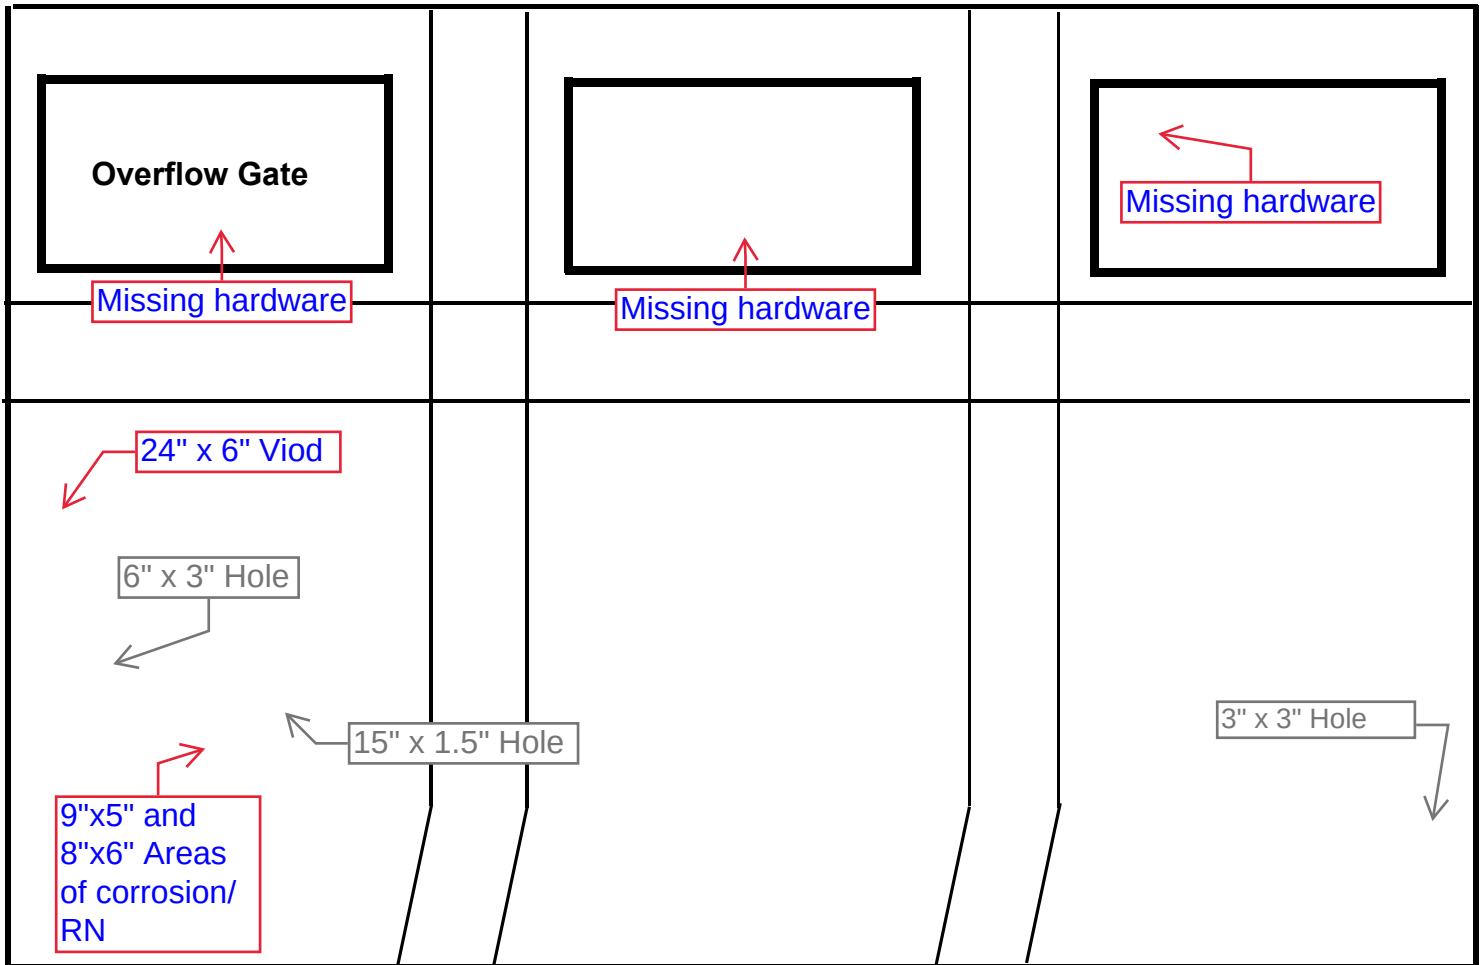
Bent 31Bent 30

- Heavy corrosion w/ scaling
- Heavy marine growth present
- No undermining noted during inspection
- Exposed aggregate on concrete at waterline
- Missing hardware on right gate (left plate)
- Missing hardware on left and middle gate (swing arm to gate)
- Large patches of corrosion left gate z-sheet 9"x5" and 8"x6"

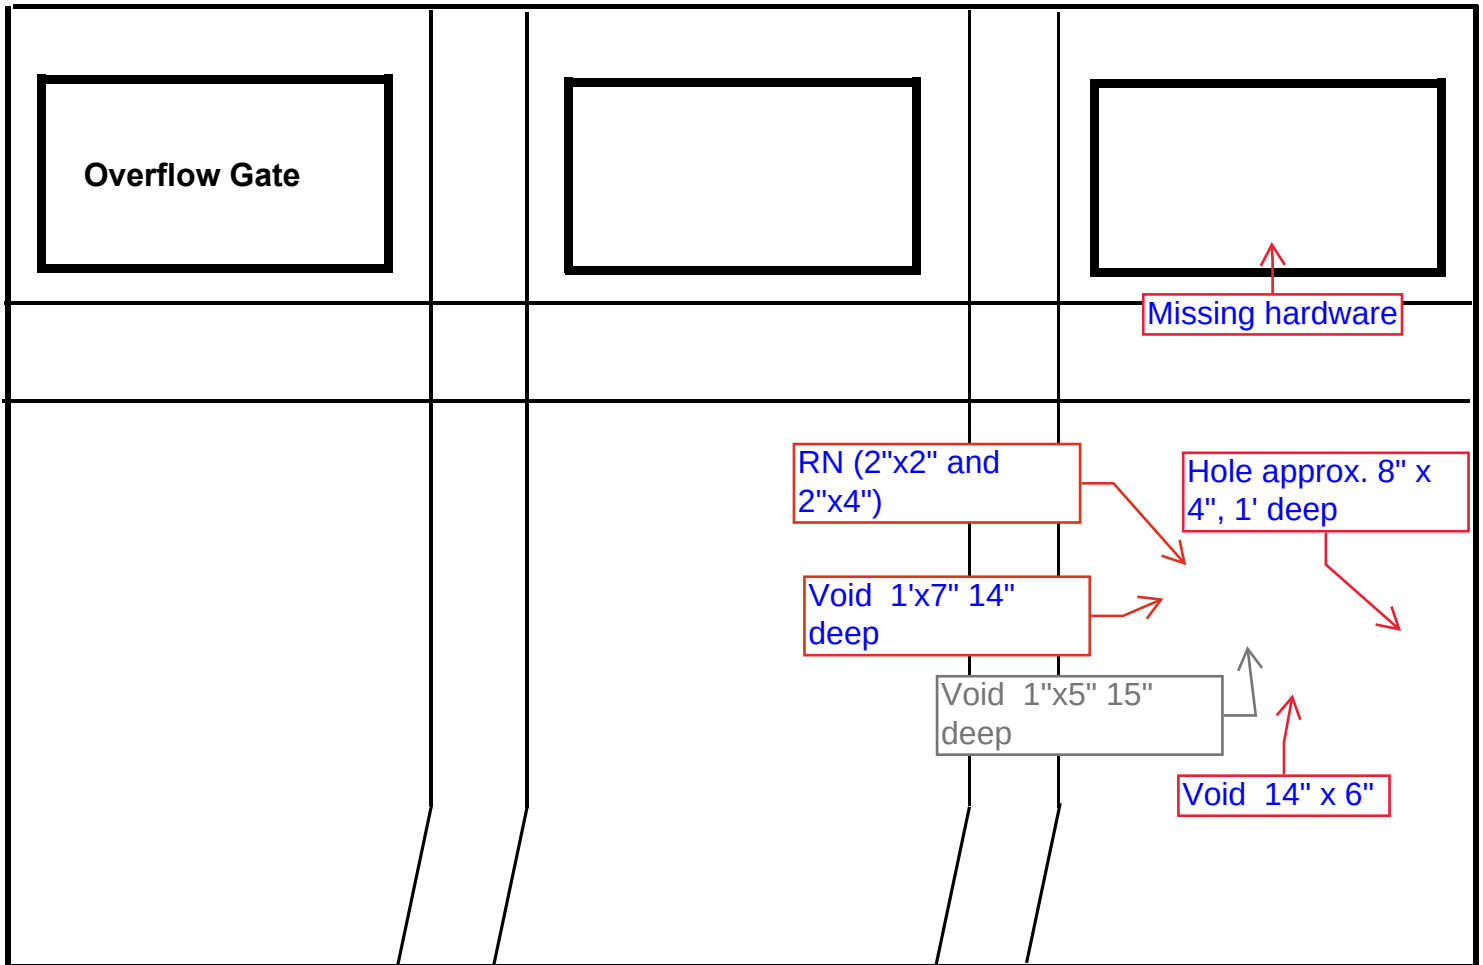
Bent 32

- Heavy marine growth
- Heavy corrosion
- Exposed aggregate on concrete
- Corrosion/ rust noduling right gate (2"x2" and 2"x4")
- Missing washer on tieback bracket middle gate
- Missing hardware on right flapper (right two swing arms to gate)
- Missing hardware on middle flapper (swing arm to gate)
- Missing/ loose hardware on left flapper gate

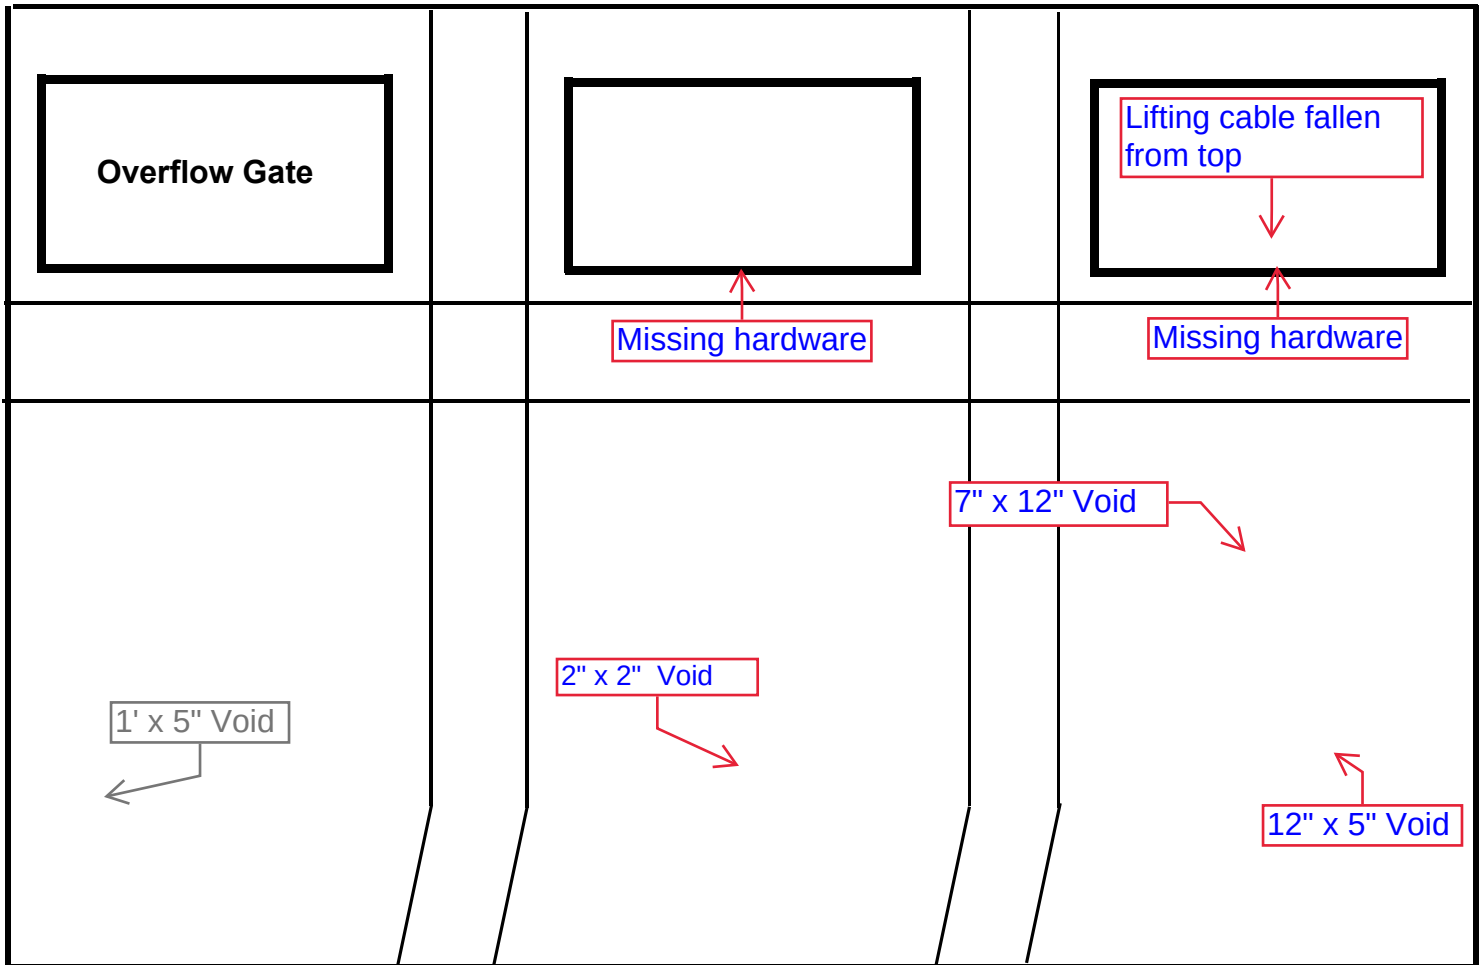
- Heavy marine growth
- Heavy corrosion
- Exposed aggregate on concrete
- Right gate - broken lifting cable and missing hardware (3 bolts)
- Middle gate - swing arm (middle and left) bolts missing, right severely corroded
- Left gate - swing arm (middle and right) bolts missing, left severely corroded; lift cable twisted

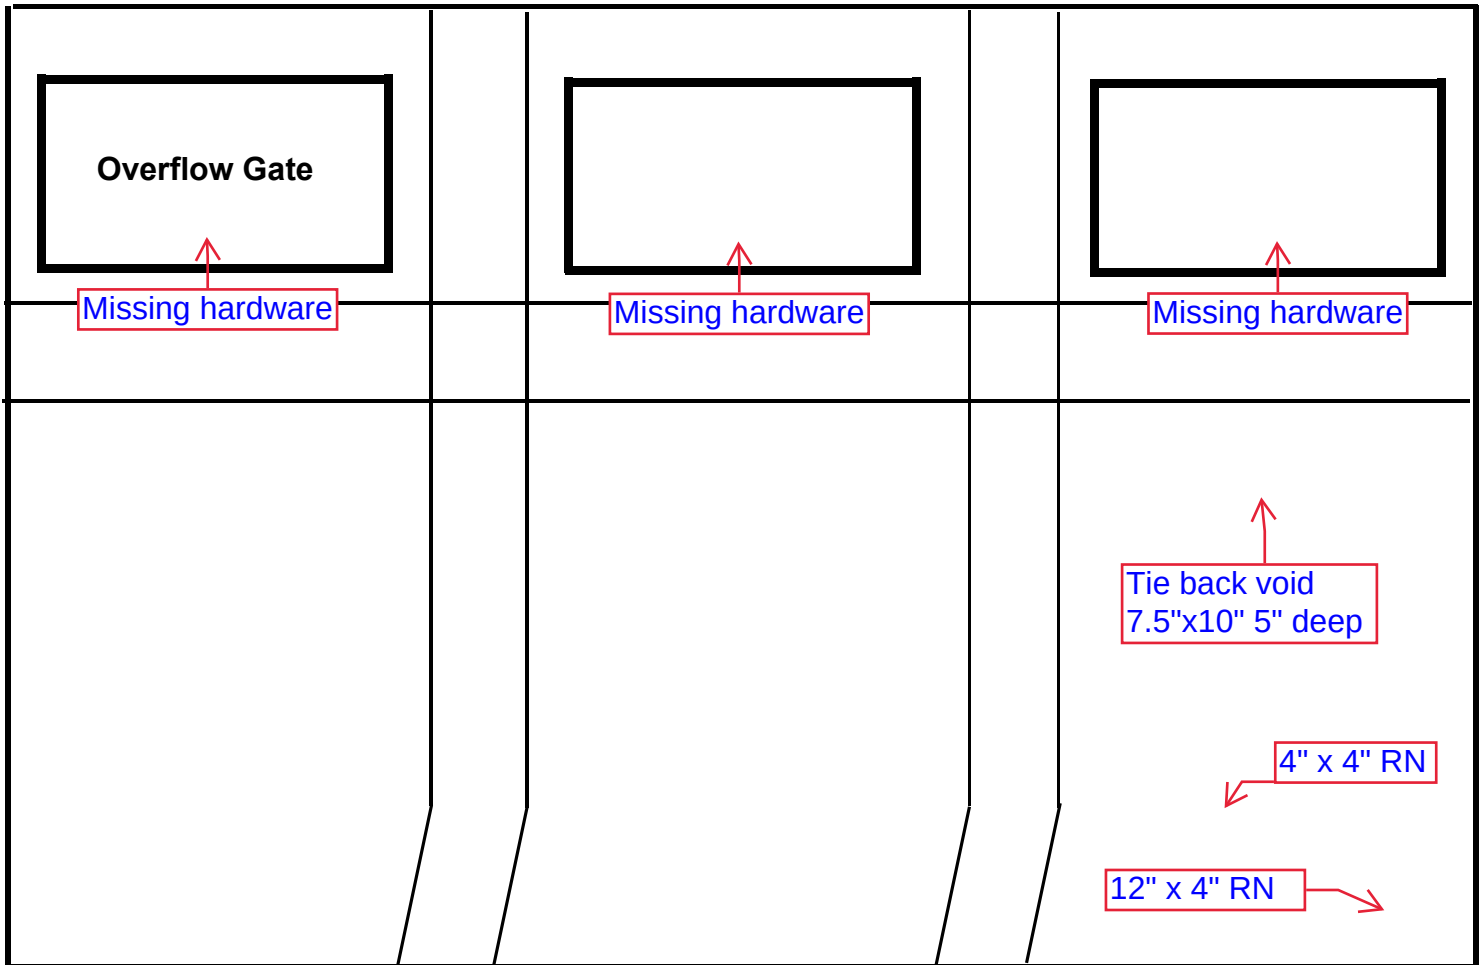
- Heavy marine growth
- Heavy corrosion
- Exposed aggregate on concrete
- Right gate - missing (left and middle) bolts for swing arm to gate; right severely corroded
- Middle gate - All (x3) attaching bolts missing
- Left gate - missing (left and missing) bolts for swing arm; right severely corroded
- Corrosion patches right gate (12"x4") (4"x4")

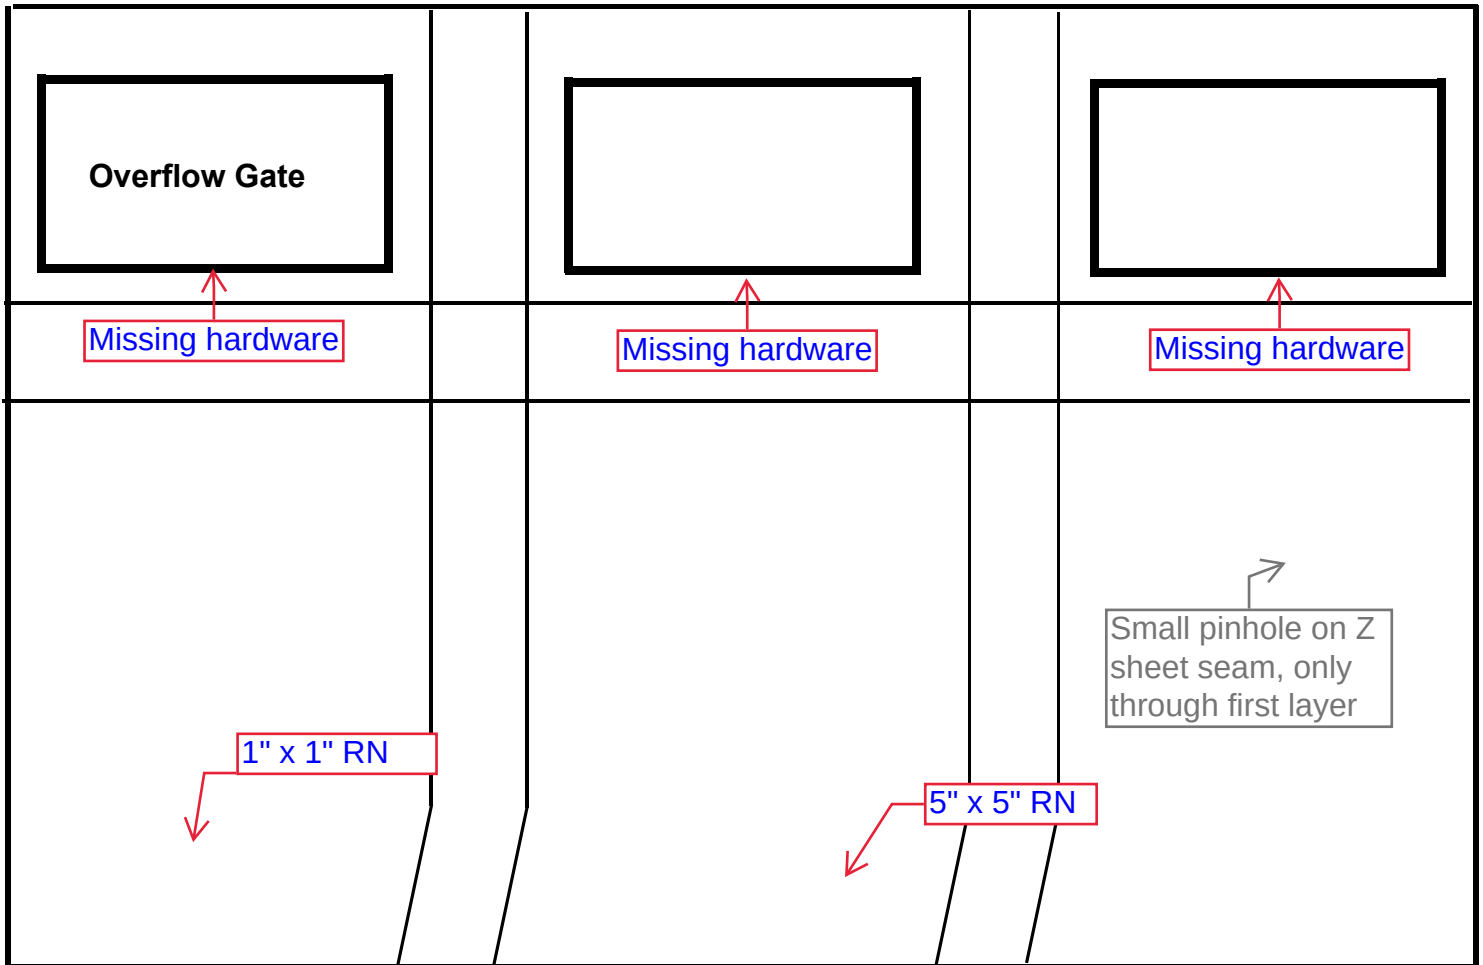
- Heavy marine growth
- Heavy corrosion
- Right gate - All (x3) attaching bolts missing
- Middle gate - Missing middle bolt; left and right heavily corroded
- Left gate - right swing arm missing bolt; left and right corroded
- Rust nodule on middle gate 5" off bottom
- Exposed aggregate on concrete

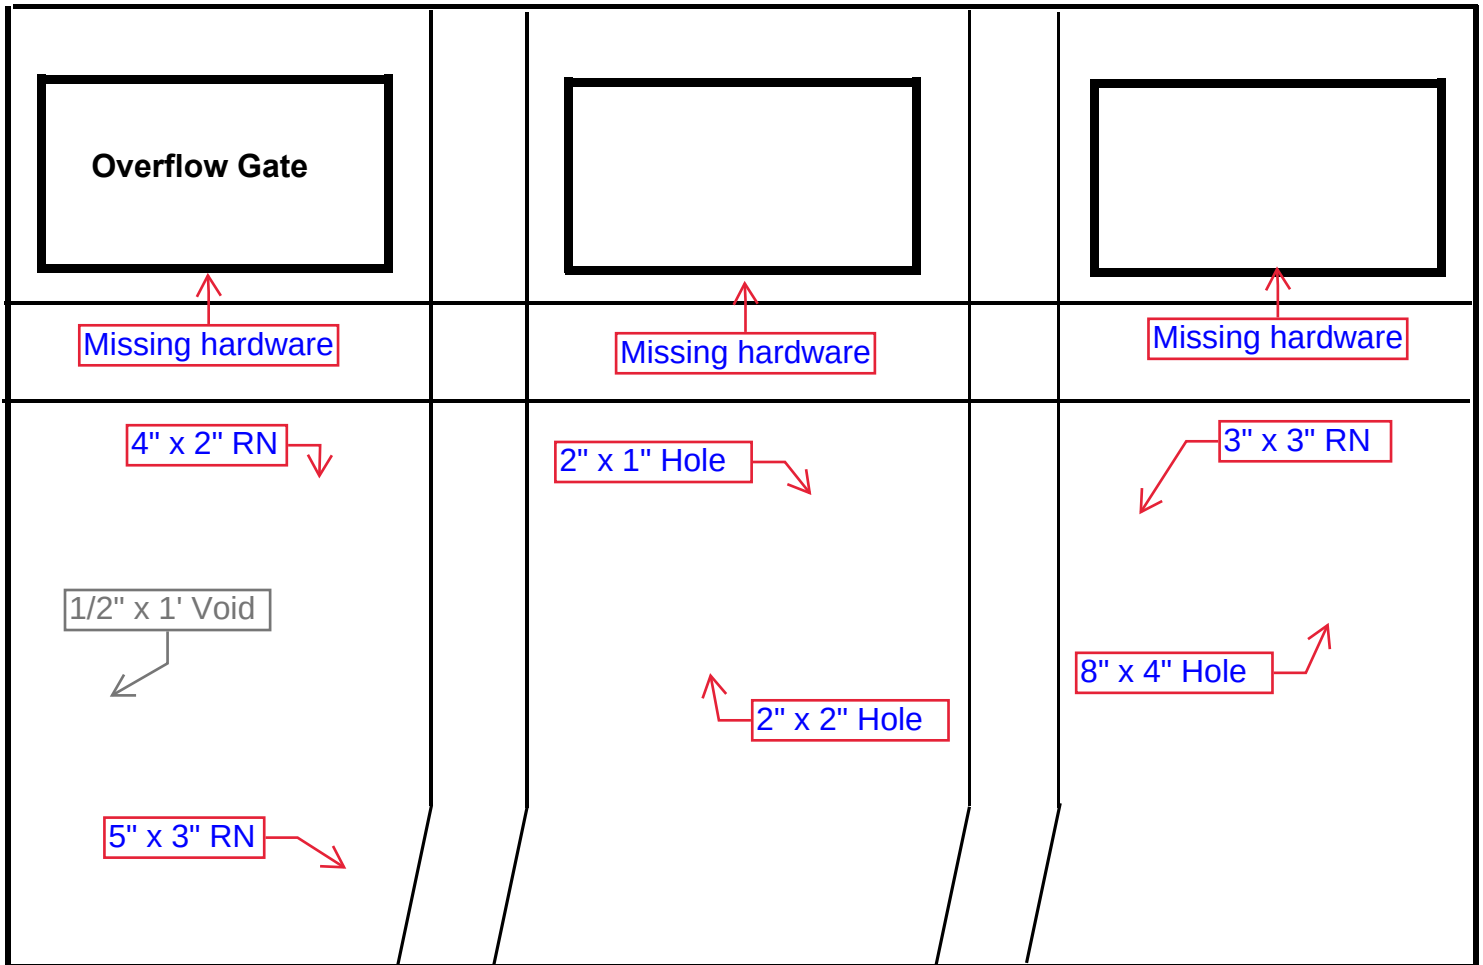
Bent 36

- Heavy marine growth
- Heavy corrosion
- Exposed aggregate on concrete
- Right gate - Middle and right swing arms missing hardware; left heavily corroded
- Middle gate - middle and right swing arm bolts missing; left heavily corroded
- Left gate - Middle swing arm bolt missing; left and right heavily corroded

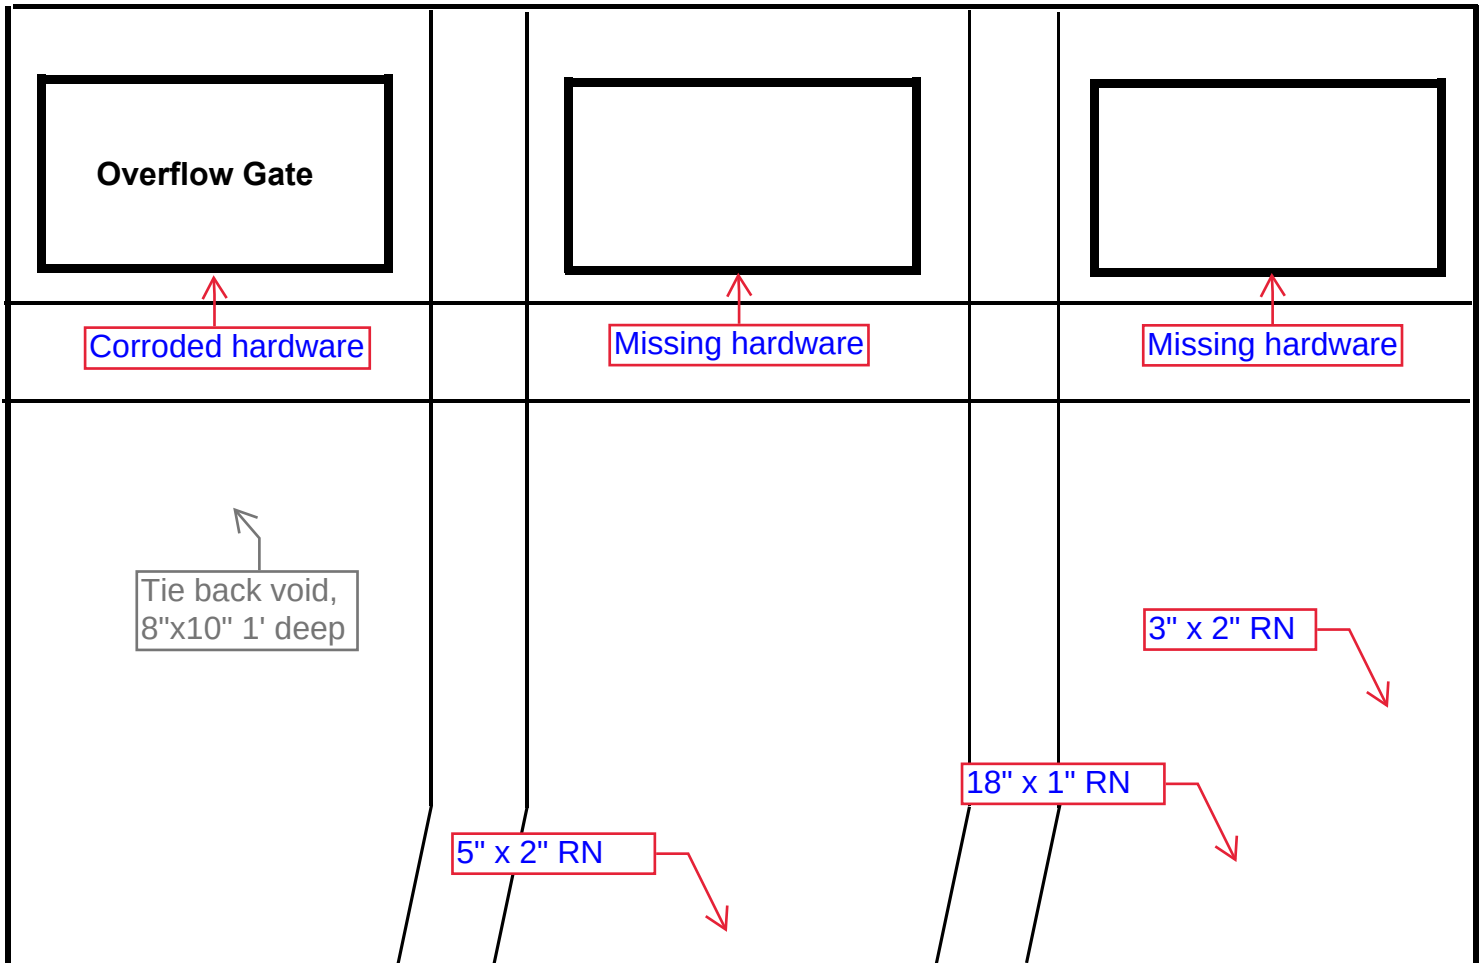
- Heavy marine growth present throughout
- Heavy corrosion unlocalized throughout
- Exposed aggregate on concrete at waterline
- Rust nodules present
- Right gate - missing middle swing arm bolt
- Middle gate - missing bolts right and middle; left corroded and missing nut
- Left gate - Corroded hardware; cable improperly rigged
- Popout in left header

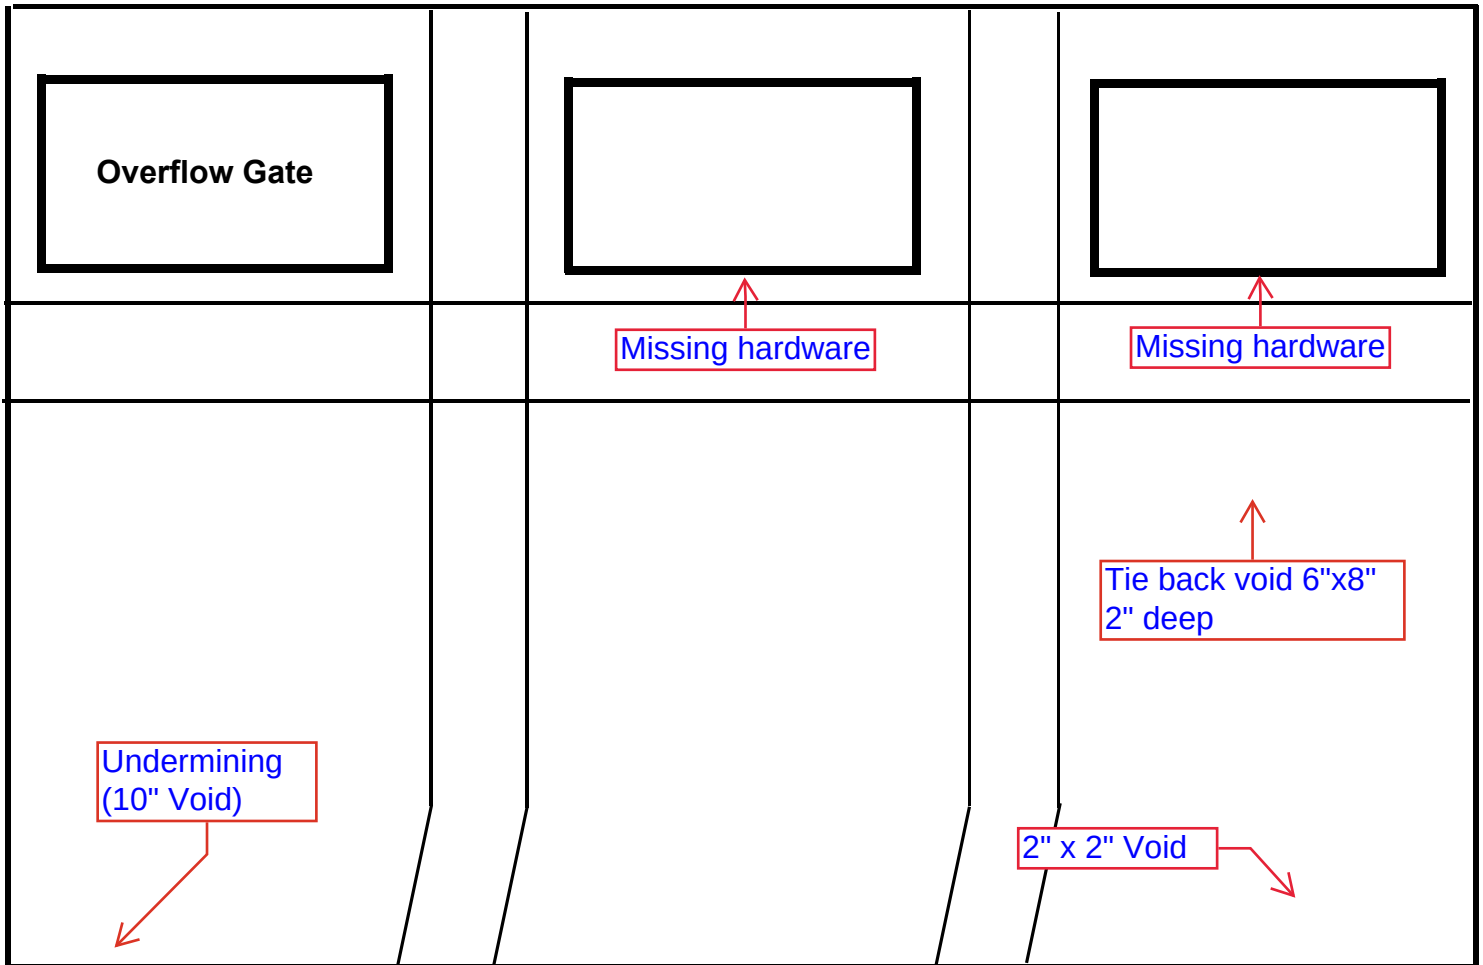
- Heavy marine growth present throughout
- Heavy corrosion unlocalized throughout
- 2x2" hole under right gate
- Exposed aggregate on concrete
- Void noted left of 2nd slant pile near tieback under header
- Right gate - missing middle bolts; left and right corroded
- Middle gate - missing right bolt
- Large undermining void left gate (10")

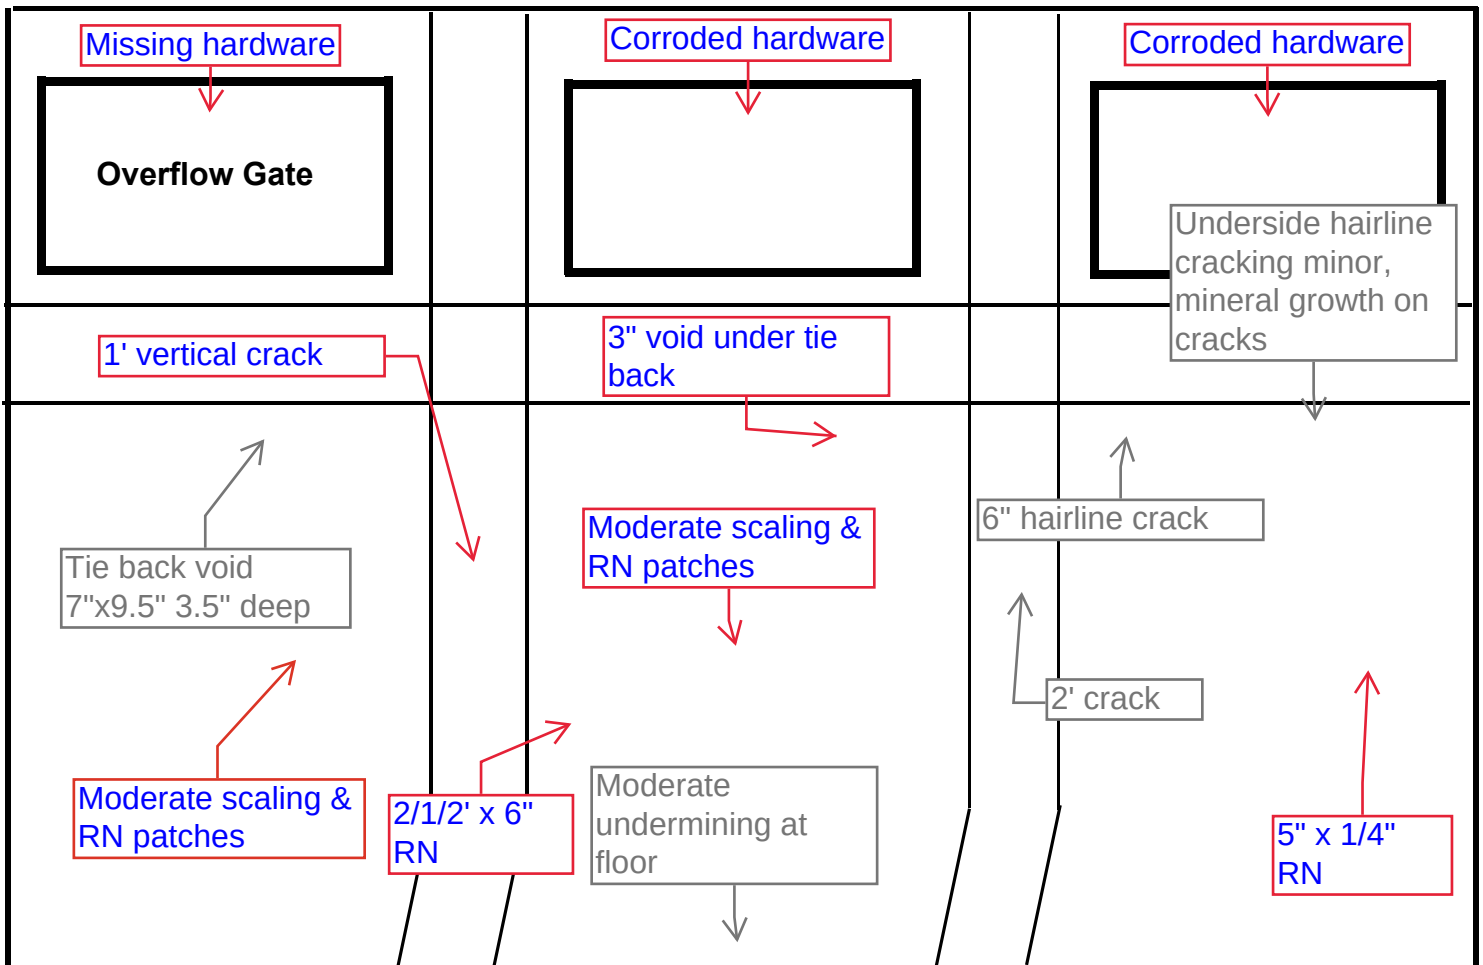
- No cracking under cap noted
- Heavy hard marine growth
- Most previous cracks not identified (covered by hard growth)
- Moderate rust noduling throughout underside
- Moderate scaling present throughout
- Moderate exposed aggregate
- Right gate - corroding middle hardware; bottom wood panel splitting
- Middle gate - corroded hardware; cable improperly rigged; splitting in wood panel
- Left gate - missing hardware on right arm; middle corroded; wood panel splitting
- Spalling on Bent 43 joint

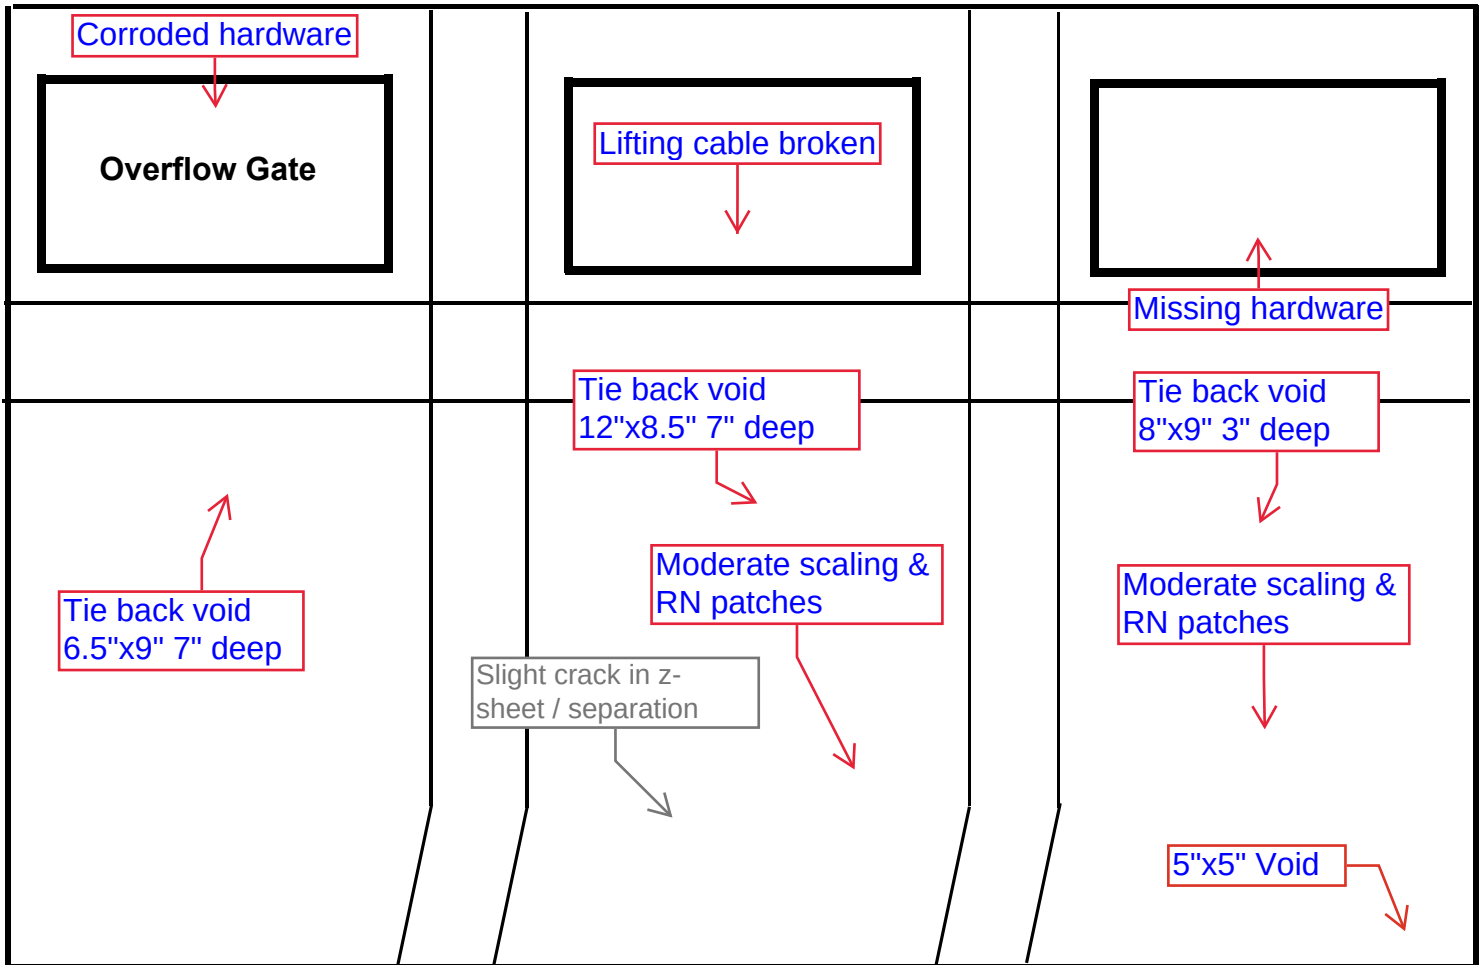
- Heavy marine growth
- Moderate corrosion
- Heavy exposed aggregate throughout
- Void under right gate (5"x5")
- Right gate - middle and right hardware missing; left corroded; gap in wood panel; cable improperly rigged
- Middle gate - middle hardware corroded; broken lifting cable
- Left gate - corroding hardware, cracking wooden panel
