**RE: Addendum #4 25-40 Utility Services Dive Services**

A comprehensive inspection was conducted by In Depth Inc. on both the saltwater and freshwater sides of the Deer Point Dam between March 14 and 16, 2025. Certified commercial divers performed the inspection, documenting physical defects, corrosion, biological fouling, and the condition of structural and mechanical components.

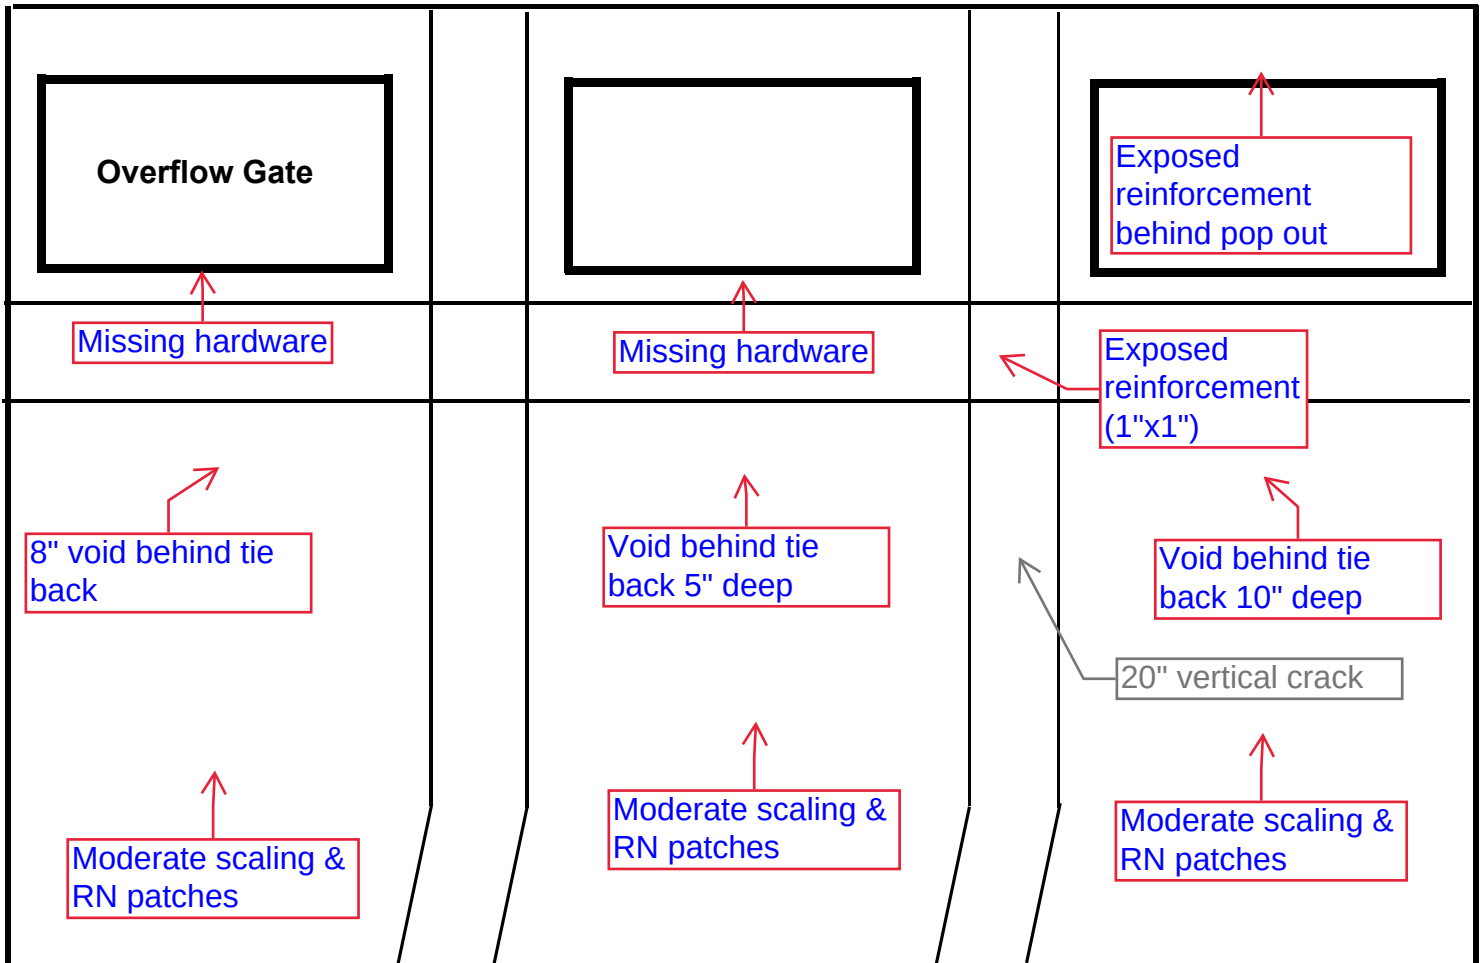
- No cracking under cap noted
- Heavy hard marine growth
- Moderate corrosion w/ scaling throughout entire section
- Minor to moderate exposed aggregate present
- Exposed reinforcement at right batter pile to header joint (1"x1")
- Right gate - debris stuck in gate
- Middle gate - middle missing hardware; left corroded; cable improperly rigged
- Left gate - middle missing; right and left corroded
- Spalling on left header

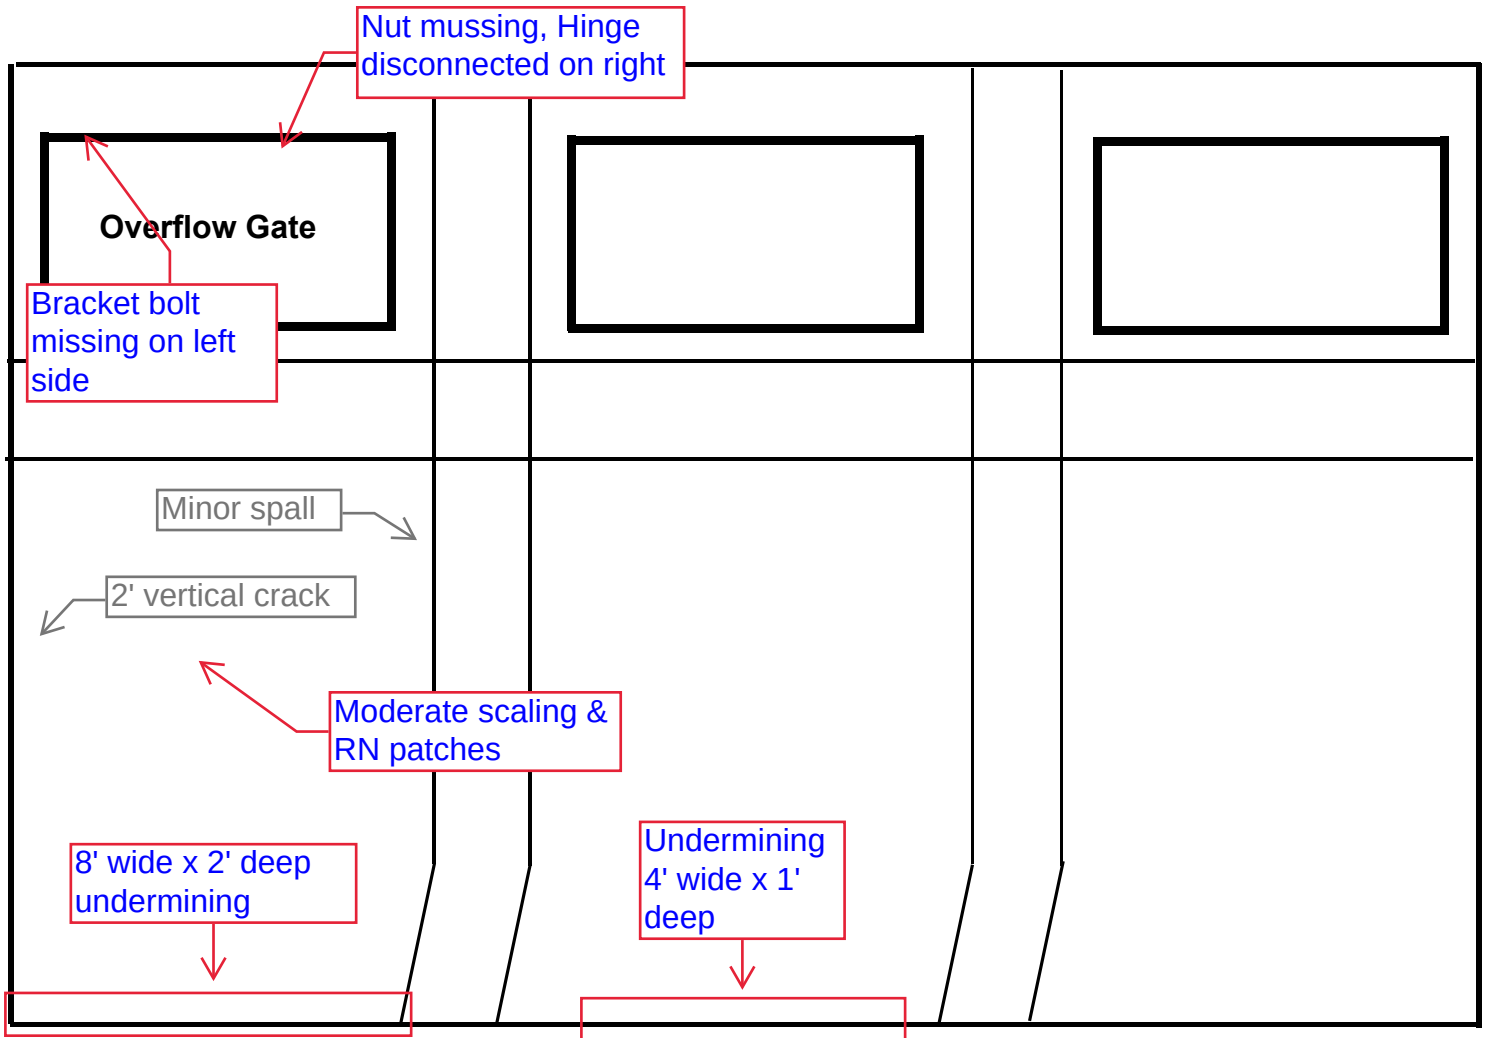
- No cracking under cap noted
- Heavy hard marine growth
- Moderate scaling on Z sheet throughout section
- Moderate exposed aggregate noted
- No undermining found on right side
- Undermining middle gate (4' wide x 1' deep)
- Undermining left gate (8' wide x 2' deep)
- Left gate - missing hardware on right (nut) and left (bolt)

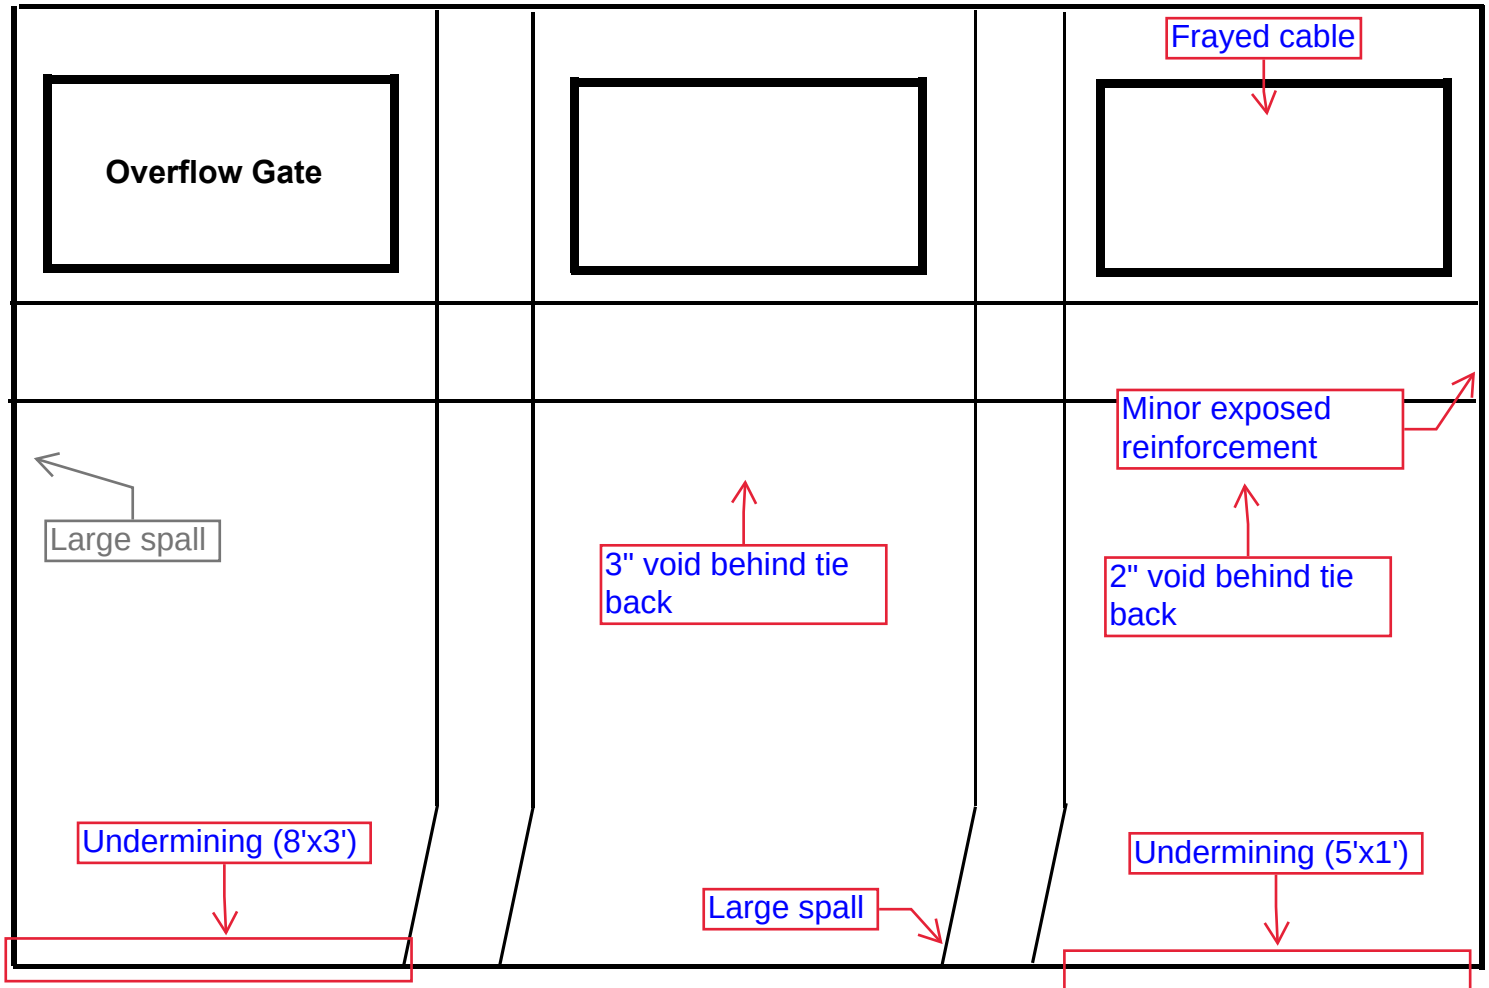
- No cracking under cap noted
- Heavy hard marine growth
- Moderate exposed aggregate noted
- Right side batter pile has a spall 2"w x 3"h x 1/2"d towards bottom of pile
- Right gate - Frayed cable wire
- Undermining right gate (5' wide x 1' deep)
- Undermining on left side (6-8' long x 2-3' in depth)

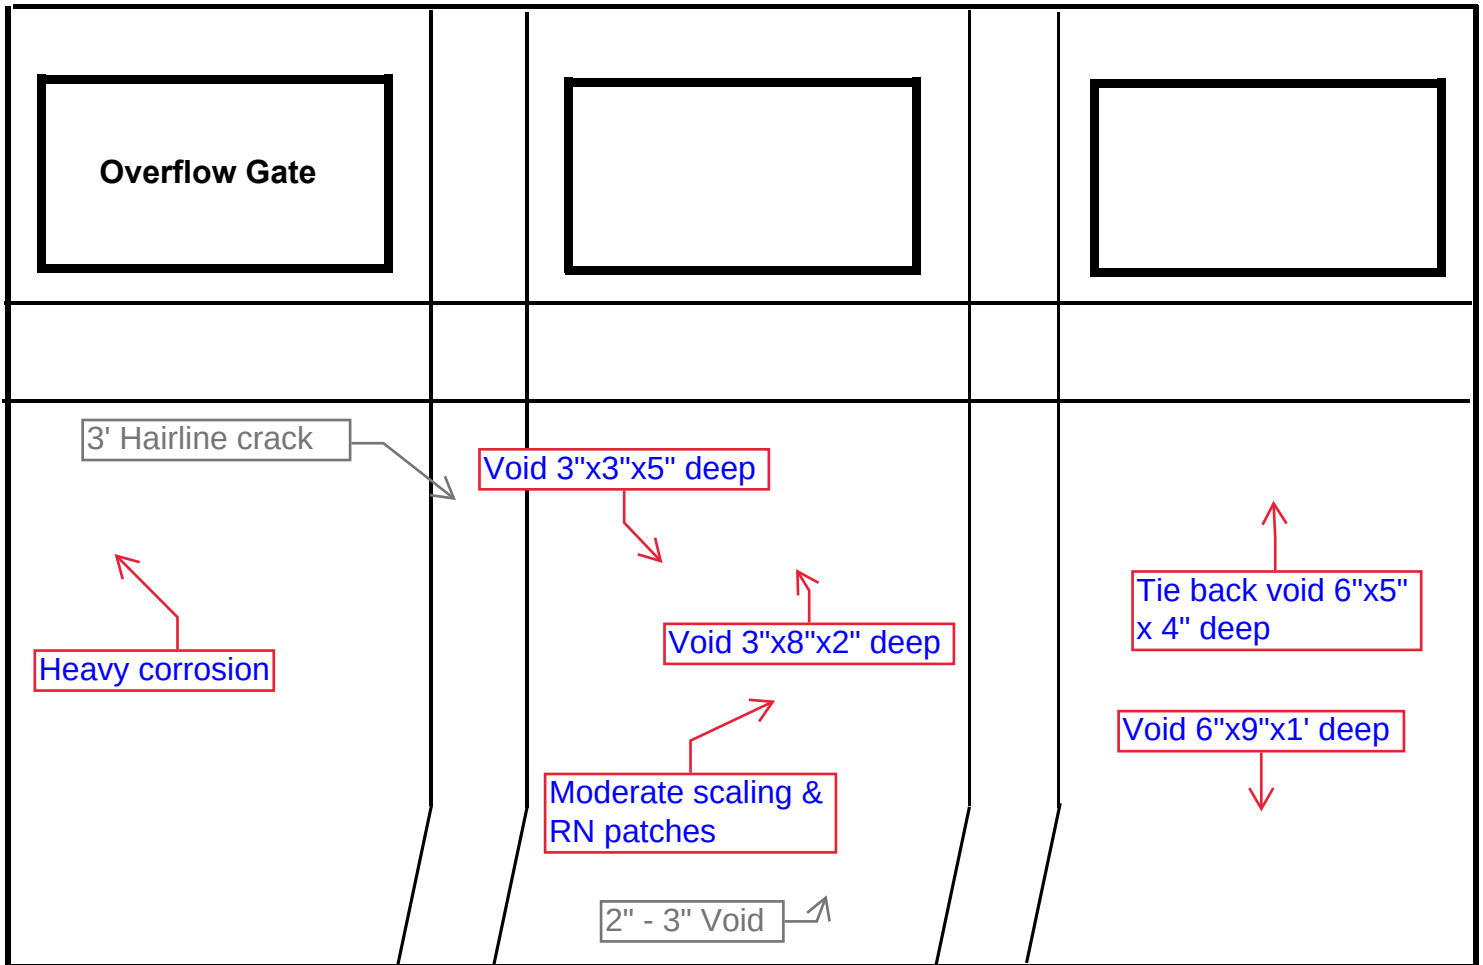
- No cracking under cap noted
- Heavy hard marine growth
- Moderate corrosion throughout section
- Heavy exposed aggregate at the waterline
- Void right bay (6"w x 9"h x 1' deep)
- Tieback void right (6"w x 5"h x 4" deep)
- Voids in middle bay
  - 3"w x 3"h x 5"deep
  - 3"w x 8"h x 2"deep
- No undermining noted

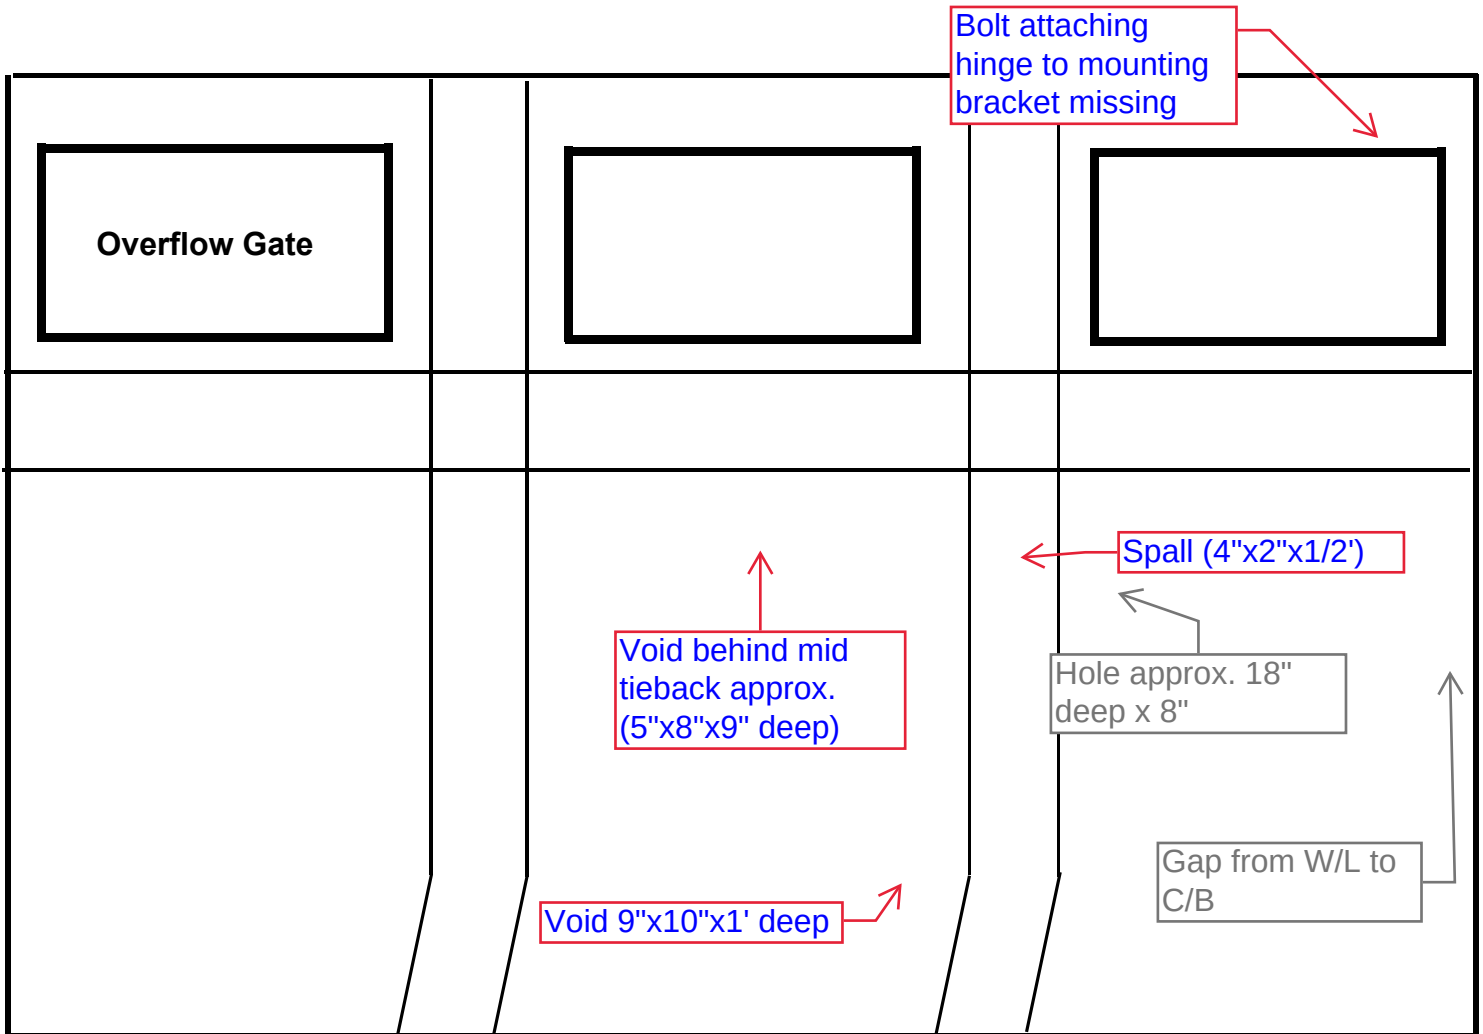
- No cracking under cap noted
- Heavy hard marine growth
- Moderate scaling present on Z sheets
- Heavy exposed aggregate at the waterline
- No undermining noted
- Right gate - missing hardware
- Mid bay voids
  - Tieback void middle (5"w x 8"h x 9" deep)
  - 9"x10"x1' deep

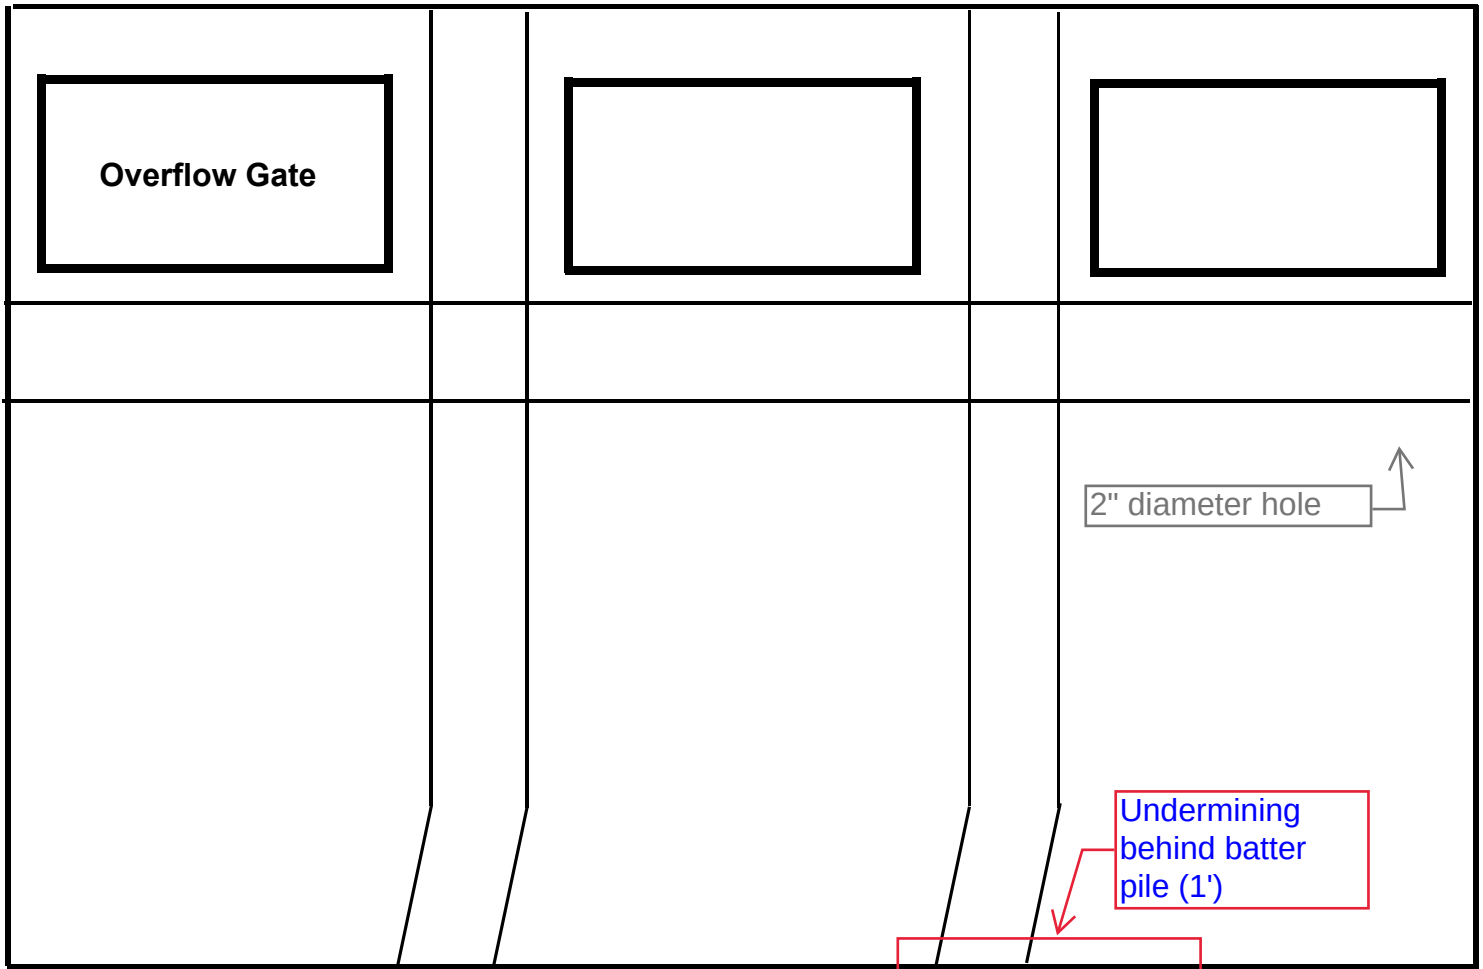
- Heavy hard marine growth
- Minor spalling present under cap
- Heavy exposed aggregate
- Minor to moderate corrosion
- Undermining right bay 1' deep localized behind vertical pile

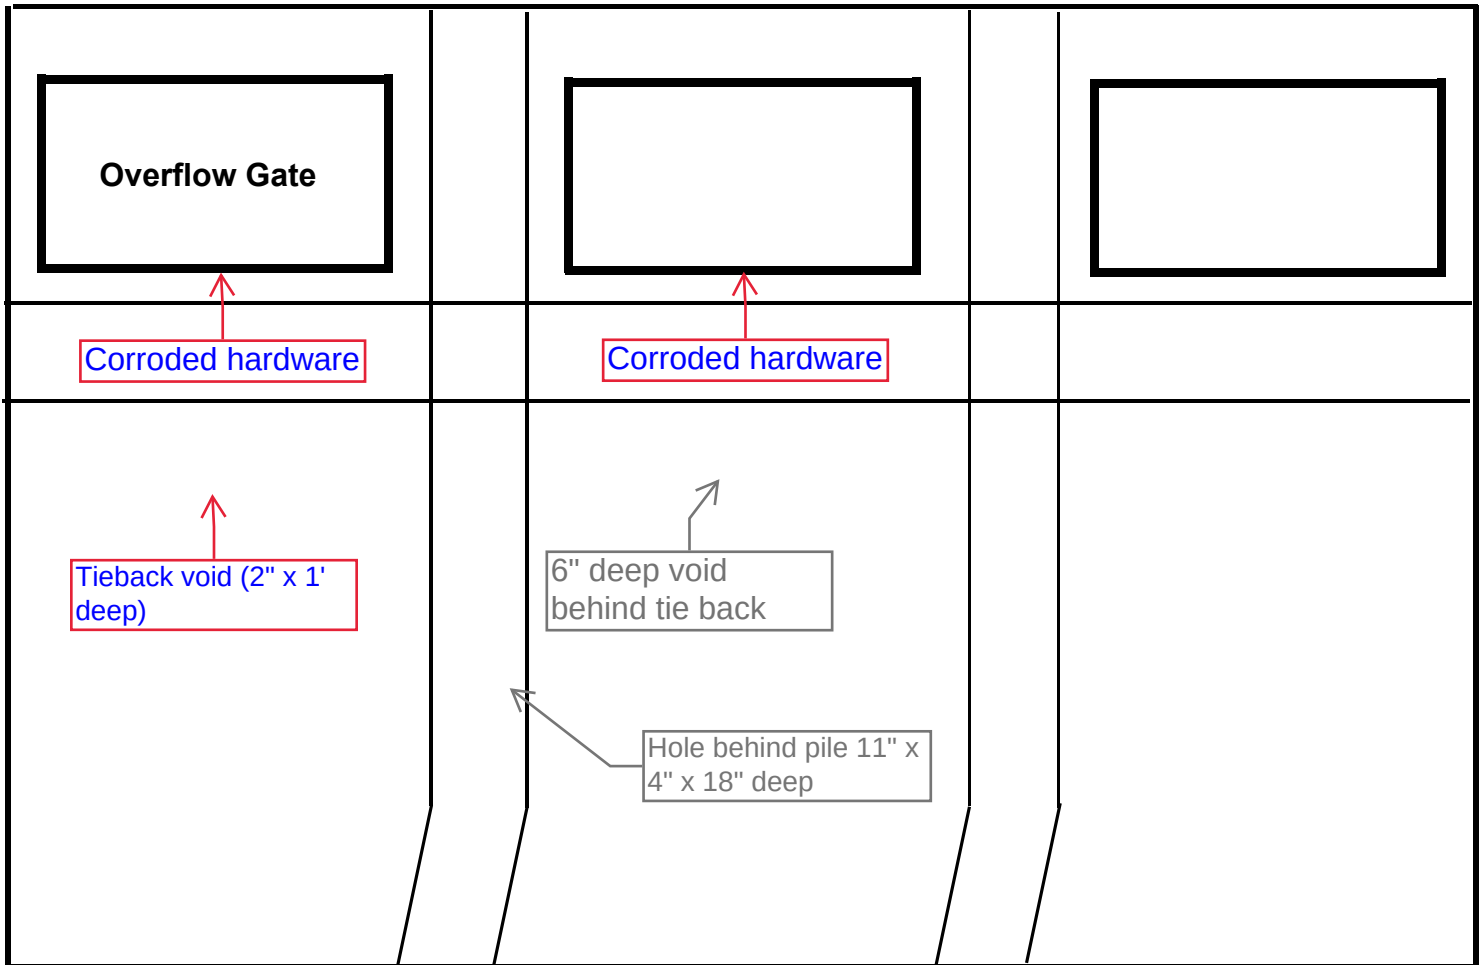
- No cracking under cap noted
- Moderate exposed aggregate
- No undermining noted during inspection
- Heavy exposed aggregate at the waterline
- Left and middle gate - heavy corrosion on cable shackle
- Left tieback void (2"w x 1' deep)

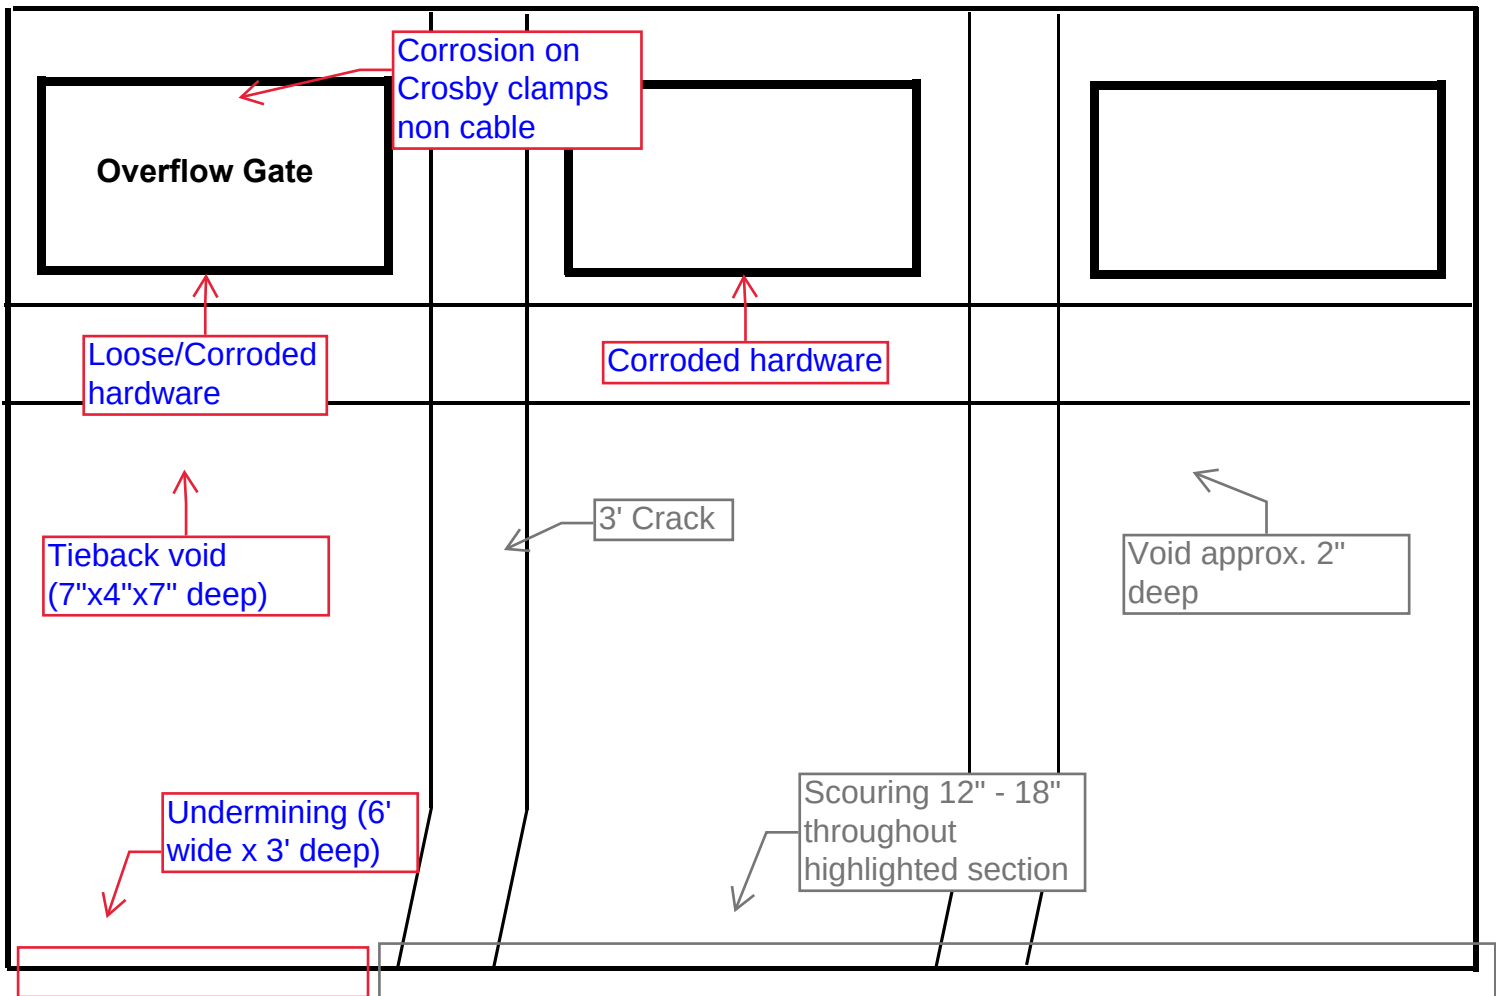
- No cracking under cap noted
- Heavy hard marine growth
- No undermining noted on right and middle
- Undermining under left gate (6' wide x 3' deep)
- Moderate exposed aggregate throughout
- Middle gate - corroding hardware on cable connection to gate
- Left gate - anchor bolt loose; corroding hardware; vegetation in gate
- Void left tieback (7"w x 4"h x 7" deep)

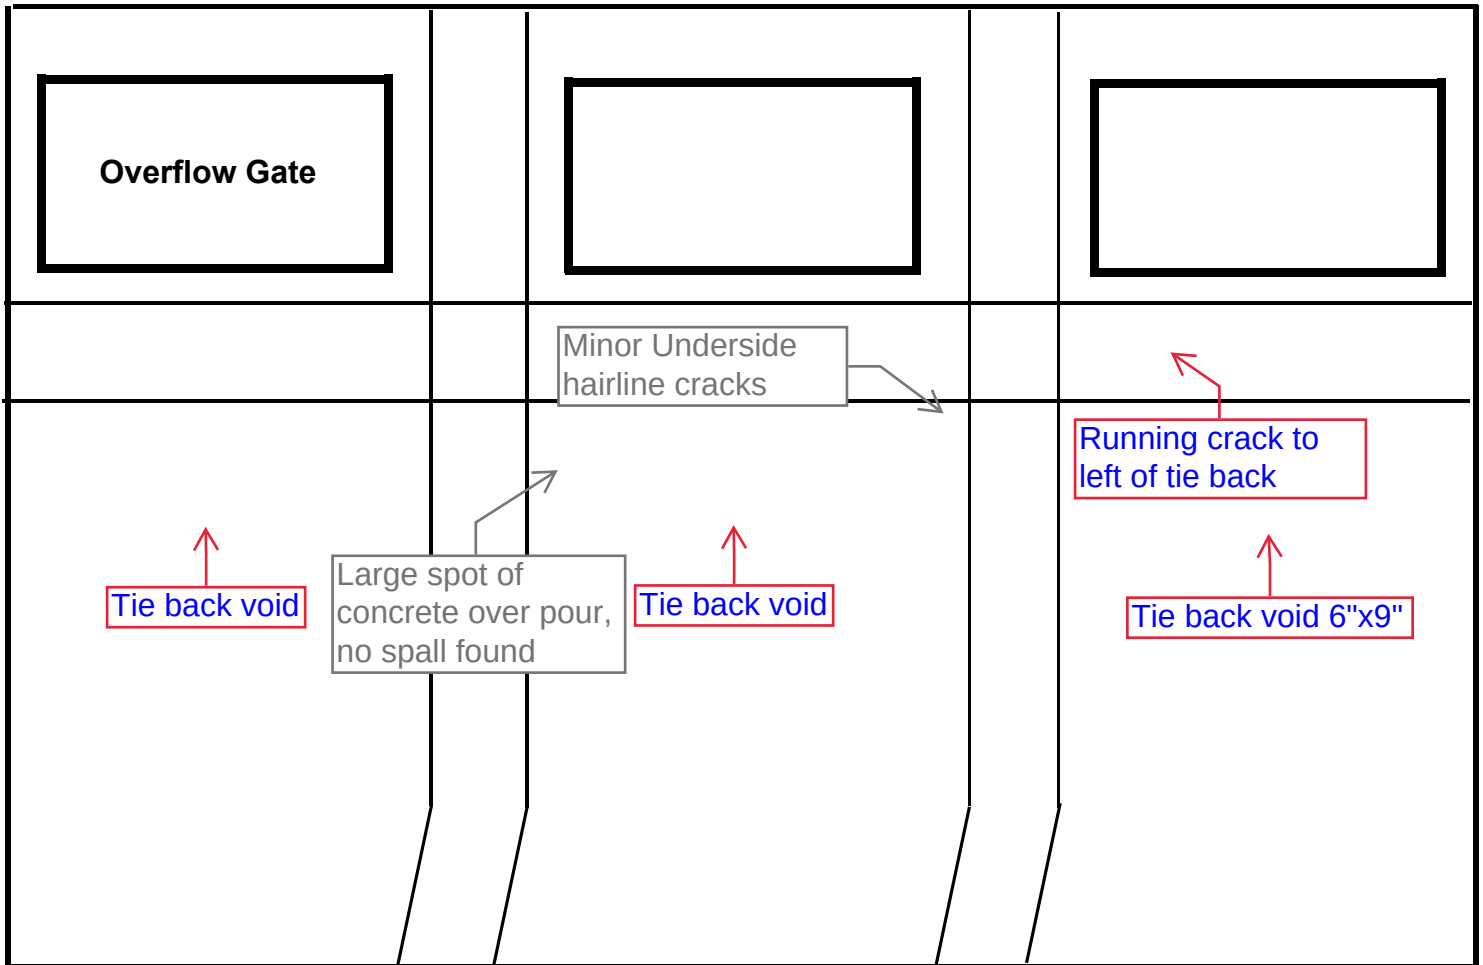
- Heavy hard marine
- Heavy exposed aggregate and Moderate/ Heavy bugholing
- Heavy corrosion and marine growth around all three tie backs
- Hairline crack on right gate header to the left of tie back (approx. 3')
- Large accumulation of marine growth behind right batter pile
- Weld seams and hardware on tiebacks in Good condition
- Fishing line debris wrapped on left tieback
- Gate cables in Good condition

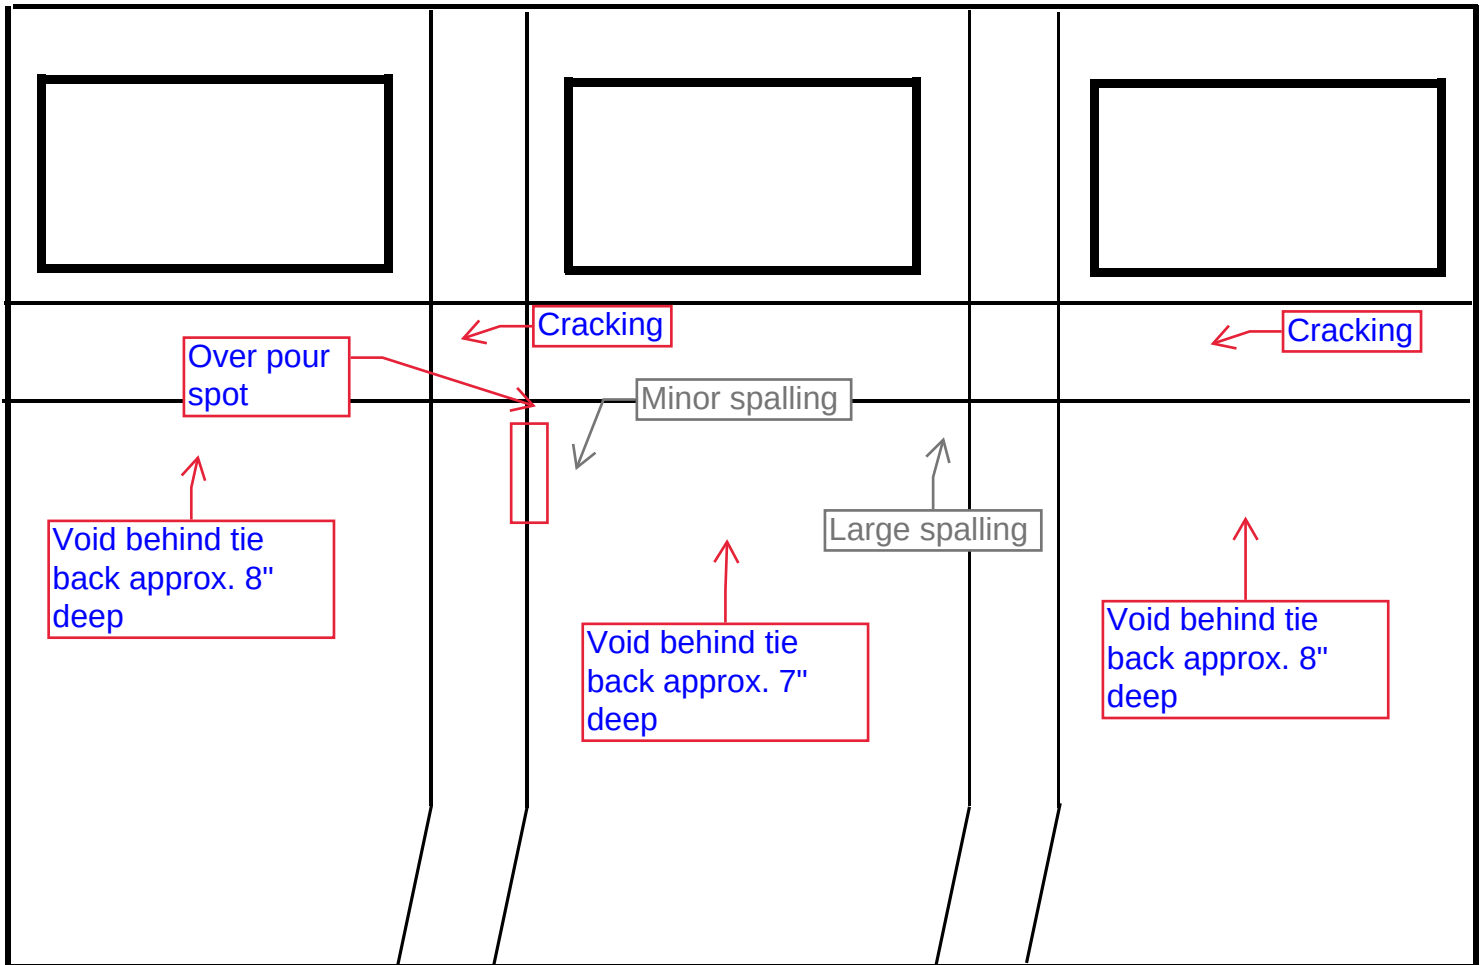
- Heavy hard marine growth
- Heavy exposed aggregate and Moderate/ Heavy bugholing
- Large void around all three tie backs; heavy corrosion and marine growth
- Previous identified exposed reinforcement not found
- Tieback weld seams and hardware in Good condition
- Moderate hairline cracking present throughout header
- Loose eye bolt on left gate
- Gate lifting cables in good condition

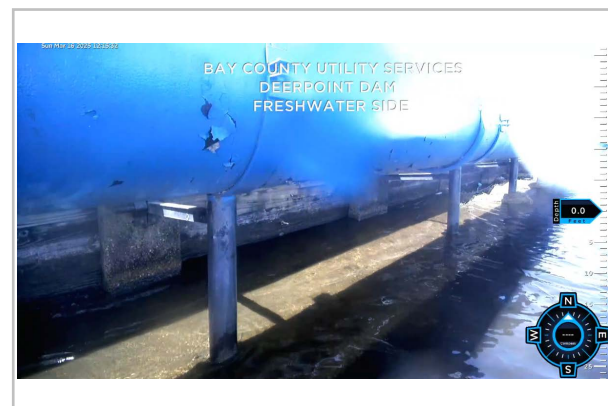
Freshwater Pipe Coating Failure

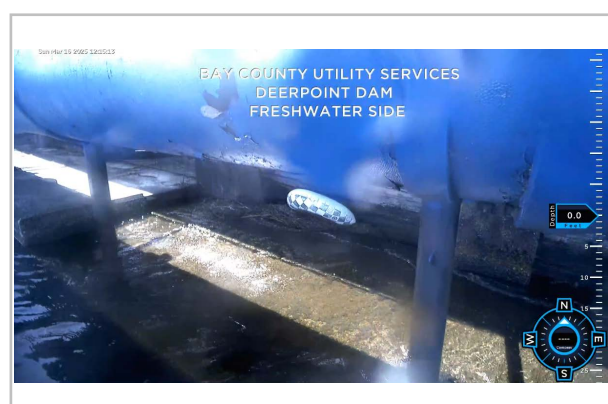
Freshwater Stuck Float and Debris

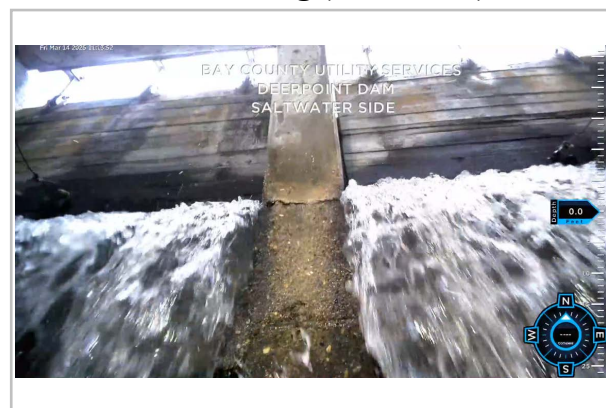
## Pile Cracking (Bent 7 to 6)

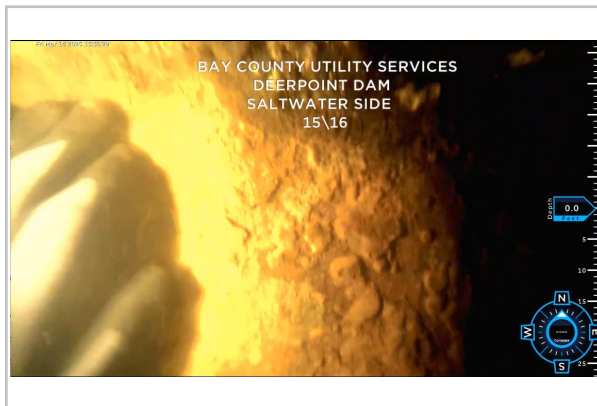
## Corrosion on Z-Sheet Patch

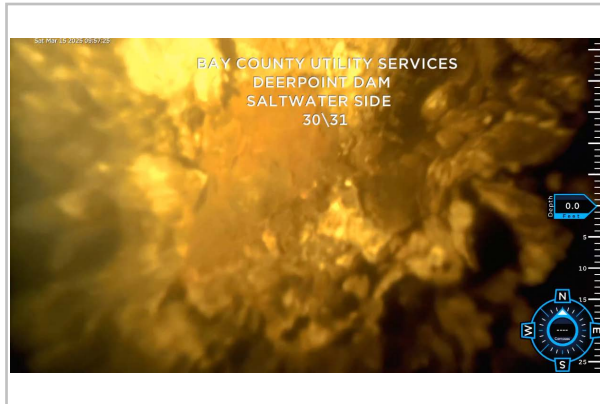
Corrosion on Z-Sheet

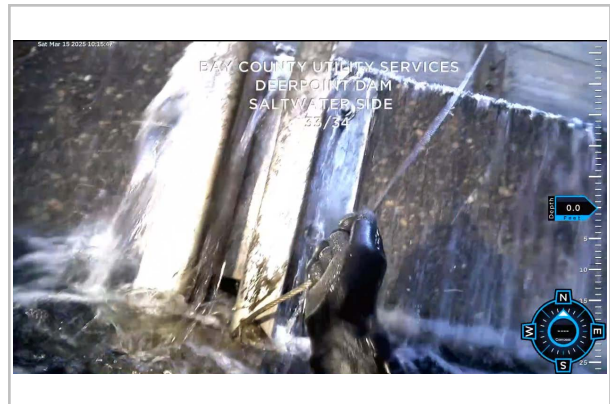
Broken Lifting Cable

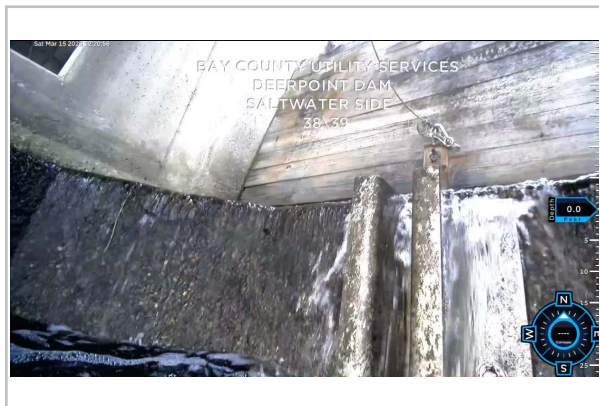
Popout in Header

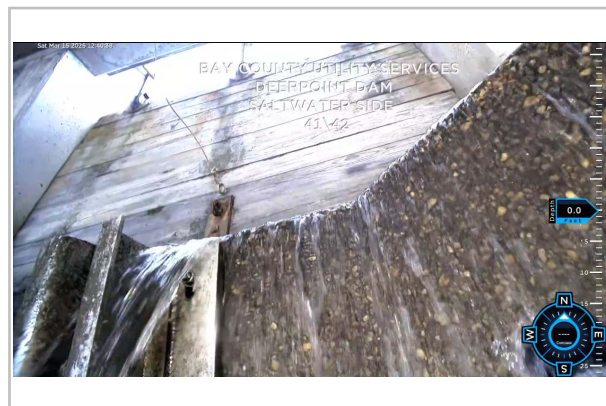
Missing Hardware on Gate Swing Arms

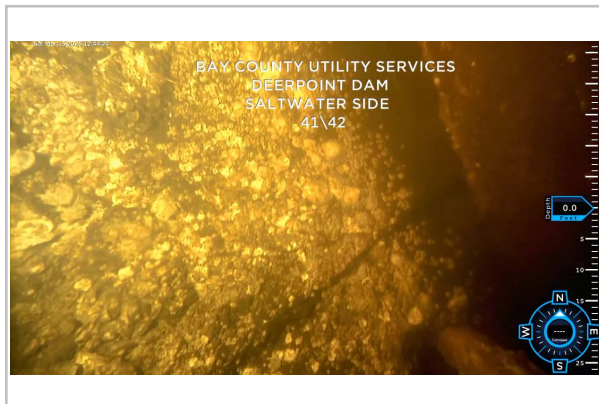
Undermining (41/42)

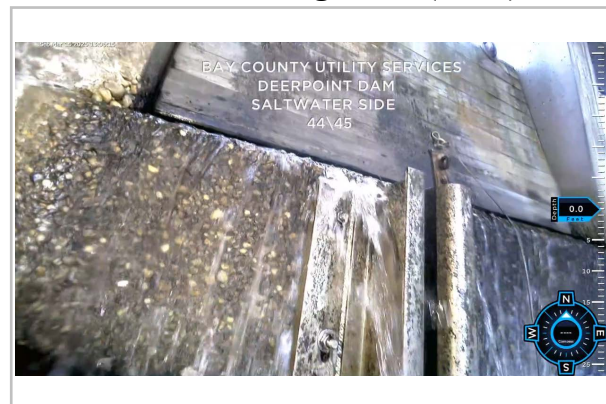
Broken Lifting Cable (44/45)

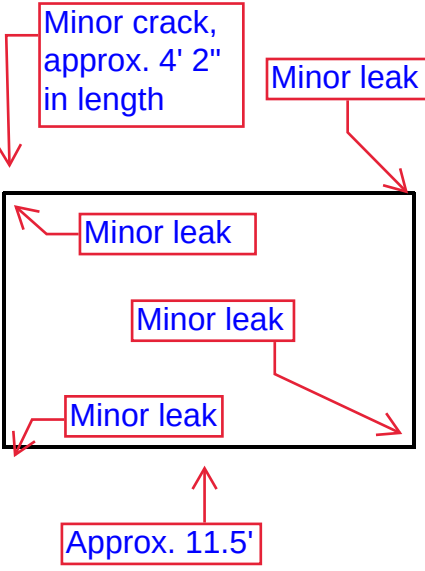
| Gate #3 | Gate #2 | Gate #1 |
|---|---|---|
| <ul style="list-style-type: none"> <li>• Heavy marine growth</li> <li>• Anodes in place 4x's 95 % life</li> <li>• Surface corrosion and rut noduling present below waterline</li> <li>• Clean floor; floors and roof in good condition</li> <li>• Heavy exposed agg and pitting in concrete</li> <li>• Back of gate, gasket has mod cracks, mod marine growth</li> <li>• Minor exposed reinforcements noted</li> <li>• Minor to moderate cracking &amp; pop-outs noted in roof</li> <li>• Moderate concrete abrasion noted throughout</li> <li>• Length: Approx. 76'</li> <li>• Minor bumper dry rot</li> </ul> | <ul style="list-style-type: none"> <li>• Minor unevenness noted throughout floor</li> <li>• Gasket in good / fair condition, minor deterioration present</li> <li>• Heavy exposed aggregate noted</li> <li>• Anodes approx. 95% life, couple old anodes present</li> <li>• Length: approx. 71'</li> <li>• Corrosion w/ pitting on flapper gate</li> <li>• Heavy marine growth on flapper &amp; anodes</li> <li>• Two (2) loose nuts on door hinge on the right side recommended to tighten down</li> </ul> | <ul style="list-style-type: none"> <li>• Gasket in good / fair condition</li> <li>• Heavy exposed aggregate noted throughout; especially along bottom on hallway 1</li> <li>• Moderate abrasion noted in sluiceway</li> <li>• Length: approx. 66'</li> <li>• Moderate corrosion on flapper</li> <li>• Gate constructed of aluminum</li> <li>• Minor to moderate cracking on bumper material</li> <li>• Anodes look good 95% life</li> <li>• Mod -heavy marine growth</li> <li>• Surface corrosion and rust noduling present behind growth; difficult to fully evaluate behind growth</li> <li>• Overpour in some small areas</li> <li>• Minor hairline cracking</li> <li>• Sluice gate 1 no leaks noted, gasket in good condition</li> <li>• Sluice gate 2 slight leak top right and left corners, center of top, mod leak along bottom of gate</li> <li>• Walls and roof look satisfactory</li> </ul> |

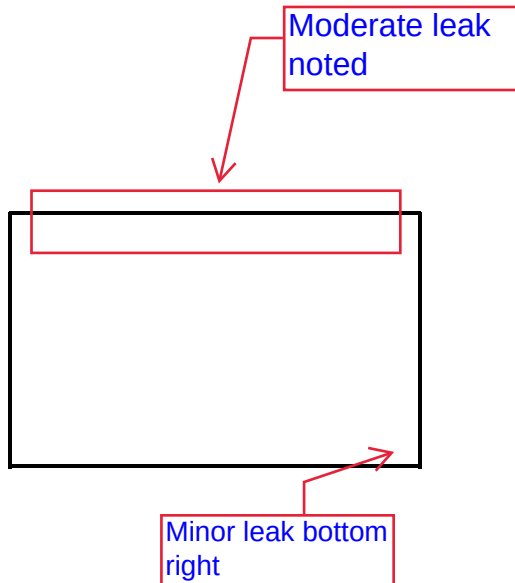
- Minor bend noted in upper "L" bracket
- Gasket deterioration top left
- Shaft satisfactory
- 70% marine growth
- Hardware present and tight
- Gasket pushed out on #2 (top)
- Missing a couple nuts and bolts on top seal

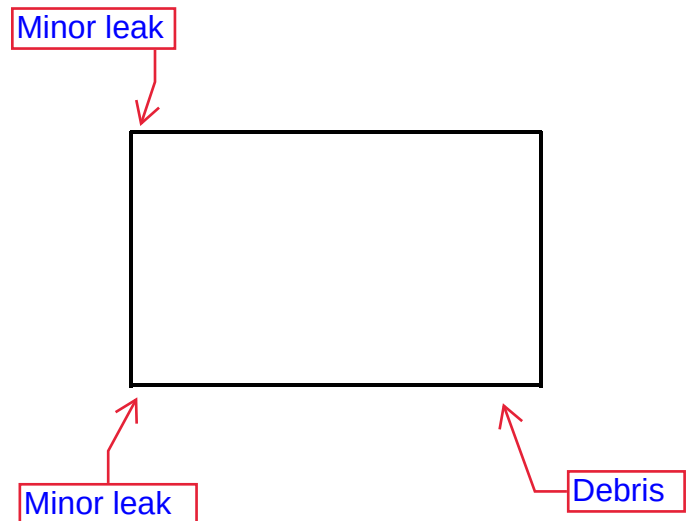
- Minor flow / leak (bottom left & top left)
- Debris / trash (minor)
- Moderate corrosion throughout
- Heavy marine growth present
- Approx. 40% - 50% life left on anodes
- Stem looks satisfactory
- Gate adjustment bolt 3/4" shaft is 1/2"
- Side rail bolt is 1/4" nut is 1/2"
- Bottom seal is 1/4" shaft, nut is 1/2"
- Scour on apron near bottom of number 1

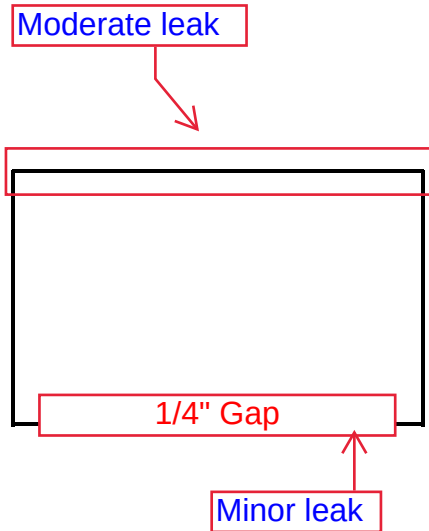
- Heavy marine growth
- Corrosion w/ pitting
- Top of gate missing seal gasket
- Remaining gasket in place and satisfactory condition
- Minor leak bottom right corner
- Slight bend in the stem
- Hardware missing for top seal

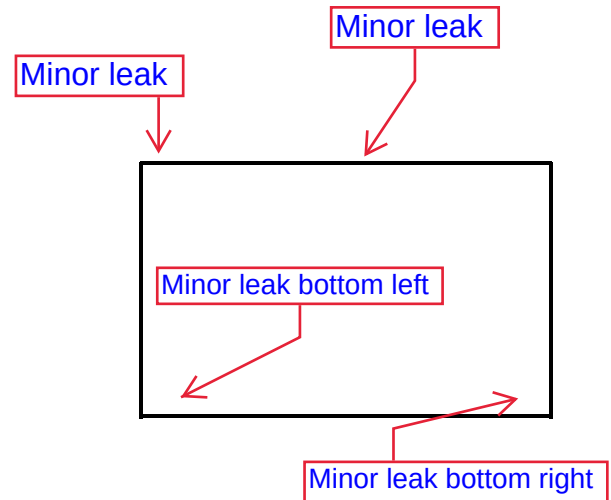
- Corrosion w/ pitting noted
- Heavy marine growth
- Approx. 50% - 60% life left on anodes
- Minor leak bottom right side and left side
- Gasket in place and satisfactory condition
- Minor leak top left and middle
- All hardware on top seal present

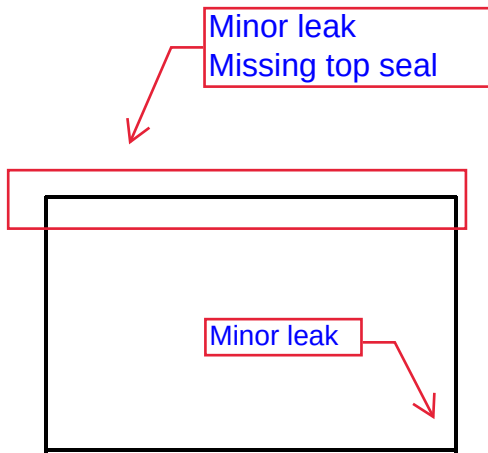
- Mod leak top left side
- Bottom right side minor leak
- No seal on top
- Soft growth noted on all gates
- Bent anchor bolt on guide into the wall
- Adjusted large gap (3") to close

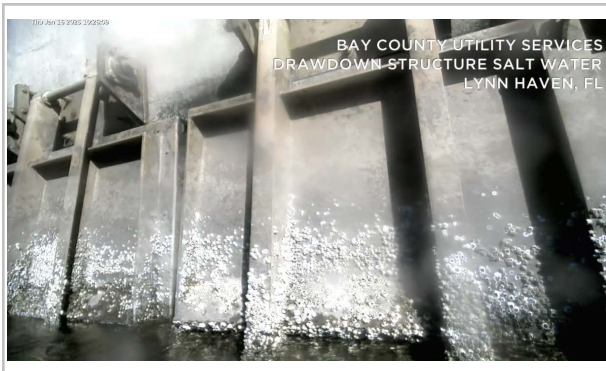
**Leak (Flapper Gate 10)**

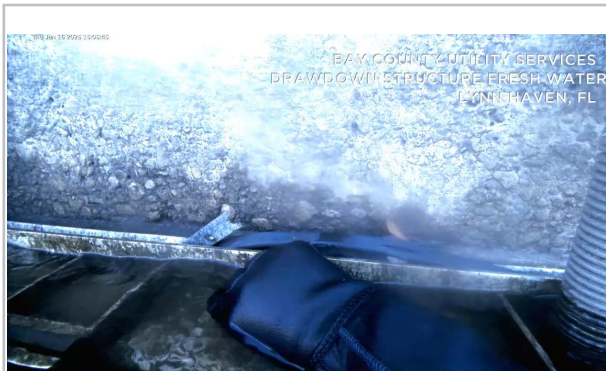
**Heavy Exposed Aggregate (Wall)**

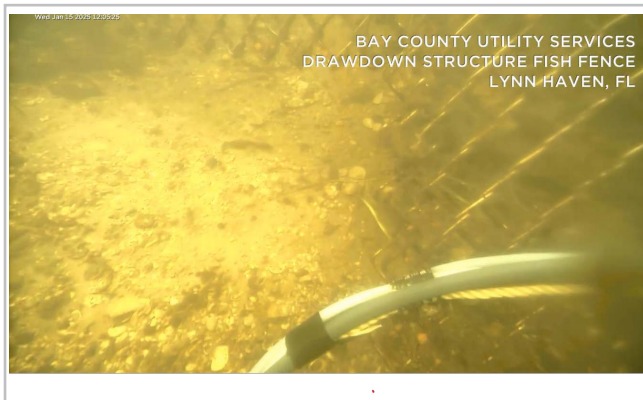
**Loose Pin (Forward #7)**

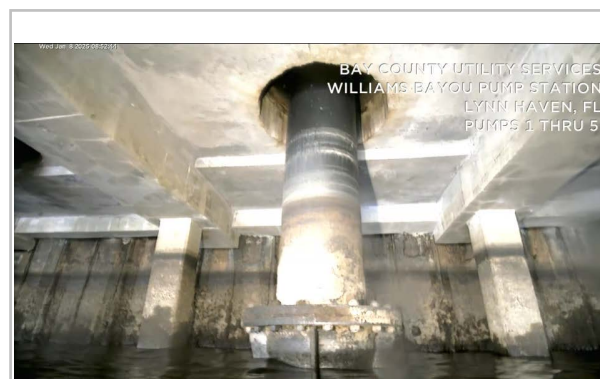
**Exposed Reinforcement - Header Near Pump 1**
