RE: Addendum #4 25-40 Utility Services Dive Services

Client: Bay County

Asset ID: Deer Point Dam

A comprehensive inspection was conducted by In Depth Inc. on both the saltwater and freshwater sides of the Deer Point Dam between March 14 and 16, 2025. Certified commercial divers performed the inspection, documenting physical defects, corrosion, biological fouling, and the condition of structural and mechanical components.

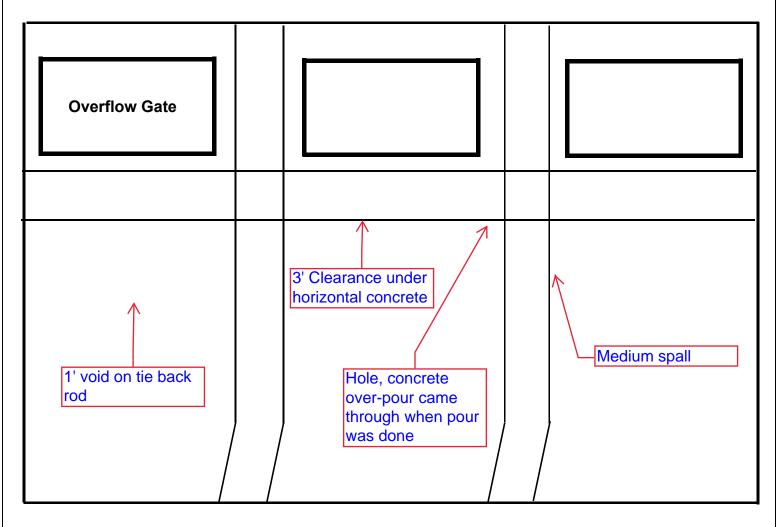
Bent 3 Bent 2

- Moderate growth on Z sheets
- Minor scaling noted on Z sheets
- Minor growth present on pile
- Moderate exposed aggregate present on header
- Minor crack on underside of pile cap repaired with Splash Zone

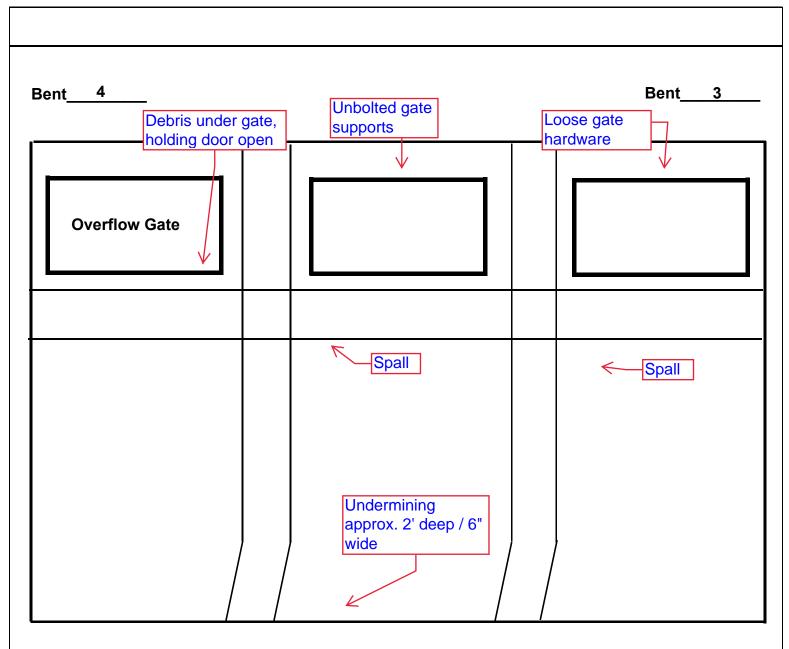
Undermining approx. 16" deep / 3" wide

- Minor to moderate growth on Z sheets
- Moderate scaling noted on Z sheets
- Minor spalling (small medium) present on header
- Moderate growth noted on pile
- Right flapper has debris in it keeping gate open
- Heavy marine growth
- Heavy exposed aggregate
- All holes have been patched

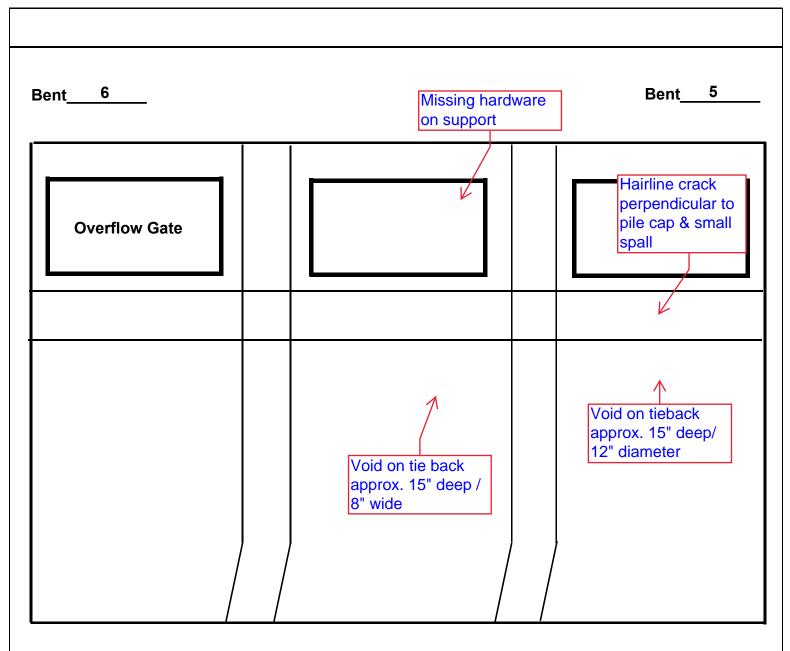
- Minor scaling noted on Z sheet
- Minor growth on z sheets & piles
- Heavy marine growth present
- Heavy exposed aggregate on concrete
- Area of undermining under middle gate near right gate, area is 5' wide and 1-2' deep
- Missing piece of wood on left flapper gate top left corner
- No repairs were performed

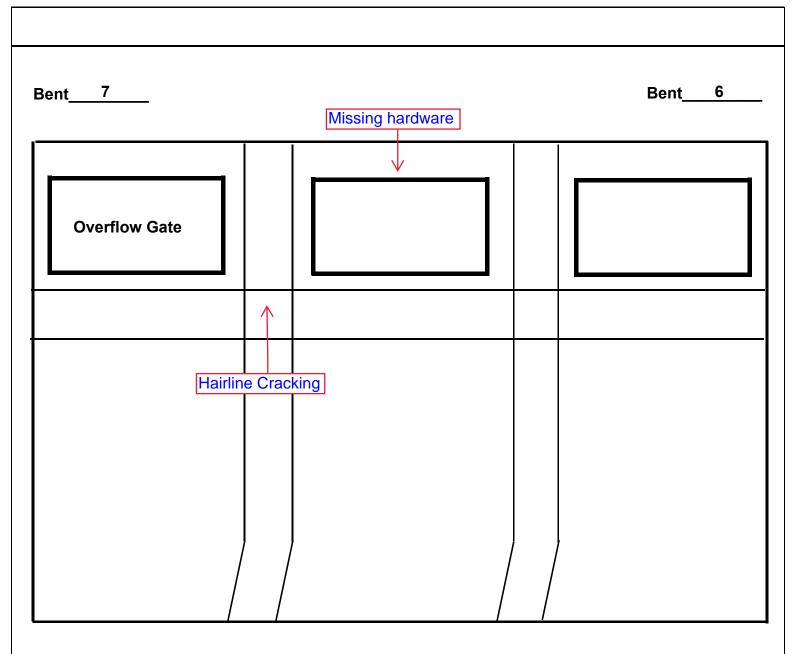
- Minor growth noted throughout Z sheets & pile
- Minor scaling present on Z sheets
- Corrosion present throughout with moderate marine growth
- All holes patched over
- Heavy exposed aggregate on concrete
- Exposed reinforcement on header
- Cracking present on pile between middle gate and left gate

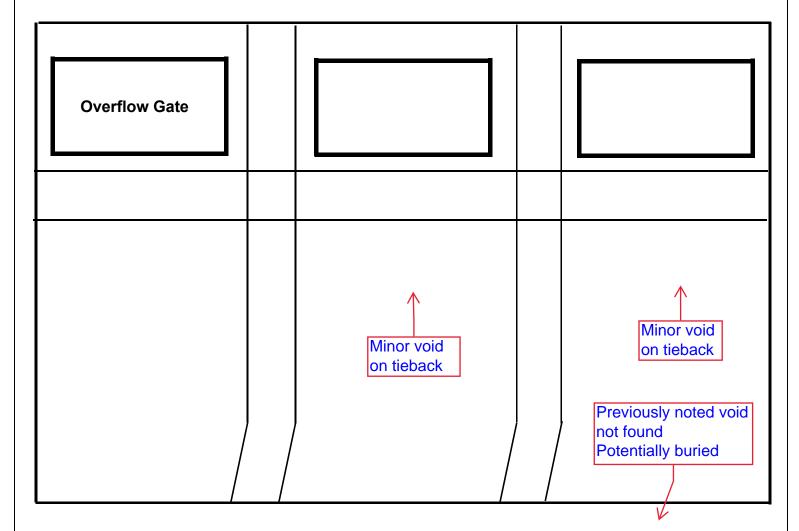
Bent 11 Bent 10

- Moderate to heavy growth on Z sheets / piles
- Corrosion noted throughout
- Hole has been patched
- Exposed aggregate present on concrete
- Minor tieback voids (1/2" to 1")

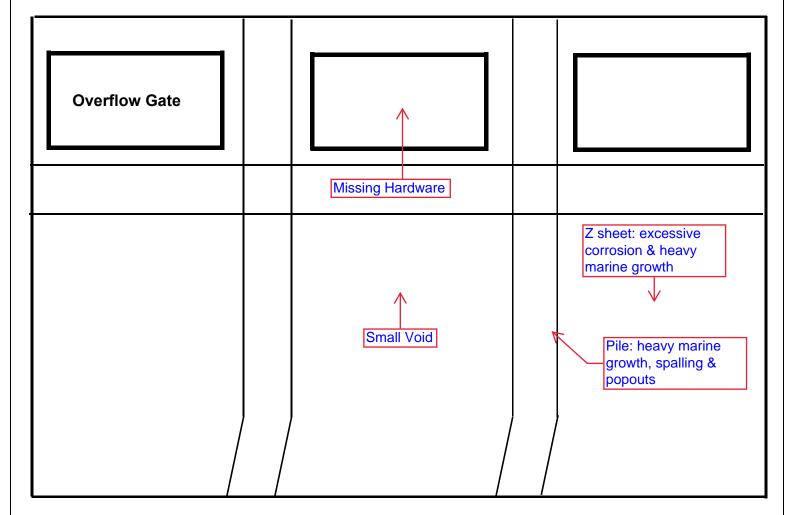
Bent 16 Bent 15

- Moderate corrosion present on Z sheets
- Moderate growth at splash zone / heavy below waterline
- Missing hardware on middle gate
- Patches in place
- Small hole 1-1/2"x3"x1/4" under Gate #2 located approx. 36" from header

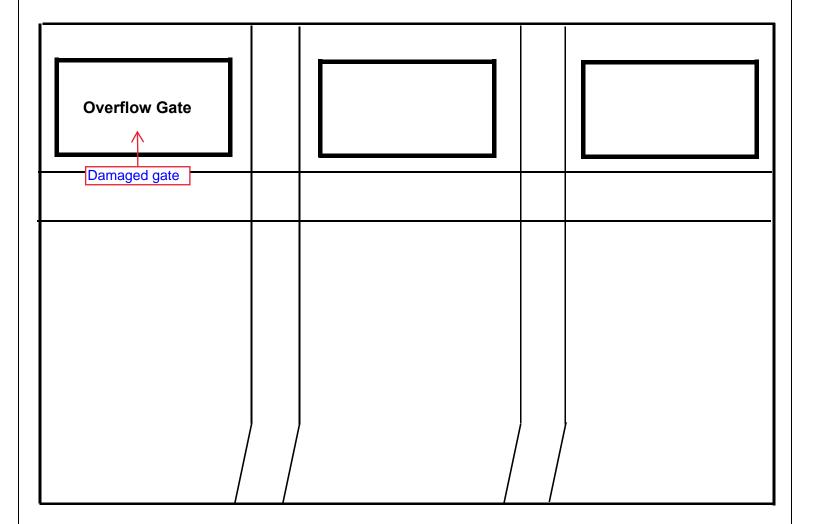
- Heavy growth noted on Z sheets / piles
- Moderate corrosion on sheet pile
- Holes have been patched
- Exposed aggregate on concrete
- No undermining noted
- Holes (x3) in left gate with unsecured hardware

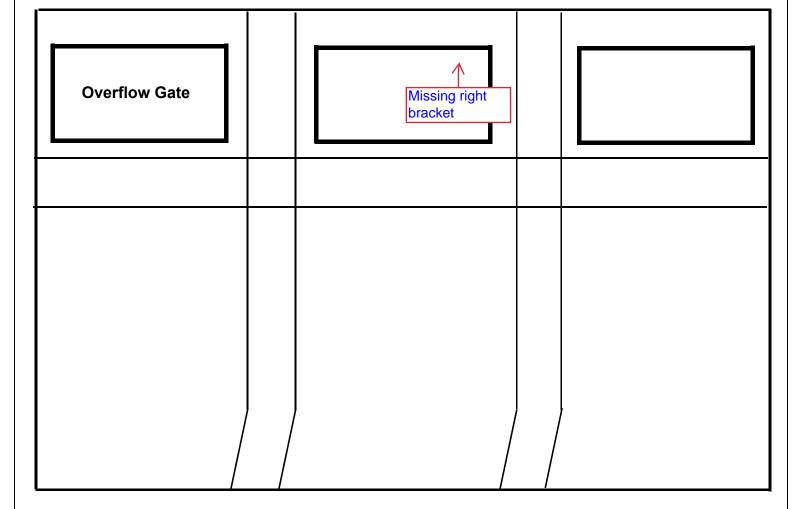
Bent 19 Bent 18

- Heavy growth noted on Z sheets / piles
- Holes have been patched up
- No undermining noted
- Middle gate missing nut and right bracket on flapper

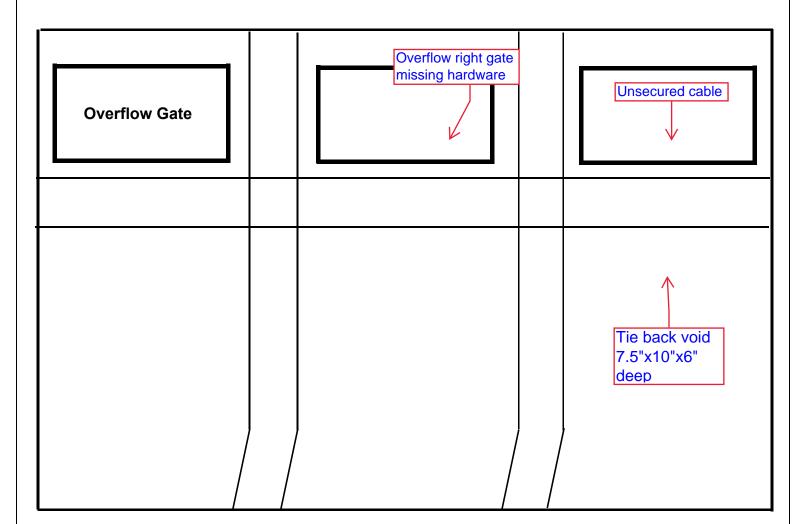
Bent 21 Bent 20

- Heavy marine growth
- Heavy corrosion
- Holes have been patched
- No undermining noted
- Exposed aggregate on concrete
- Void on tieback on right side
- Middle gate missing hardware

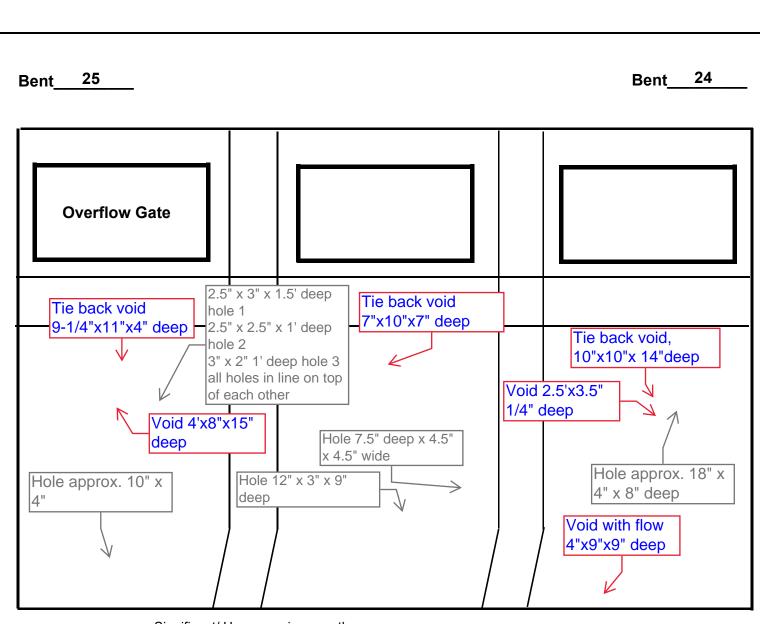
- Significant/ Heavy marine growth
- Scaling present
- Significant corrosion present
- Heavy exposed aggregate at the waterline
- Void on right gate tie back with water flow (10"w x 10"h x 14" deep)
- Void on middle gate tieback (7"w x 10"h x 7" deep)
- Void on left gate tieback with water flow (9-1/4"w x 11"h x 4" deep)
- Void right gate, 2.5"w x 3.5"h x 1/4"d, 46" from header
- Void right gate with flow, 4"w x 12"h x 9"d, 46" (near bottom)
- Void left gate 4"w x 8"h x 15"d, 42-1/2" from header

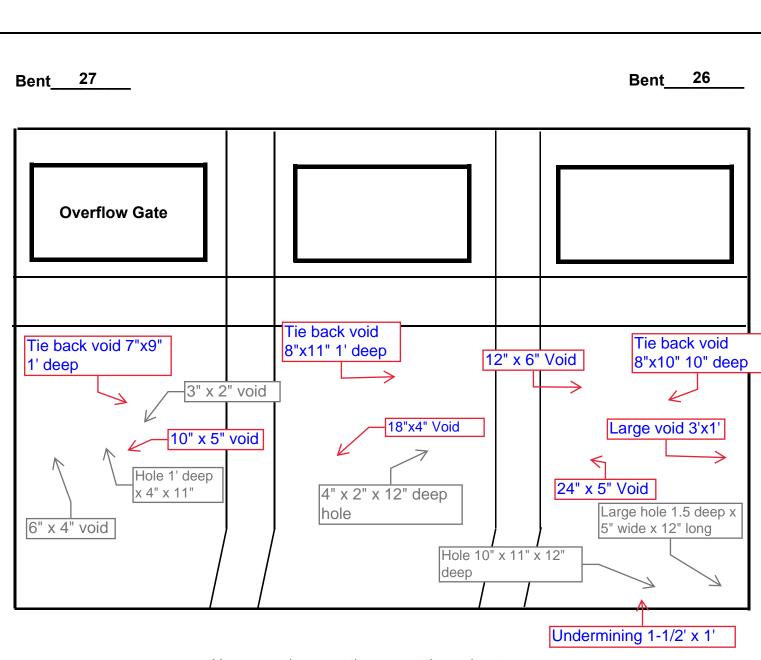
- Heavy marine growth present throughout
- Heavy corrosion unlocalized throughout
- Exposed aggregate present at waterline
- No undermining noted in middle gate and left gate

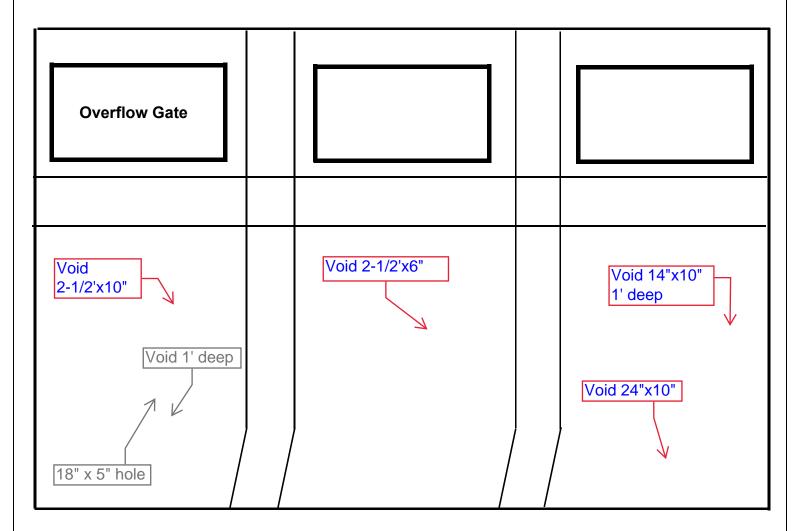
27 Bent 28 Bent

- All overflow gates missing hardware
- Heavy marine growth
- Heavy corrosion
- No undermining found
- Holes are still present

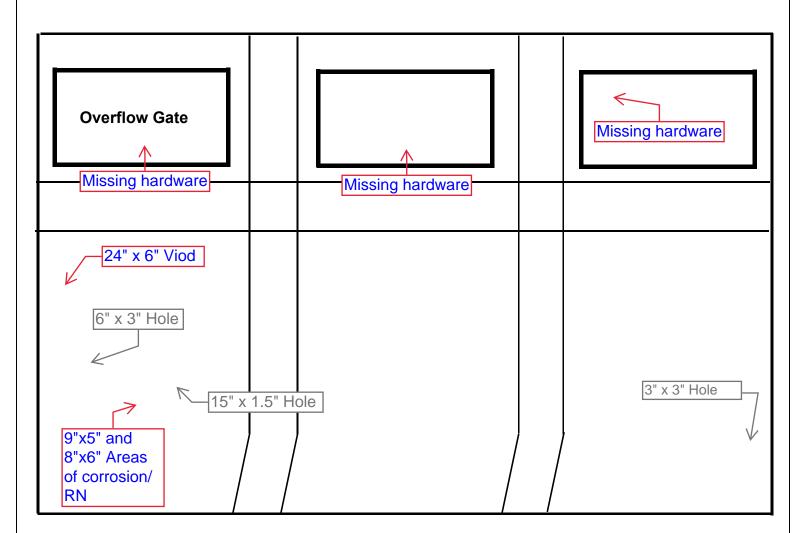
Bent 31 Bent 30

- Heavy corrosion w/ scaling
- Heavy marine growth present
- No undermining noted during inspection
- Exposed aggregate on concrete at waterline
- Missing hardware on right gate (left plate)
- Missing hardware on left and middle gate (swing arm to gate)
- Large patches of corrosion left gate z-sheet 9"x5" and 8"x6

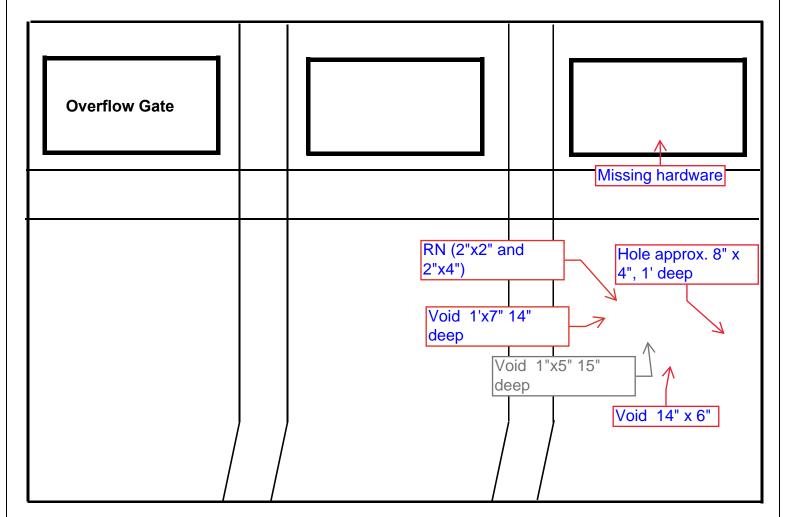
Bent 33 Bent 32

- · Heavy marine growth
- Heavy corrosion
- Exposed aggregate on concrete
- Corrosion/ rust noduling right gate (2"x2" and 2"x4")
- Missing washer on tieback bracket middle gate
- Missing hardware on right flapper (right two swing arms to gate)
- Missing hardware on middle flapper (swing arm to gate)
- Missing/ loose hardware on left flapper gate

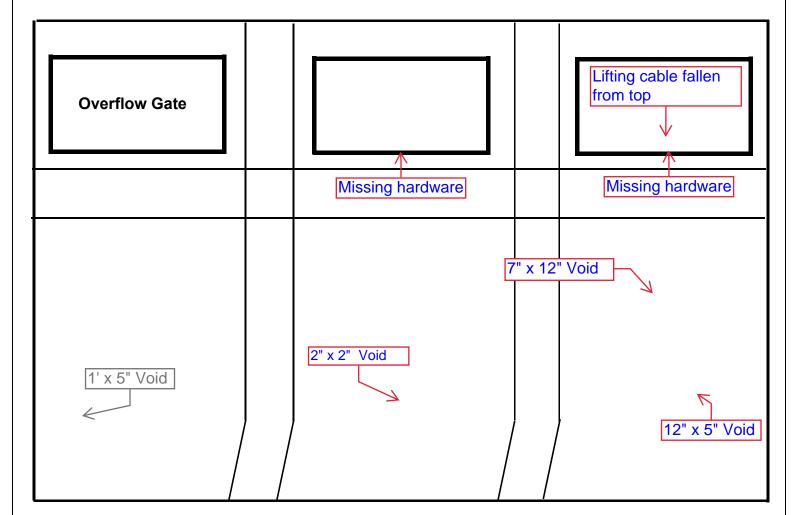
34 Bent 33 Bent

- Heavy marine growth
- Heavy corrosion
- Exposed aggregate on concrete
- Right gate broken lifting cable and missing hardware (3 bolts)
- Middle gate swing arm (middle and left) bolts missing, right severely corroded
- Left gate swing warm (middle and right) bolts missing, left severely corroded; lift cable twisted

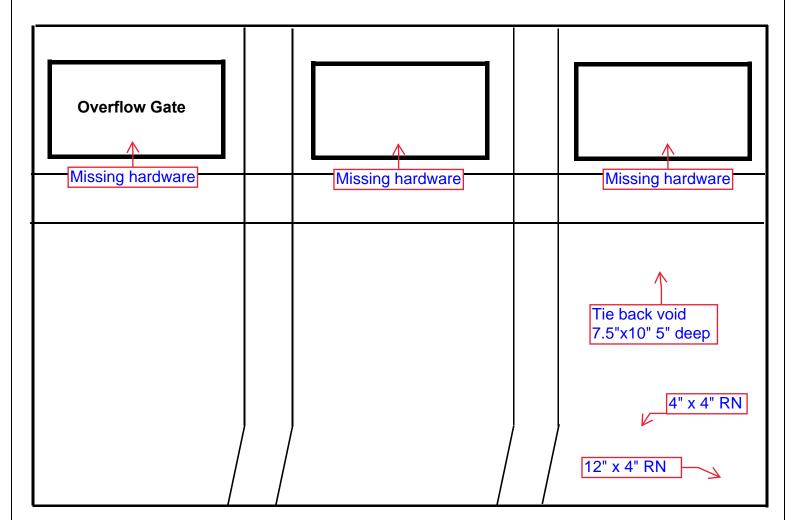
Bent 35 Bent 34

- Heavy marine growth
- Heavy corrosion
- Exposed aggregate on concrete
- Right gate missing (left and middle) bolts for swing arm to gate;
 right severely corroded
- Middle gate All (x3) attaching bolts missing
- Left gate missing (left and missing) bolts for swing arm; right severely corroded
- Corrosion patches right gate (12"x4") (4"x4")

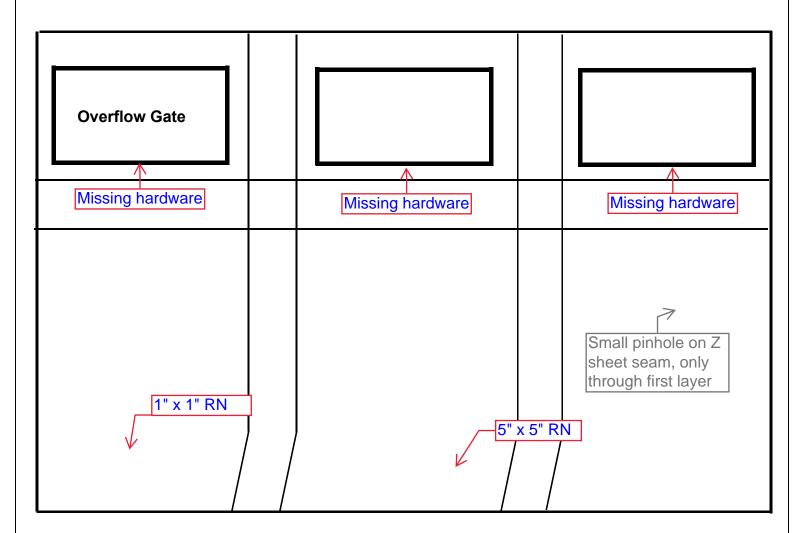
Bent 36 Bent 35

- Heavy marine growth
- Heavy corrosion
- Right gate All (x3) attaching bolts missing
- Middle gate Missing middle bolt; left and right heavily corroded
- Left gate right swing arm missing bolt; left and right corroded
- Rust nodule on middle gate 5" off bottom
- Exposed aggregate on concrete

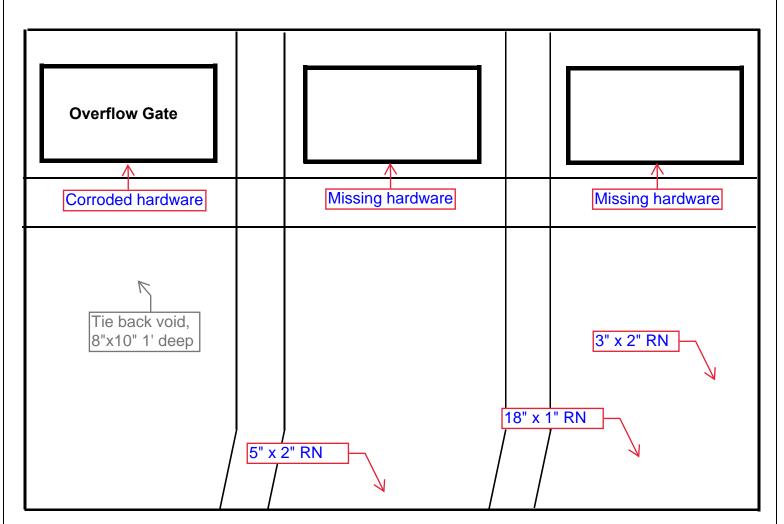
Bent___39___ Bent___38___

- Heavy marine growth present throughout
- Heavy corrosion unlocalized throughout
- Exposed aggregate on concrete at waterline
- Rust nodules present
- Right gate missing middle swing arm bolt
- Middle gate missing bolts right and middle; left corroded and missing nut
- Left gate Corroded hardware; cable improperly rigged
- Popout in left header

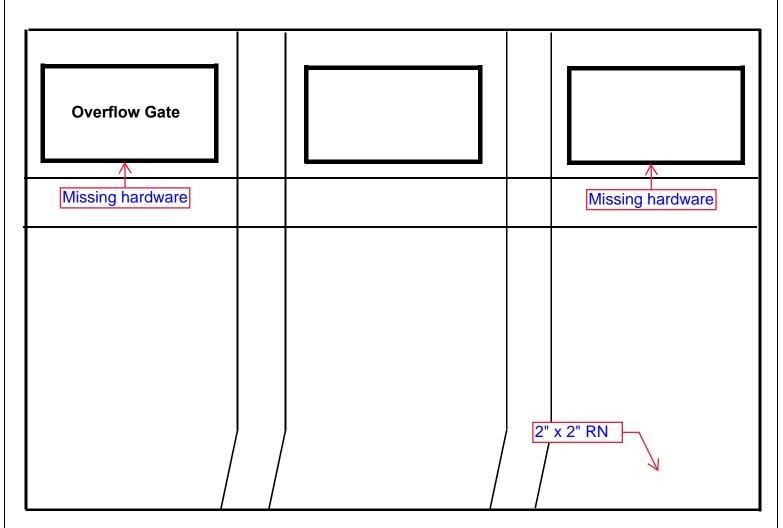
Bent 41 Bent 40

- · Heavy marine growth
- Heavy corrosion
- Exposed aggregate on concrete
- No undermining noted
- Right gate Wood panel loose/ damaged (no leak); missing hardware on left and middle; right corroded; cable improperly rigged
- Left gate Middle bolt missing; left and right corroded

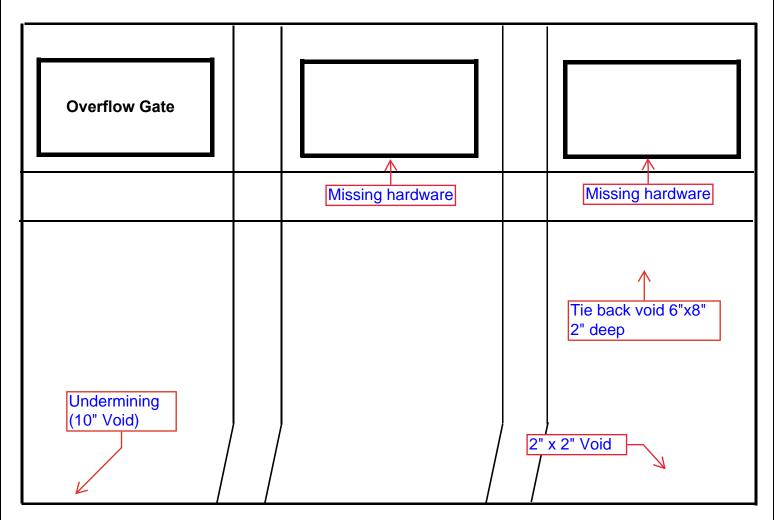
Bent 42 Bent 41

- Heavy marine growth present throughout
- Heavy corrosion unlocalized throughout
- 2x2" hole under right gate
- Exposed aggregate on concrete
- Void noted left of 2nd slant pile near tieback under header
- Right gate missing middle bolts; left and right corroded
- Middle gate missing right bolt
- Large undermining void left gate (10")

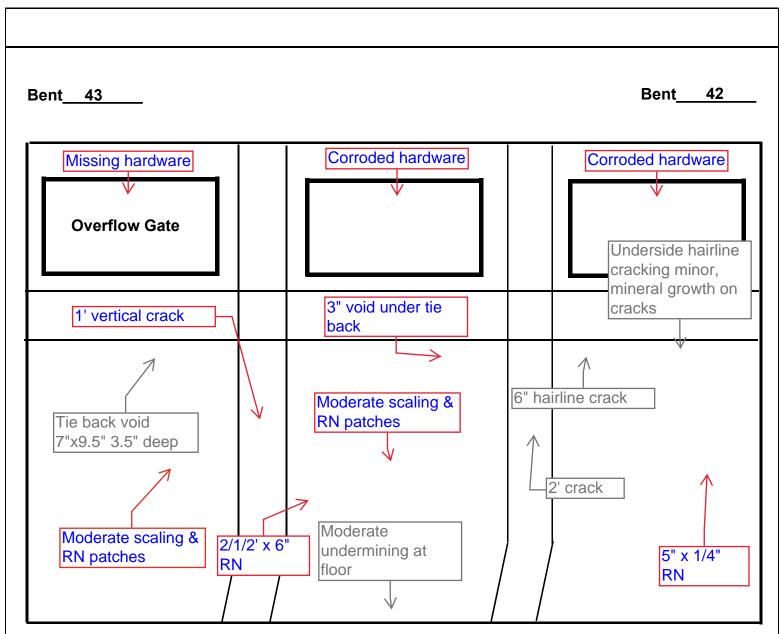
- No cracking under cap noted
- Heavy hard marine growth
- Most previous cracks not identified (covered by hard growth)
- Moderate rust noduling throughout underside
- · Moderate scaling present throughout
- Moderate exposed aggregate
- · Right gate corroding middle hardware; bottom wood panel splitting
- Middle gate corroded hardware; cable improperly rigged; splitting in wood panel
- Left gate missing hardware on right arm; middle corroded; wood panel splitting
- Spalling on Bent 43 joint

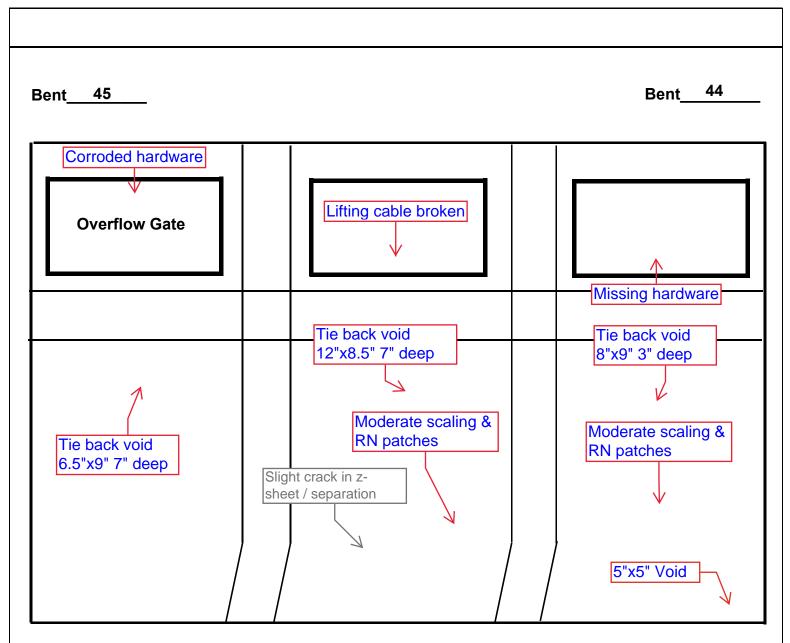
- · Heavy marine growth
- Moderate corrosion
- Heavy exposed aggregate throughout
- Void under right gate (5"x5")
- Right gate middle and right hardware missing; left corroded; gap in wood panel; cable improperly rigged
- Middle gate middle hardware corroded; broken lifting cable
- Left gate corroding hardware, cracking wooden panel

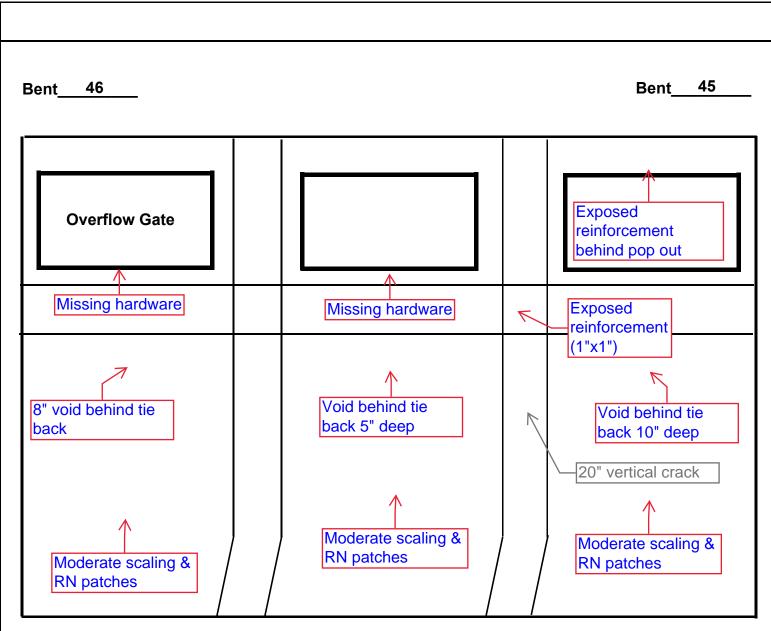
- No cracking under cap noted
- Heavy hard marine growth
- Moderate corrosion w/ scaling throughout entire section
- Minor to moderate exposed aggregate present
- Exposed reinforcement at right batter pile to header joint (1"x1")
- Right gate debris stuck in gate
- Middle gate middle missing hardware; left corroded; cable improperly rigged
- Left gate middle missing; right and left corroded
- Spalling on left header

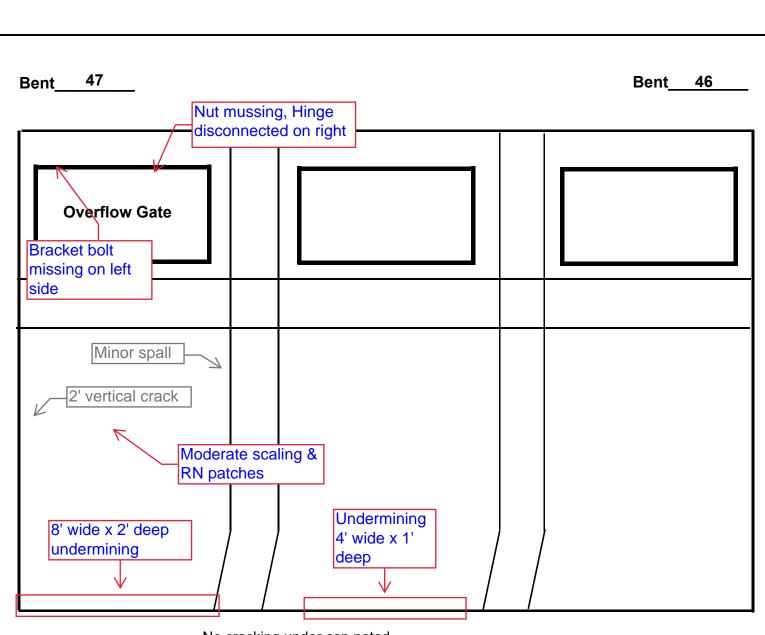
- No cracking under cap noted
- Heavy hard marine growth
- Moderate scaling on Z sheet throughout section
- Moderate exposed aggregate noted
- No undermining found on right side
- Undermining middle gate (4' wide x 1' deep)
- Undermining left gate (8' wide x 2' deep)
- Left gate missing hardware on right (nut) and left (bolt)

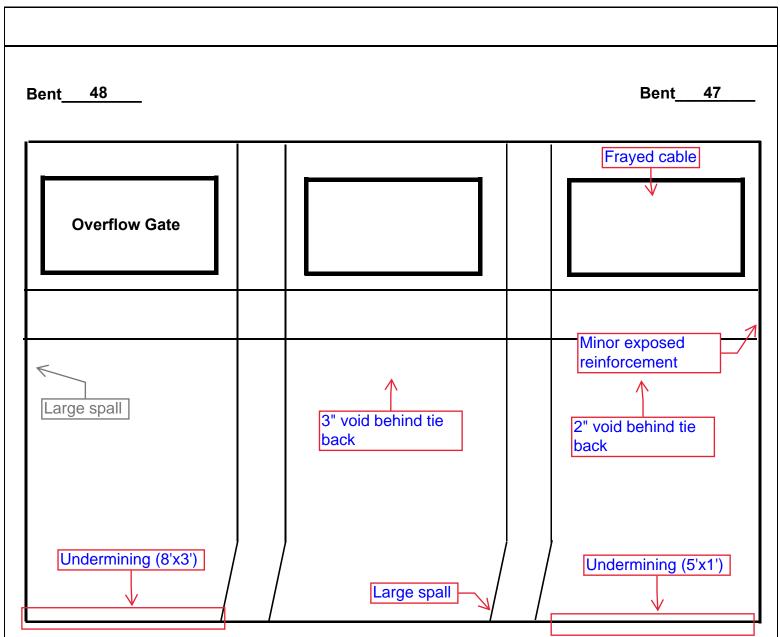
- No cracking under cap noted
- Heavy hard marine growth
- Moderate exposed aggregate noted
- Right side batter pile has a spall 2"w x 3"h x 1/2"d towards bottom of pile
- Right gate Frayed cable wire
- Undermining right gate (5' wide x 1' deep)
- Undermining on left side (6-8' long x 2-3' in depth)

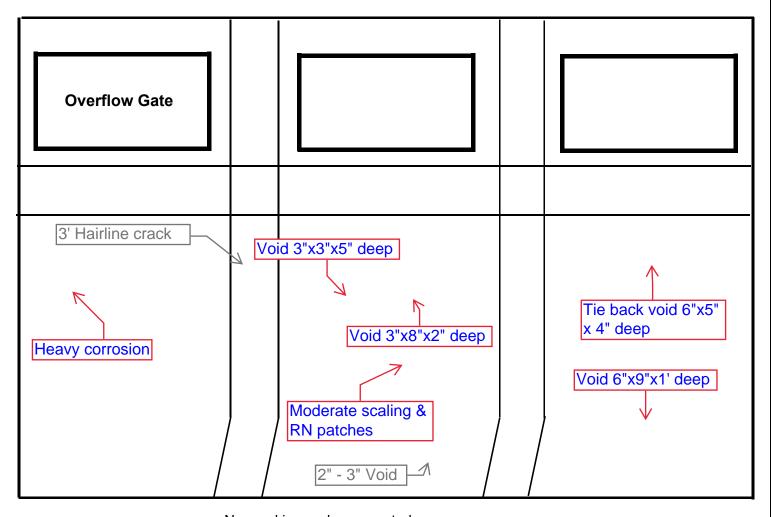
Bent 49 Bent 48

- · No cracking under cap noted
- · Heavy hard marine growth
- Moderate corrosion throughout section
- Heavy exposed aggregate at the waterline
- Void right bay (6"w x 9"h x 1' deep)
- Tieback void right (6"w x 5"h x 4" deep)
- Voids in middle bay
 - o 3"w x 3"h x 5"deep
 - o 3"w x 8"h x 2"deep
- No undermining noted

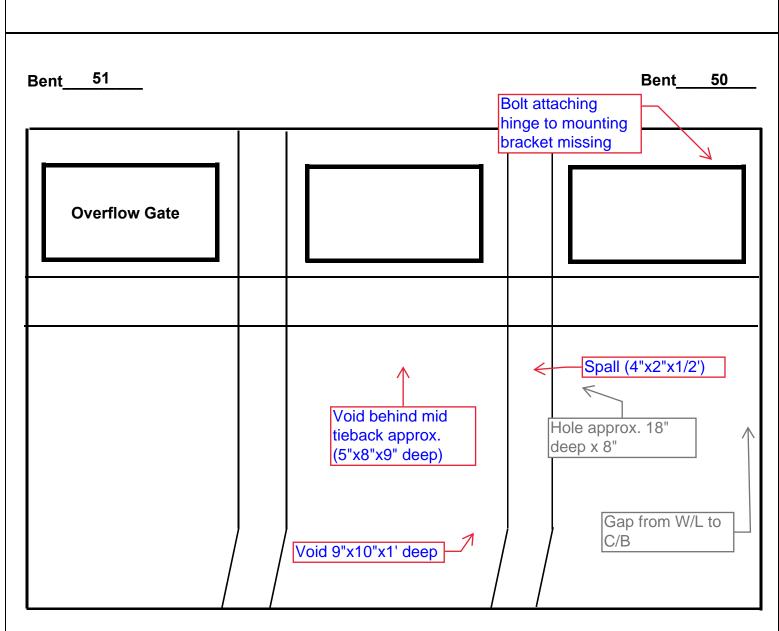
- No cracking under cap noted
- · Heavy hard marine growth
- Moderate scaling present on Z sheets
- Heavy exposed aggregate at the waterline
- · No undermining noted
- Right gate missing hardware
- Mid bay voids
 - o Tieback void middle (5"w x 8"h x 9" deep)
 - o 9"x10"x1' deep

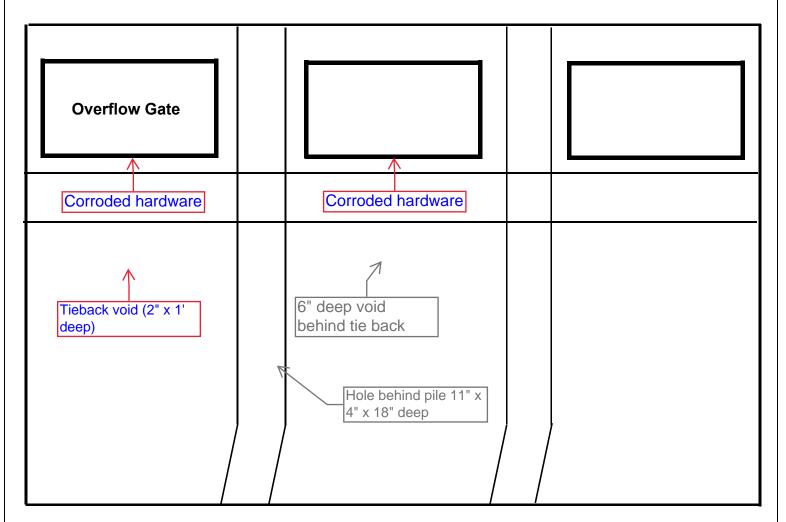
Bent 53 Bent 52

- No cracking under cap noted
- · Moderate exposed aggregate
- No undermining noted during inspection
- Heavy exposed aggregate at the waterline
- Left and middle gate heavy corrosion on cable shackle
- Left tieback void (2"w x 1' deep)

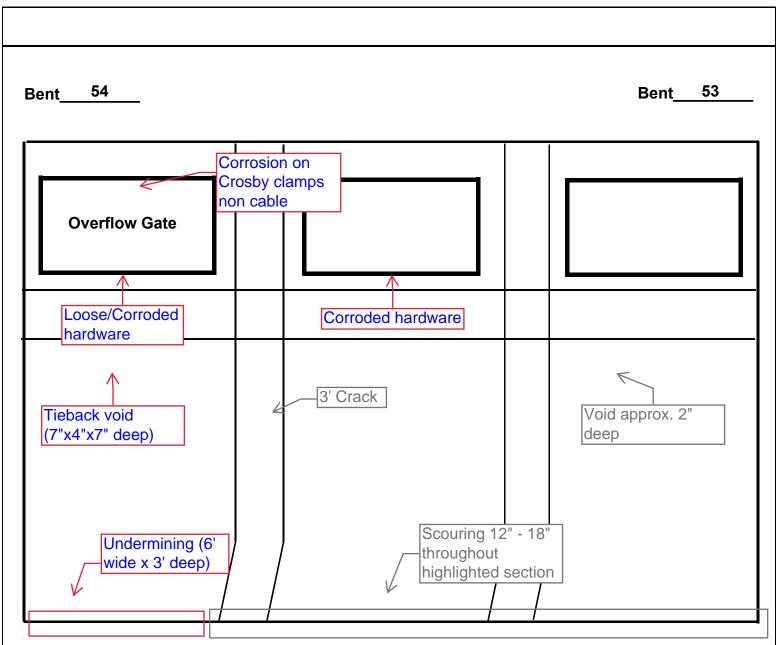
- No cracking under cap noted
- Heavy hard marine growth
- No undermining noted on right and middle
- Undermining under left gate (6' wide x 3' deep)
- Moderate exposed aggregate throughout
- Middle gate corroding hardware on cable connection to gate
- Left gate anchor bolt loose; corroding hardware; vegetation in gate
- Void left tieback (7"w x 4"h x 7" deep)

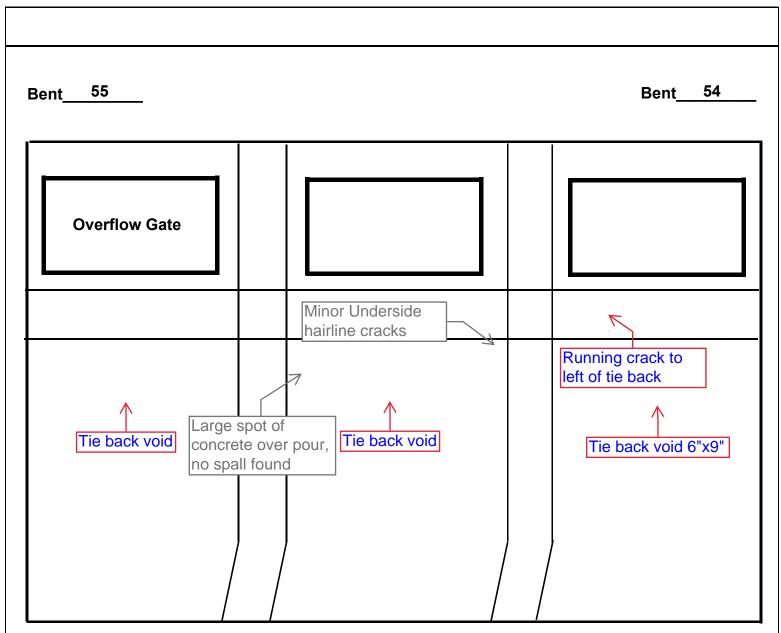
- Heavy hard marine
- Heavy exposed aggregate and Moderate/ Heavy bugholing
- Heavy corrosion and marine growth around all three tie backs
- Hairline crack on right gate header to the left of tie back (approx. 3')
- Large accumulation of marine growth behind right batter pile
- Weld seams and hardware on tiebacks in Good condition
- Fishing line debris wrapped on left tieback
- · Gate cables in Good condition

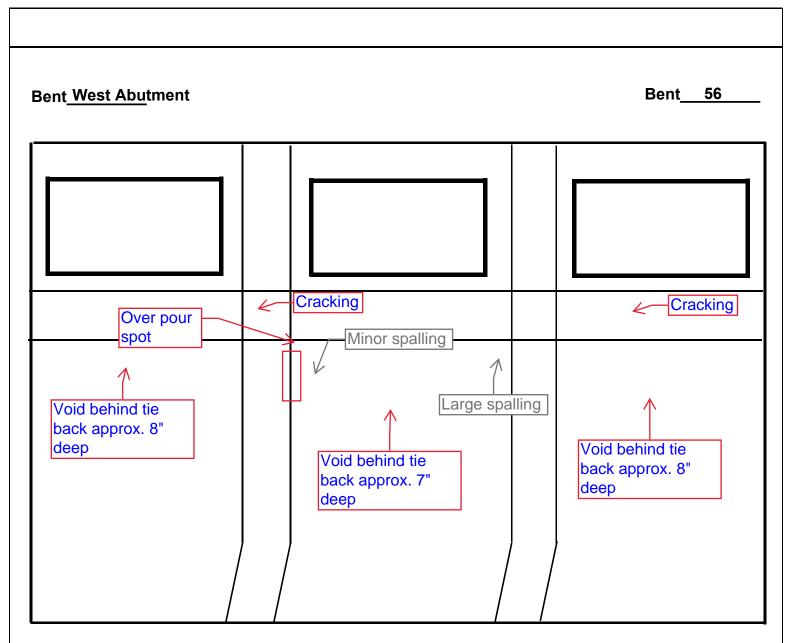
- Heavy hard marine growth
- Heavy exposed aggregate and Moderate/ Heavy bugholing
- Large void around all three tie backs; heavy corrosion and marine growth
- Previous identified exposed reinforcement not found
- Tieback weld seams and hardware in Good condition
- Moderate hairline cracking present throughout header
- Loose eye bolt on left gate
- Gate lifting cables in good condition

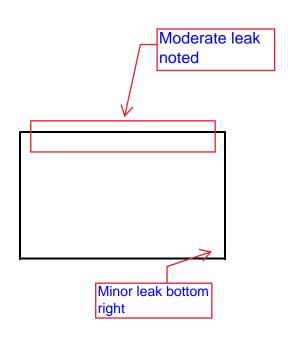
Gate #2 Gate #1

- Minor bend noted in upper "L" bracket
- Gasket deterioration top left
- Shaft satisfactory
- 70% marine growth
- Hardware present and tight
- Gasket pushed out on #2 (top)
- Missing a couple nuts and bolts on top seal

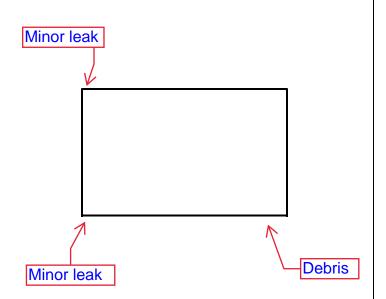
- Minor flow / leak (bottom left & top left)
- Debris / trash (minor)
- Moderate corrosion throughout
- Heavy marine growth present
- Approx. 40% 50% life left on anodes
- Stem looks satisfactory
- Gate adjustment bolt 3/4" shaft is 1/2"
- Side rail bolt is 1/4" nut is 1/2"
- Bottom seal is 1/4" shaft, nut is 1/2"
- Scour on apron near bottom of number 1

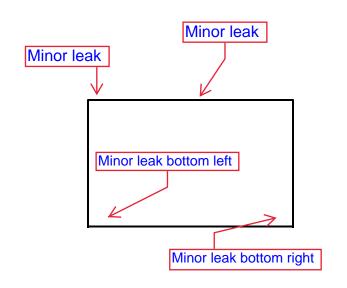
- Corrosion w/ pitting noted
- Heavy marine growth
- Approx. 50% 60% life left on anodes
- Minor leak bottom right side and left side
- Gasket in place and satisfactory condition
- Minor leak top left and middle
- All hardware on top seal present

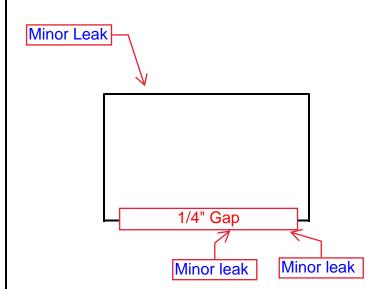
- Heavy marine growth
- Approx. 75% life left on anodes
- Corrosion w/ pitting
- Minor leak middle of gate right side
- Gasket satisfactory condition
- Minor leak bottom right
- Minor leak top left

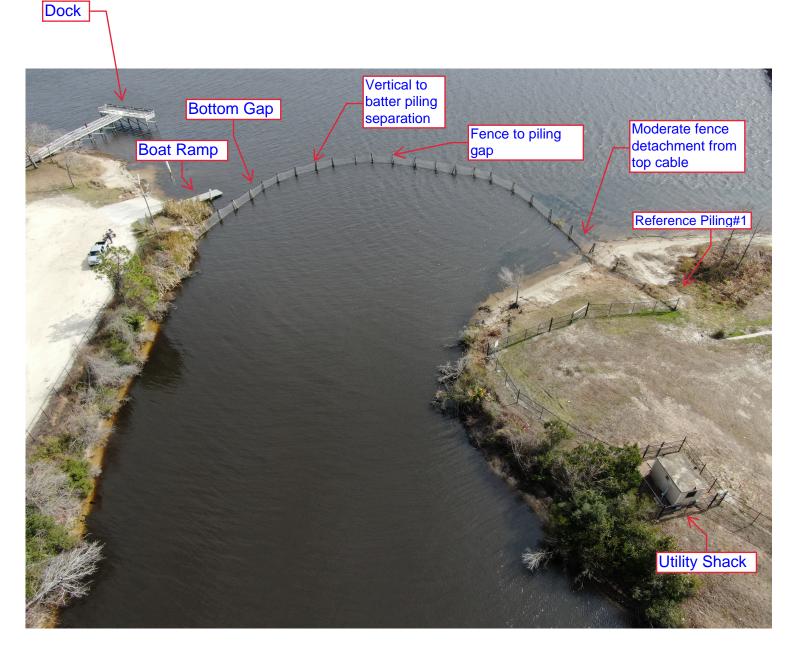
Fish Containment Fence

- Pins forward of pilings #7, 11 and 12 are unsecured and need to be reinstalled (completed 3/14/25)
- Most remaining pin re-anchored and secured to bottom profile (completed 3/14/25)
- Minor top cable to fence detachment unlocalized throughout
- Forward of piling #22 approx 1'x6' bottom gap
- Vertical to batter pile separation at piling 18
- Gap between fence and piling at # 14
