Engle Martin File Number: **1000434596**  
Insured: TRICO / City of Port St. Lucie  
Subject: Letter of Findings  
*Envista File No: MAT-163839-Z3N7*

On Monday, January 22, 2024, Envista Forensics (Envista) inspected the #12 well site for the City of Port St. Lucie. The well #12 was located adjacent to the easternmost entry to the Northport K-8 school property at 102 NW Floresta Drive, in Port St. Lucie, Florida.

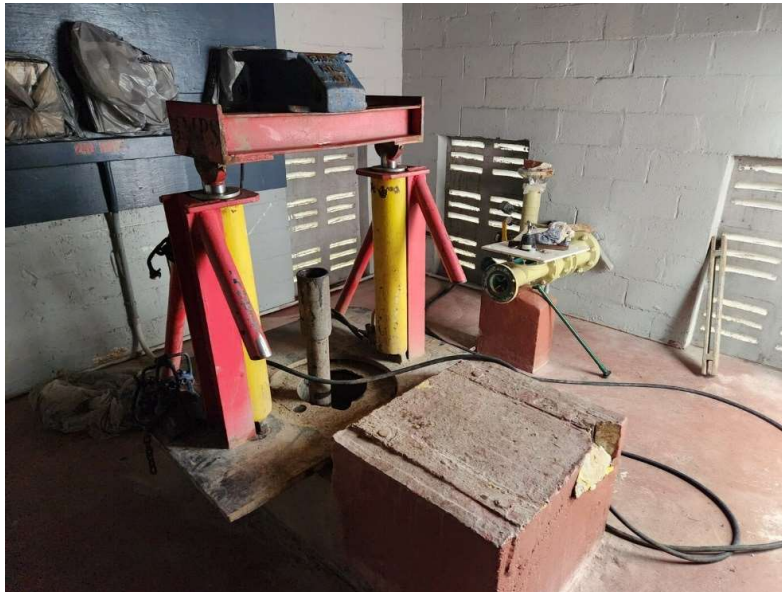
The #12 well head was located within the concrete masonry unit building at the site. Inspection of the well head was found with select above ground piping and valving removed and rigging installed over the well with a drill pipe left in place that extended approximately 2-feet above the well head opening (Photograph 1).

*Photograph 1 – Well #12 with drill pipe extended above rigging plate*

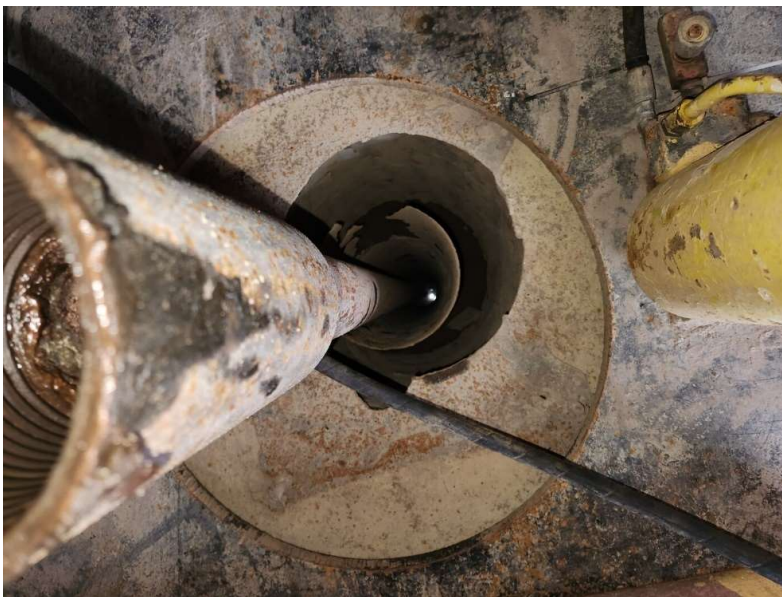
The drill pipe observed from the top of the well #12 was found to be located off center from the inner 8-inch inner steel casing (Photograph 2)

*Photograph 2 – Drill pipe off center of inner steel casing*

The subject well head had been out of service since the rehabilitation services had commenced in August 2023. During the rehabilitation services performed by AMPS, a drilling pipe became stuck in the stainless steel wire mesh screen of the inner well liner. Reportedly, several attempts were made by AMPS to remove the lodged drill pipe which to date have been unsuccessful.

Following Envista's site inspection on January 22, 2024, an addended proposal was provided by AMPS. The updated proposal services include drilling a 1.75-inch relief hole between the annular spacing of the inner 8-inch casing and the outer 16-inch casing to permit the 8-inch inner pipe to "move more freely," and allow the inner casing to be hydraulically removed.

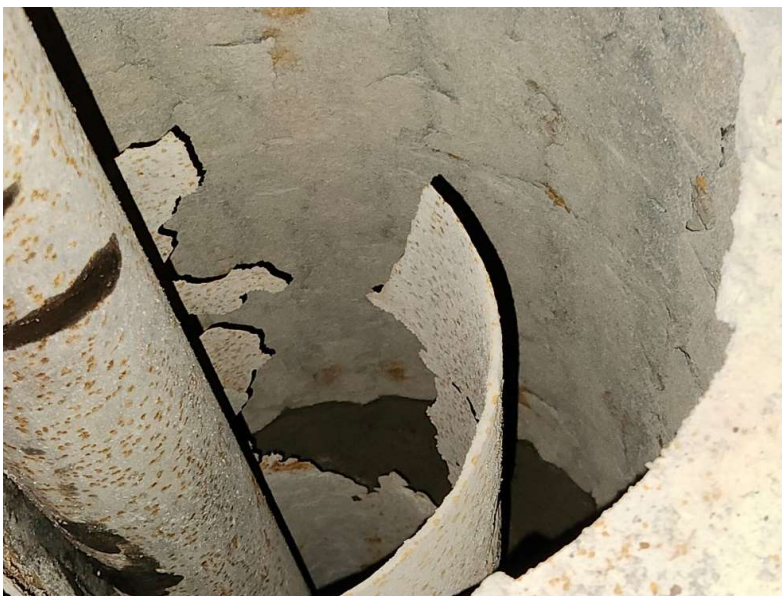
The inner 8-inch steel casing visible at the top of the well was found to be corroded with missing casing material (Photograph 3).

*Photograph 3 - Damaged inner 8-inch well casing*

The inspection of the section of the well #12 casing visible at the top of the well head was found to be corrosion damage with missing casing material. Well #12 was reportedly constructed in the year 1970 and the degradation to the inner steel casing was the purpose for its removal and replacement.
