**RE: Paradise Car Wash Cell Site Tower Design  
10870 SW Tradition Pkwy, Port St. Lucie, FL 34952 (St. Lucie County)**

For the Dynamic Towers, Inc. Paradise Car Wash Cell Site, a 150' monopole constructed of galvanized steel with the following elevations:

# ASCE 7 Hazards Report

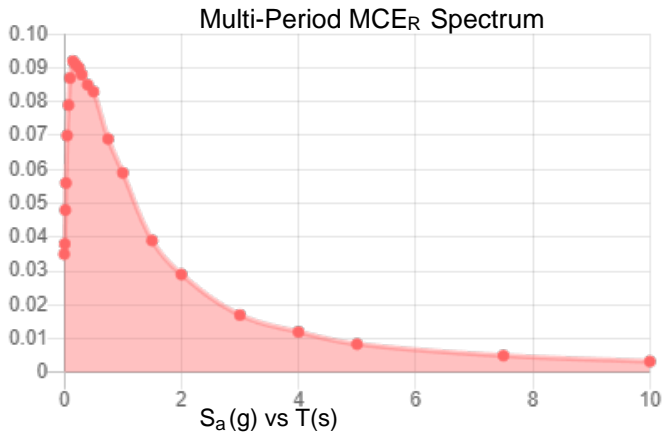
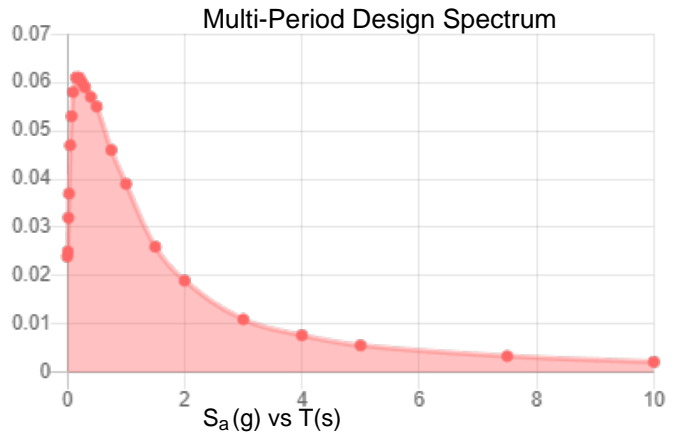
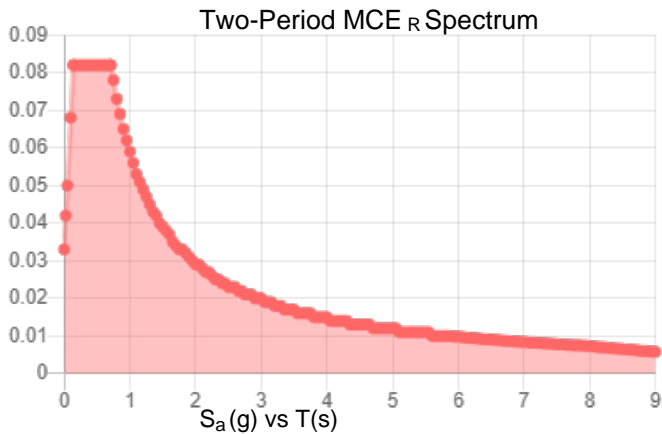
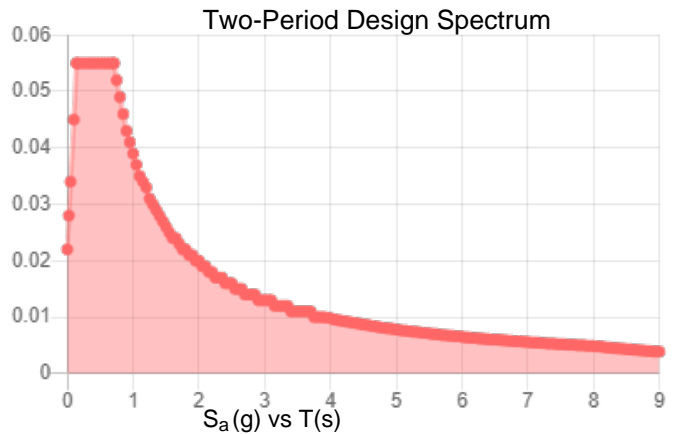
**Results:**

PGA <sub>M</sub> :	0.031	T <sub>L</sub> :	8
S <sub>MS</sub> :	0.082	S <sub>s</sub> :	0.061
S <sub>M1</sub> :	0.059	S <sub>1</sub> :	0.027
S <sub>DS</sub> :	0.055	V <sub>S30</sub> :	260
S <sub>D1</sub> :	0.039

**Seismic Design Category: A**
