**RE: Addendum #4 25-40 Utility Services Dive Services**

A comprehensive inspection was conducted by In Depth Inc. on both the saltwater and freshwater sides of the Deer Point Dam between March 14 and 16, 2025. Certified commercial divers performed the inspection, documenting physical defects, corrosion, biological fouling, and the condition of structural and mechanical components.

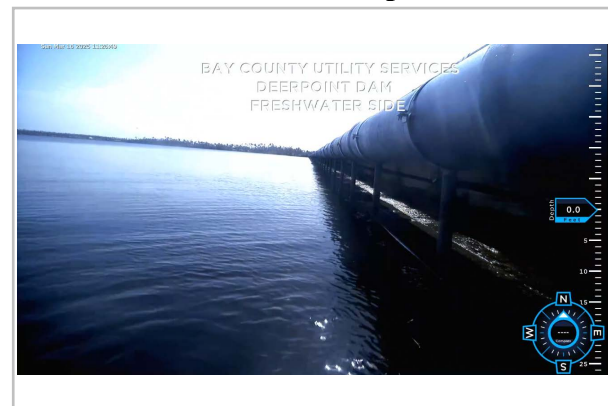
Freshwater Exposed Aggregate

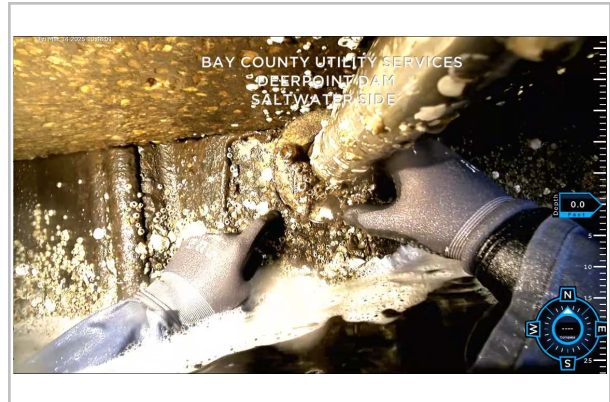
## Tieback to Z-Sheet Marine Growth

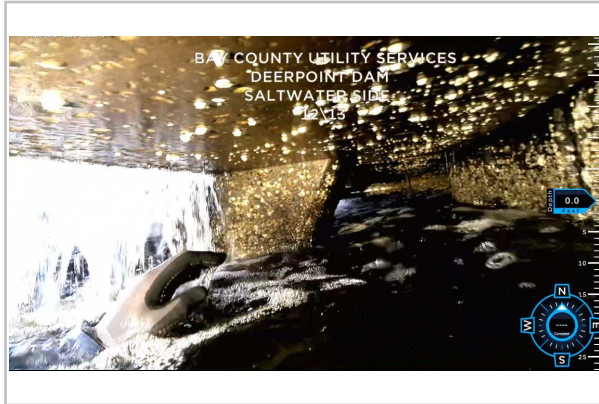
## Heavy Marine Growth

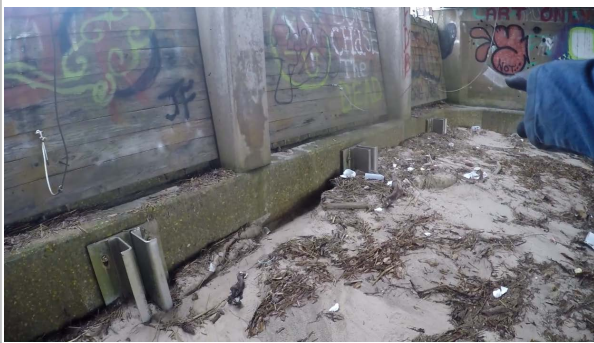
**Heavy Overburden (1/2)**

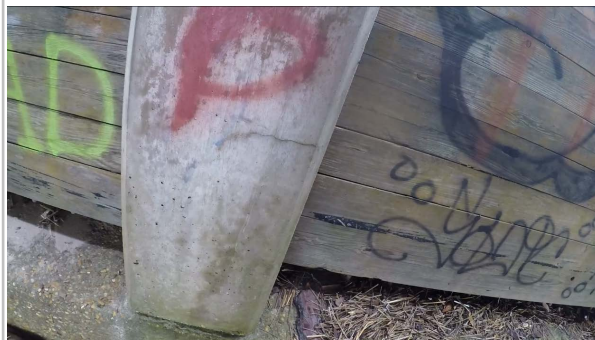
**Hairline Crack (1/2)**

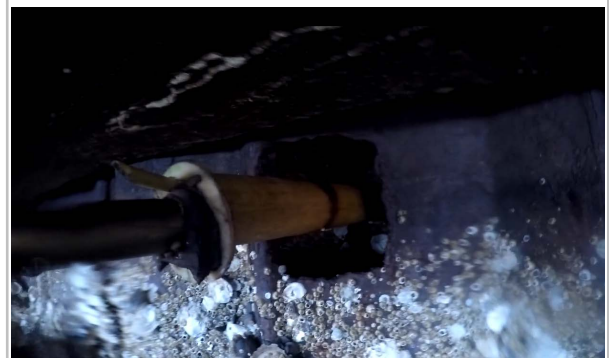
**Corrosion & Tieback Void (54/55)**

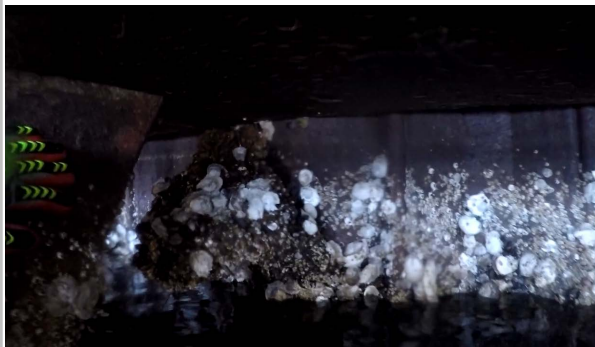
**Large Accumulation of Marine Growth (54/55)**

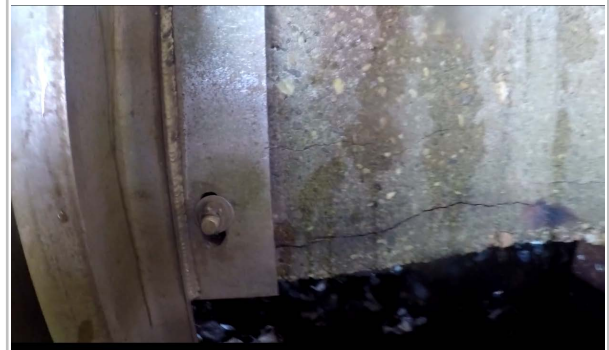
**Cracking on Header (56/ Abutment)**

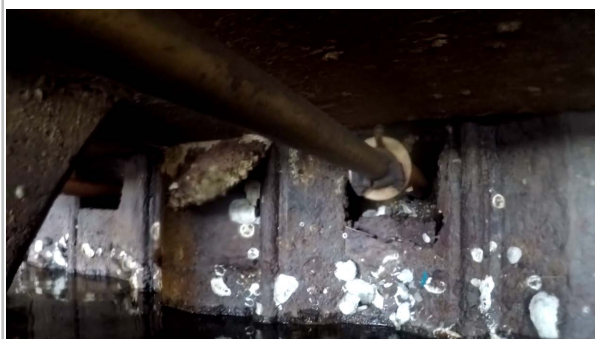
**Corrosion & Tieback Void (56/ Abutment)**

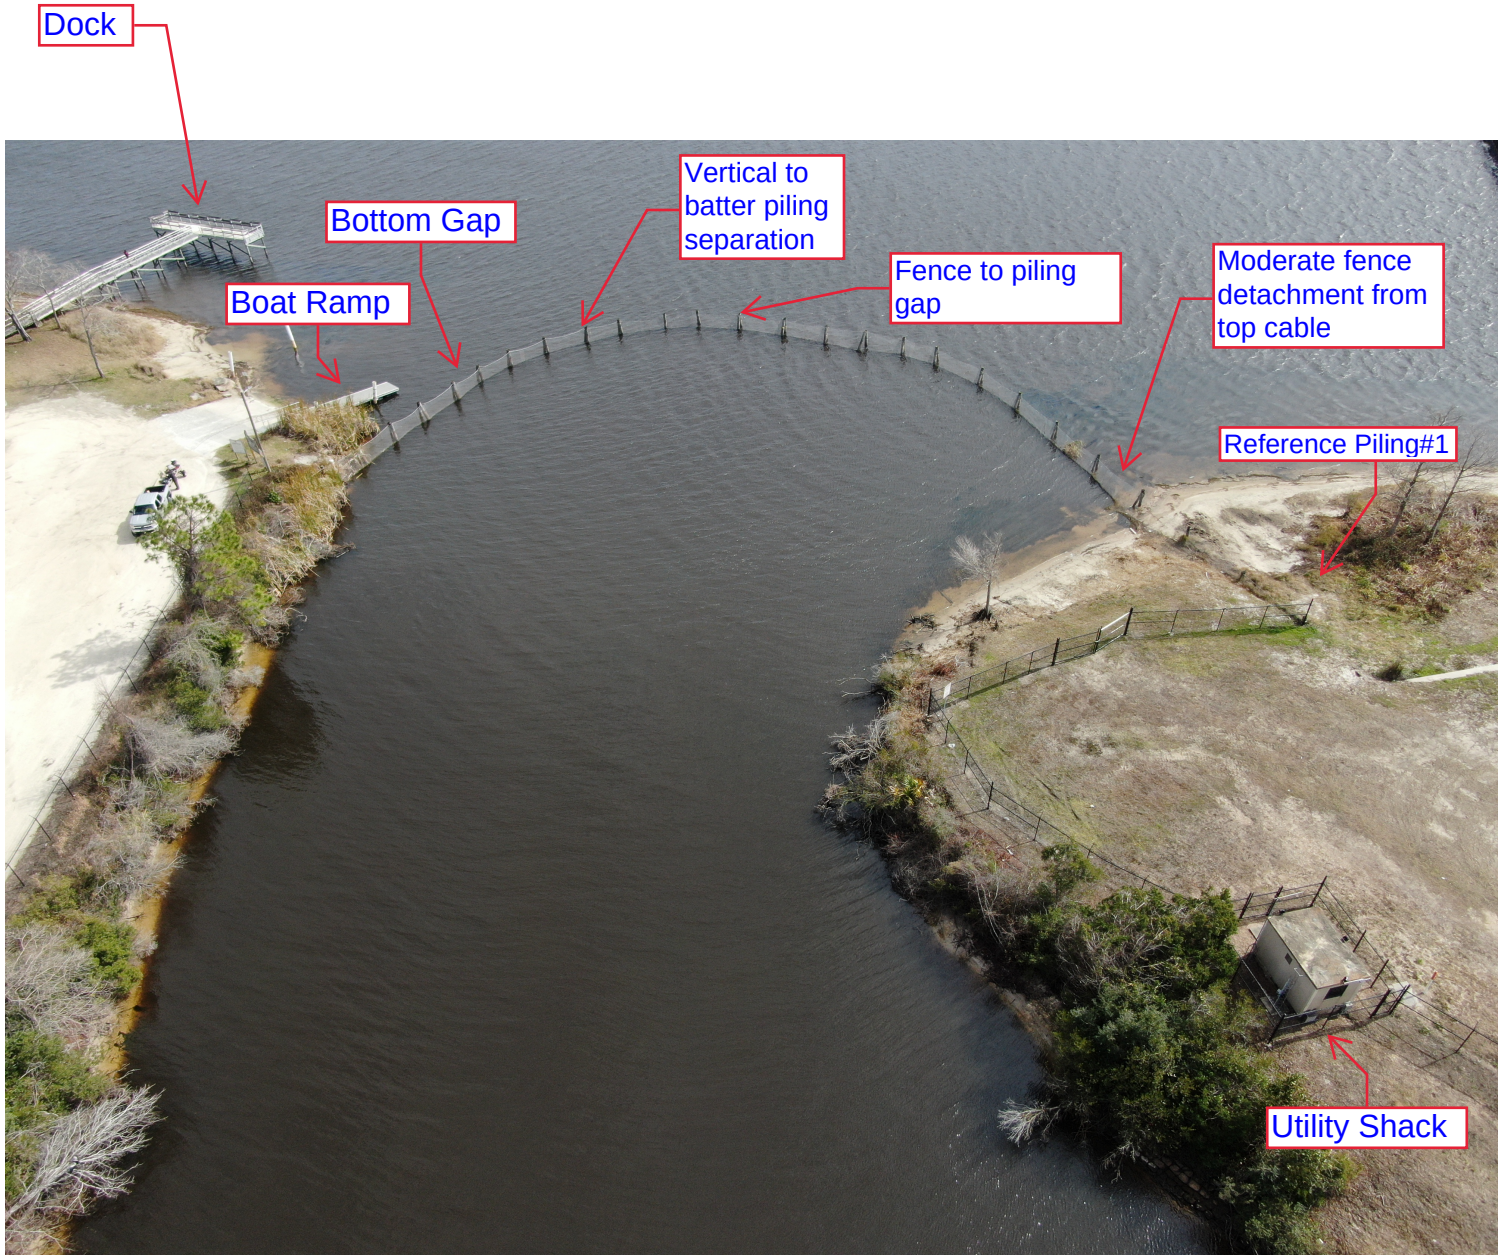
## Fish Containment Fence

- Pins forward of pilings #7, 11 and 12 are unsecured and need to be reinstalled (completed 3/14/25)
- Most remaining pin re-anchored and secured to bottom profile (completed 3/14/25)
- Minor top cable to fence detachment unlocalized throughout
- Forward of piling #22 approx 1'x6' bottom gap
- Vertical to batter pile separation at piling 18
- Gap between fence and piling at # 14

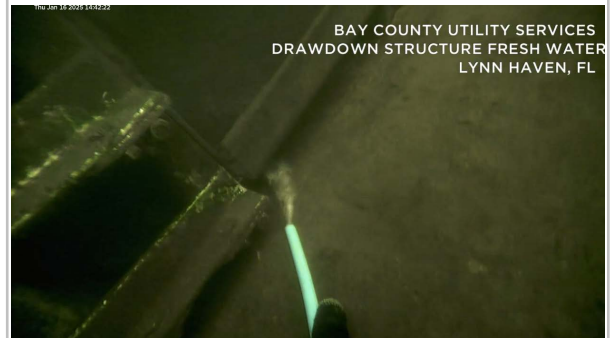
- No damage structurally
- Gate appears to be slightly open; 2" gap on gate
- Gate appears to be obstructed by debris - dead bird trapped under gate
- Sluice gate operating valve appears to be out of service
- Recommended to adjust gate
- Gasket appears to be in good condition

**Sluice Gate Gap - Fresh Water (#12)**

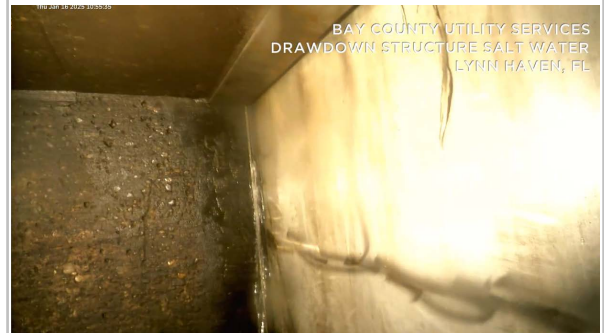
**Leak (Flapper Gate 10)**

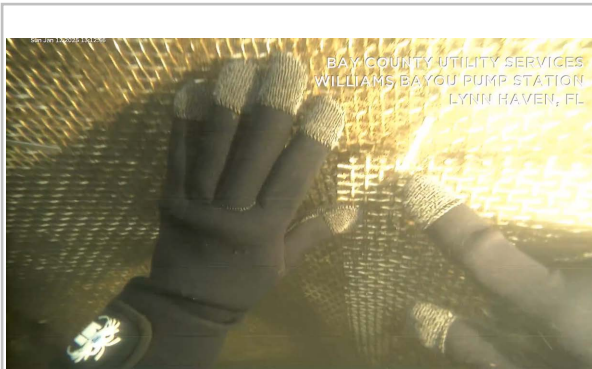
**Secured Fence Patch**

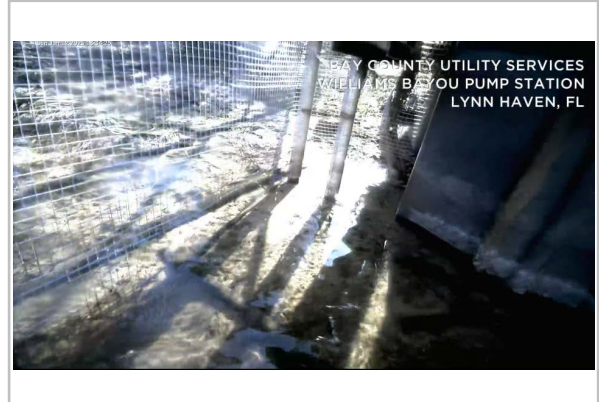
**Small Bottom Gap in Fish Fence**

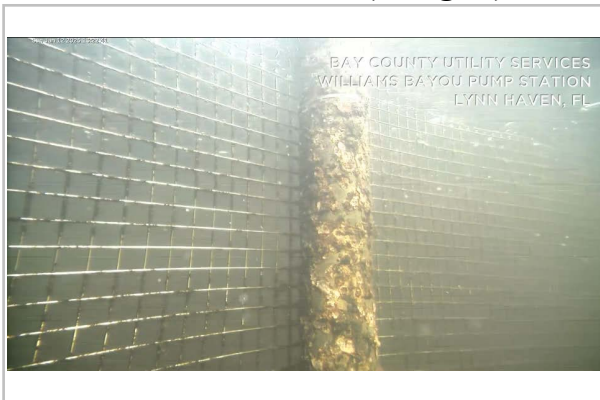
**Exterior Fence (Piling 18)**

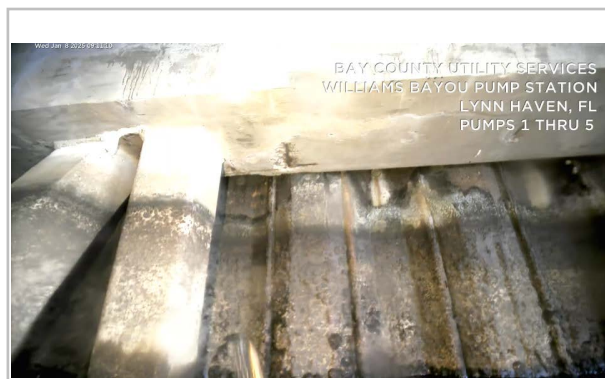
- Z Sheet Wall: mod surface corrosion throughout, mod-heavy soft growth
- Roof: mod-heavy hairline cracking, minor exposed reinforcement throughout
- Support Columns: Exposed aggregate present mod-heavy, abrasion minor-mod, waterline staining present, mod-heavy soft growth

**Exposed Reinforcement - Header Near Pump 1**
